COASTAL CLIFF LINE STABILITY AND REGRESSION IN THE NEWCASTLE REGION

M.G. Delaney

Principal Engineering Geologist, RCA Australia, Newcastle, NSW

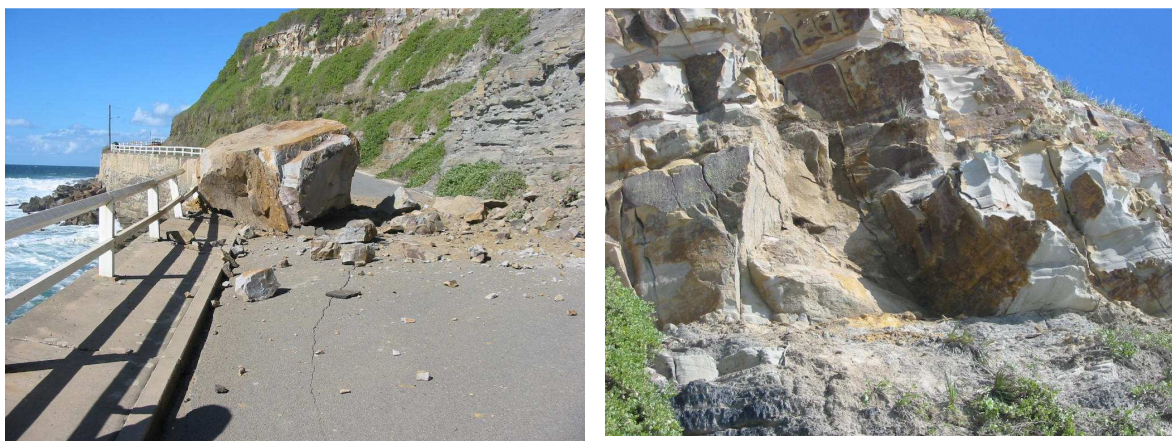
Inspection of the rock fall area from an elevated work platform noted that the sides of the failure are defined by two planar side joint planes dipping at 75° to 80° with clay infill 10 mm to 30 mm thick. The rear joint surface is an irregular to curvilinear plane dipping down out of the cliff face, with the upper half of the surface dipping at approximately 80° and the lower part at about 50° to 55° . The rear joint surface has localised zones of clay infill and extremely weathered rock up to 100 mm thick.

Photograph 1, 1a: Rock fall at Shortland Esplanade and source zone.

A siltstone layer occurs at the base of the sandstone block with fretting of the outer 100 mm forming a dry crumbly soil material. The base area of the sandstone rock that was bearing on the siltstone layer appeared to have been about 2.9 m

wide by 0.5 m to 1.1 m deep. Erosion of the siltstone has undercut the sandstone scarp up to 0.7 m in depth in the adjoining sandstone block to the north.

The rock fall mechanism appears to have involved toppling (rotation) failure. The key contributing factors are the presence of an adversely orientated hidden joint surface inclined at about 50° to 55° at the rear base of the block that significantly decreased the base area of the sandstone block that was supported on the underlying siltstone layer and the progressive erosion and fretting of the siltstone. This mechanism is illustrated in Figure 1.

It is considered that the block had been present in the cliff face with a factor of safety close to unity for years and that only minor erosion / crumbling of the siltstone base was necessary to upset the balance.

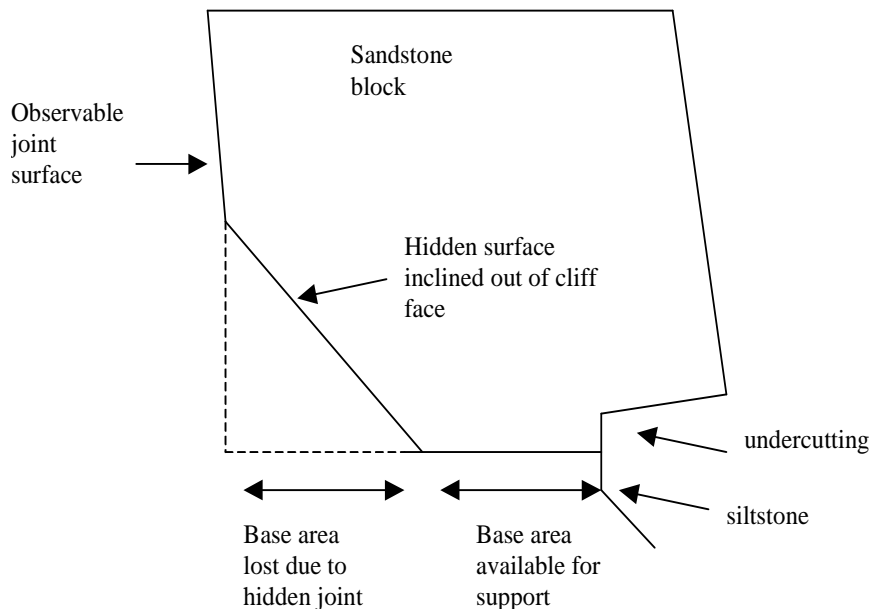
Figure 1: Sketch Illustrating Effect of Hidden Joint on Block Base Area.

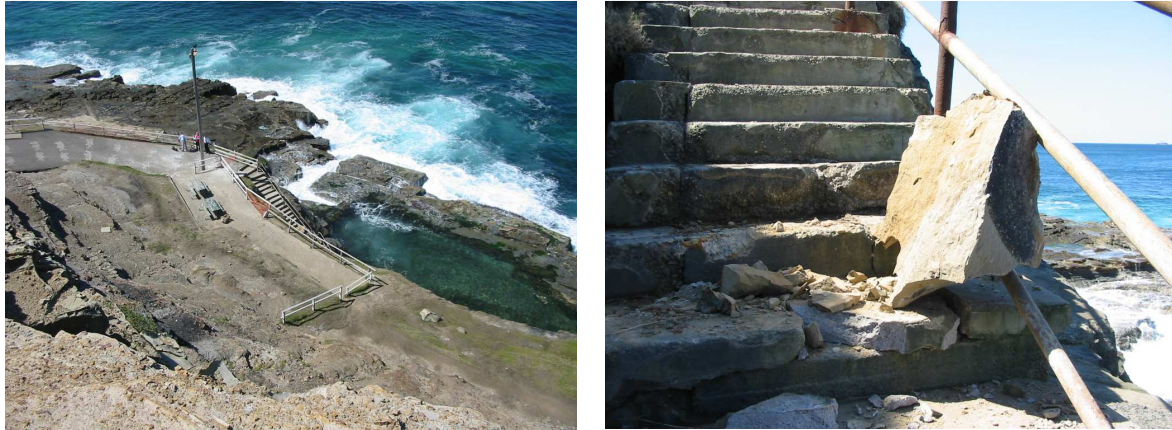
The rock fall appeared to have involved dislodgment of a sandstone wedge up to 1.5 m in size from a single location. The block split into three main rock fragments (0.5 m to 1 m in size) during the fall trajectory with fragments coming to rest near a picnic table, half way down the stairs to the baths and in the middle of the baths.

- Right side – planar joint striking 90° and vertical with clay coating / infill.
- Left side –irregular to curvilinear joint striking approximately 150° and dipping at about 50° down out of the cliff face with clay infill.
- Base surface at the junction of the above two joints of less than about 0.3 m thick.

Photograph 2, 2a: Rock fall at Bogey Hole, slope overview and rock fall fragment.

The rock fall wedge occurs in the middle of the sandstone layer and does not appear to be associated with weak siltstone / tuff materials. Localised opening of sandstone rock joints can be observed along the crest of the cliff.

The rock fall mechanism appears to have involved toppling of a wedge formed along intersecting joints. The primary causative factors are:

- Open joints with clay in-filled surfaces (common stress relief feature),
- Adversely orientated joint surfaces in particular a low angle joint surface inclined at 50° and
- Loss of base support through progressive erosion of the sandstone.

The rock fall appears to be a natural cliff erosion process associated with the presence of a sandstone wedge formed along an inclined intersecting joint surface that has progressively lost base support through erosion of the sandstone.

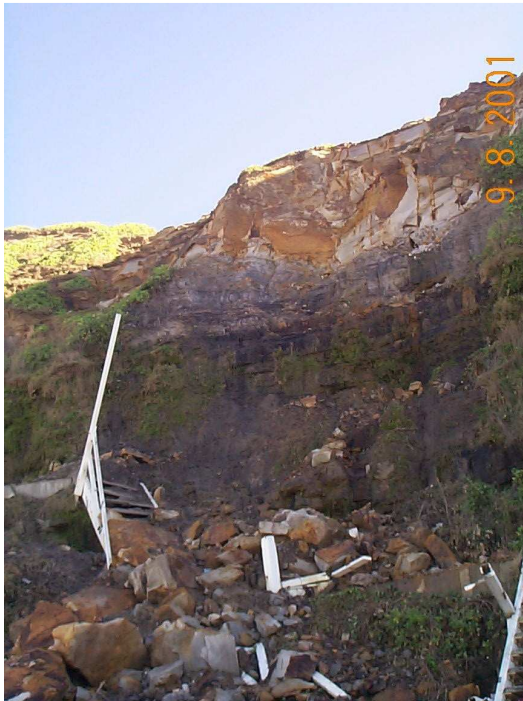
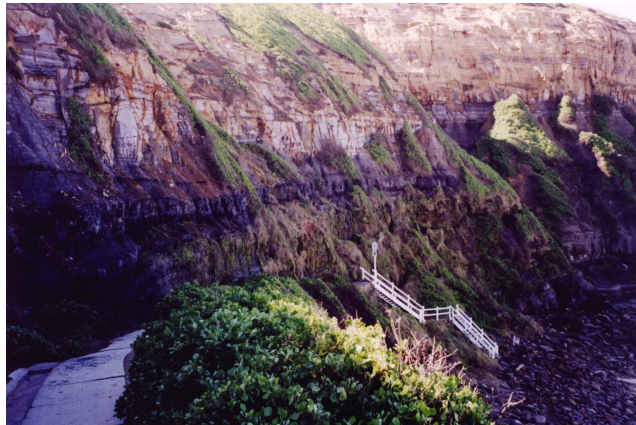
Access to Susan Gilmore Beach was via a concrete pathway with wooden stairs leading down to the beach. A rock fall from the cliff face in May 2001 during a period of heavy rainfall resulted in rock fall debris demolishing the stairway as shown in Photograph 3.

The rock fall involved toppling failure of sandstone rock estimated at about 10 m^3 from the cliff face about 5 m above the top of the stairs. The rock fall debris ran out about 10 m onto the gentler slopes below the base of the cliff.

The sandstone layer comprises moderately weathered rock with sub-vertical joints typically spaced at about 0.5 m to 1 m with a slope gradient of about 60° that overlies inter-bedded siltstone and coal associated with the Dudley Coal seam and sloping at a gradient of about 45° above the pathway and stairs.

No evidence of erosional undercutting was noted along the base of the sandstone layer in the adjoining cliff sections and no evidence was noted in a photograph of the cliff taken in 1998 (Photograph 3b).

- The presence of a limonite stained planar rock joint surface that is inclined down out of the cliff face at about 60° and orientated sub-parallel to the cliff face.
- Water pressure within the rock joints during heavy rainfall.
- Progressive loss of rock mass strength associated with long term coastal weathering processes.

Photograph 3, 3a: Rock fall at Susan Gilmore Beach. Rock fall and source area on left (2001) and area before failure above (1998).
