WAIKAREMOANA POWER SCHEME - PIRIPAUA PENSTOCK ENGINEERING GEOLOGY STUDY AND RISK ASSESSMENT

R.M. DAWSON

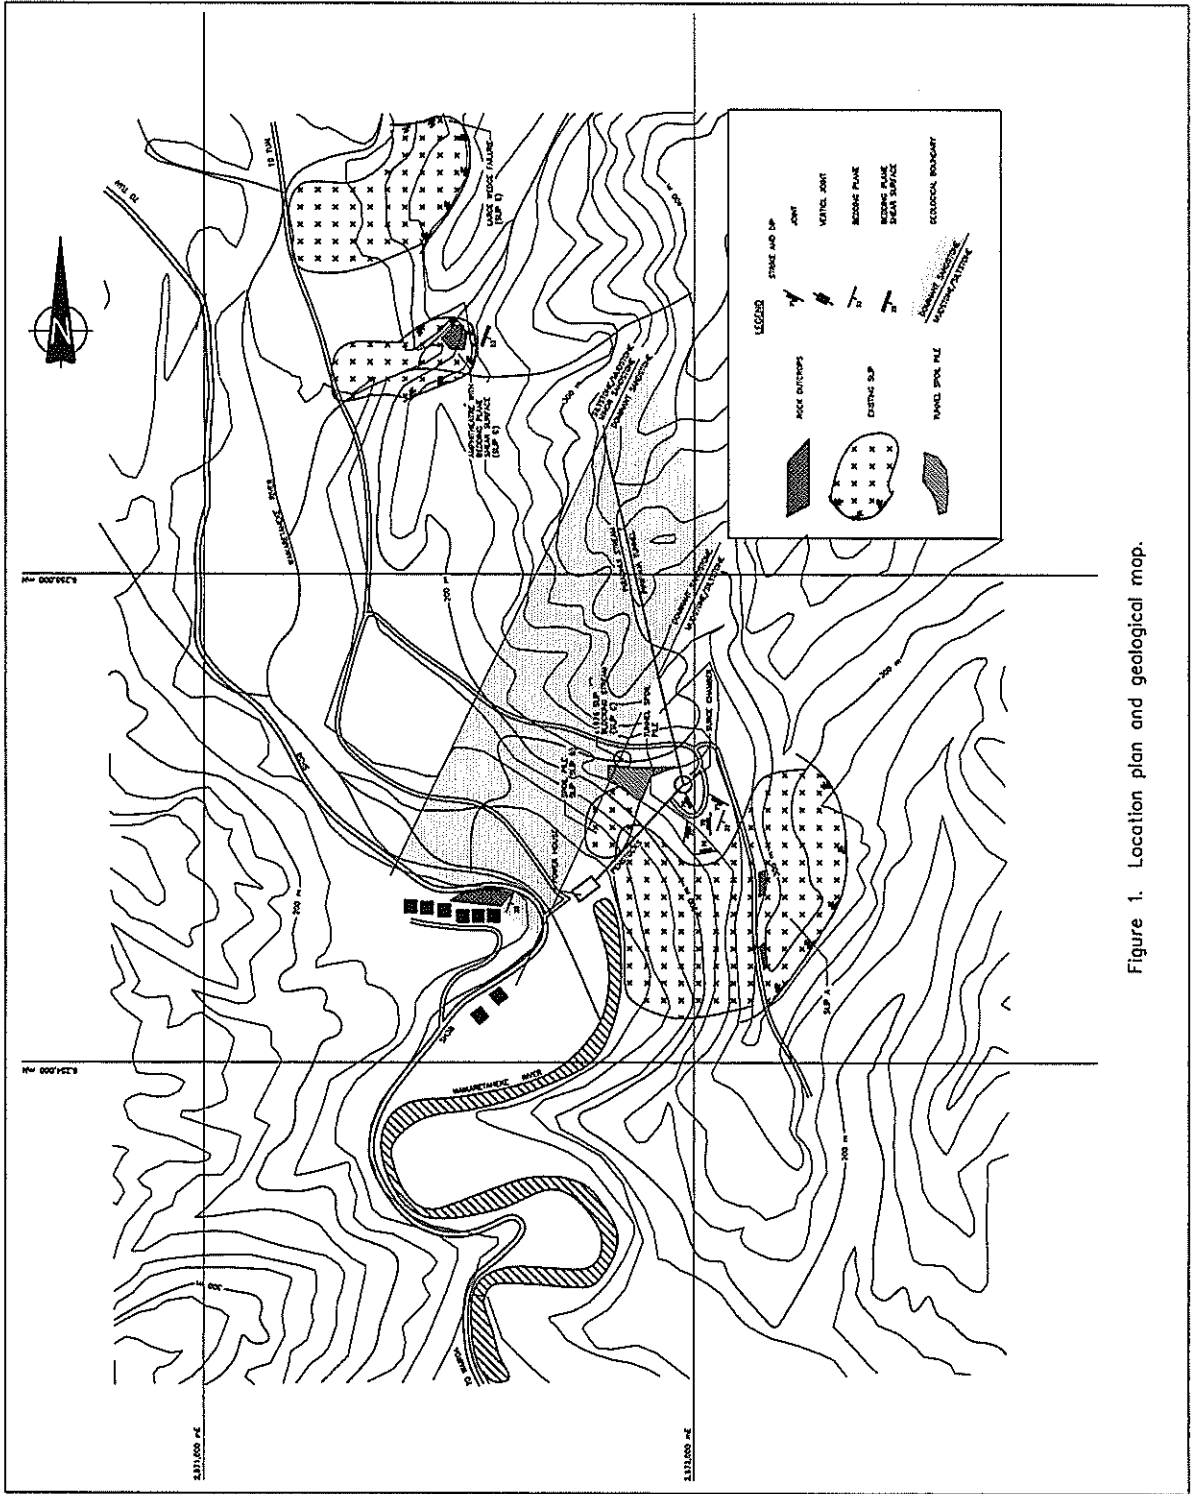
Figure 1. Location plan and geological map.

Aerial photograph interpretation suggested that two historic landslips were present in the immediate area of the Piripaua penstocks and powerhouse, as shown on Figure 1. The construction photographs showed that one of these slips was linked to construction of the tunnel leading to the surge tank, as the photo shows that the tunnel spoil was dumped on the north facing side of the ridge leading to the west from the surge chamber. Some of this spoil appears to be pushed over the ridge line and has slid down the slope towards the powerhouse.

- The toe of a landslide on the south eastern side of the penstocks has been eroded by the Waikaretaheke River (Slip A). The slip was likely to have been caused through undercutting and over-steepening of the rock mass by the Waikaretaheke River resulting in a defect controlled release surface. The slope now appears to be in equilibrium with slip debris at the toe of the slope and providing a buttress which will reduce the likelihood of further failures.

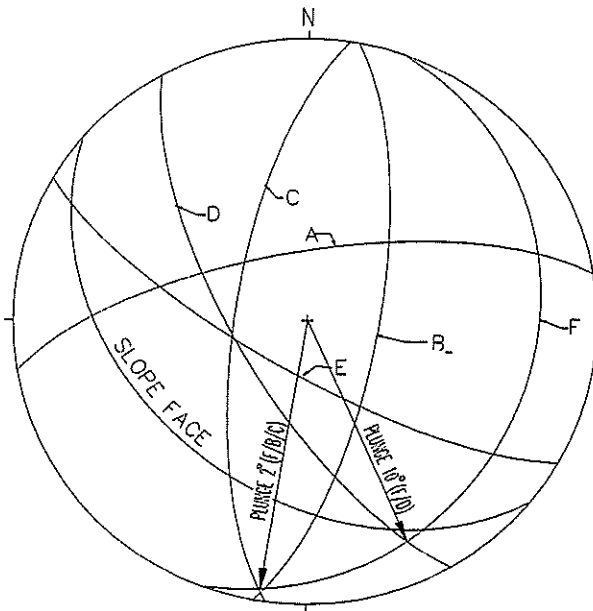
Figure 2. Design stereoplot data.

Defect surveys were carried out at the surge tank and at nearby road exposures. The defect orientations are summarised on Table 1 and Figure 2. The main defect set is bedding (set F) with the orthogonal defect sets C, D and E.

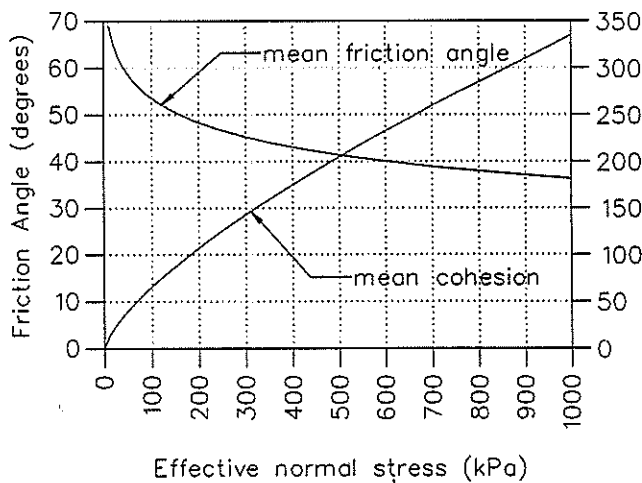
Figure 3. Mean Strength Parameters.

The shear strength versus effective normal stress curve was plotted for the 5th and 95th percentiles, and power curves fitted to them. The mean and standard deviations of c' and ϕ' were developed and are presented in equations 1 to 4 below.

The above curves are presented in Figure 3.

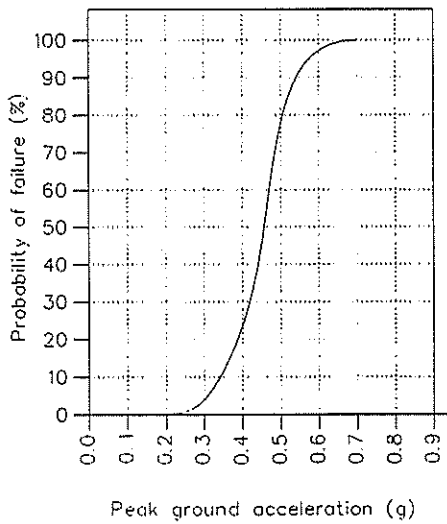
Figure 4 Effect of seismic acceleration.

To further highlight the effect seismic acceleration has on the probability of failure (failure is defined as a factor of safety less than 1.0) a relationship between PGA and probability of failure was developed. The results are presented in Table 5 and plotted in Figure 4 for large volume slips (i.e. full wedge height).

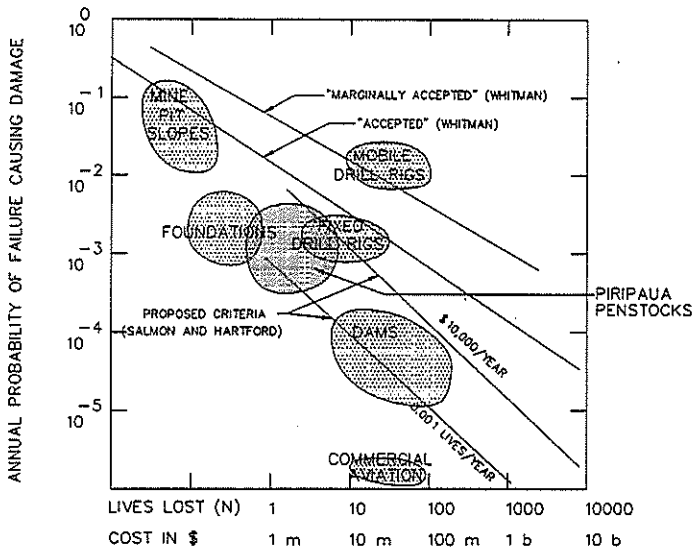
Figure 5. Risks for selected engineering projects.
(Whitman, 1984 and Salmon and Hartford, 1995)

The risk of a large wedge failure with current assumed ground water conditions (full saturation) is approximately 0.5% for any one year. Figure 5 shows some examples of normally acceptable risks for selected engineering projects as suggested by Salmon and Hartford. As shown by the area shaded for the Piripaua project, the present risk is generally within the lower range of commonly accepted risk criteria.

The critical failure analysed is a large wedge failure that is limited by the height of the slope. Due to the volume of rock involved conventional methods of reinforcement such as rock bolting or anchoring are not feasible. The only feasible option for reduction in the degree of risk is drainage of the penstock slope.

If groundwater levels proved to be high after monitoring, two main options would be available for drainage of the slope. As a relatively inexpensive option, horizontal bored drains could be installed in the slope. A drainage adit would be more effective but would involve considerably more cost.
