Site characterization of the area surrounding a sinkhole, a case study

M. P. Magagula¹, AMSAICE and G.R. Wardle¹, FSAICE

ABSTRACT

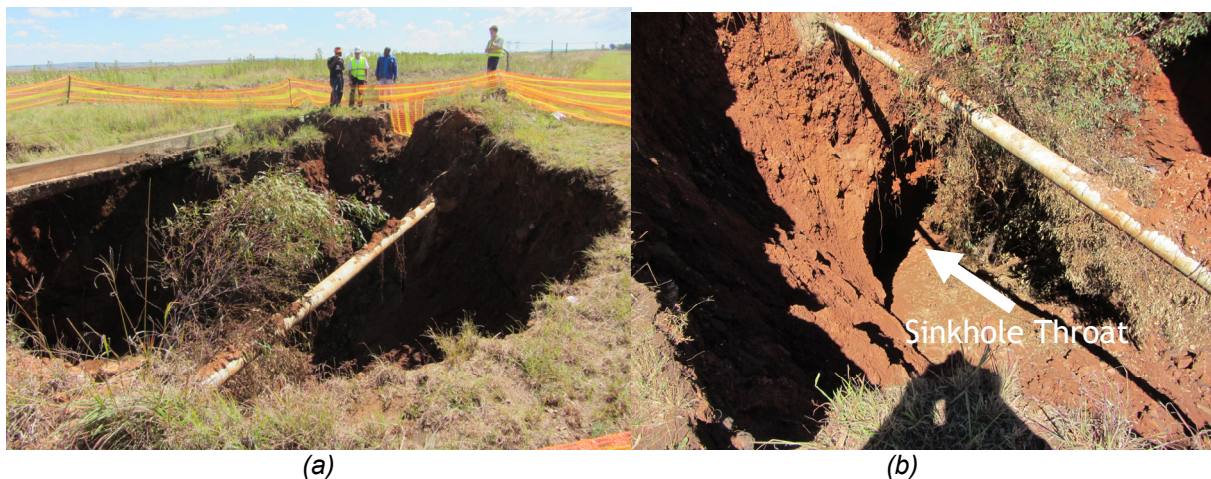
In April 2014, a sinkhole formed below a fuel distribution pipeline in the Tarlton agricultural region of Gauteng. The regional geology comprises Malmansi Subgroup dolomites of the Chuniespoort Group, Transvaal Supergroup. The sinkhole (left hand side of Figure 2) was about 10m to 12m in diameter at ground surface and was estimated to be about 7m deep on average. The sidewalls of the sinkhole were near-vertical with the overburden comprising mainly silty sand with fine chert gravels and ferricrete/manganconcrete nodules.

A preliminary site inspection of the sinkhole was undertaken to determine the possible causes of the sinkhole, as well as to assess any damage to the fuel pipeline. During the preliminary inspection, it was noted that the fuel line had neither ruptured nor had incurred any damage, thus was most likely not the reason for the sinkhole formation. Also noted during the preliminary inspection, was that at the southern end of the sinkhole, there was an approximately 1.5m diameter “throat” that disappeared from view in a southerly direction almost immediately below the pipeline (shown in the right hand side of Figure 2). It was through this throat and lower-lying cavities that the ground that originally occupied the volume of the sinkhole had been eroded.

Figure 2. (a) Sinkhole; and (b) 1.5m Sinkhole Throat

During the site visit it was also discovered that the probable cause of the sinkhole was an existing trench, termed a “security trench”, dug to prevent vehicles entering the area on the property on which the pipeline is located. The trench facilitated collection and ponding of surface water run-off, thus resulting in infiltration into the underlying subsoil and ultimately leading to the collapse of the overburden.

For safety reasons as well as to prevent water ingress into the sinkhole, which would have resulted in material washing away through the sinkhole throat, thus increasing the size of the sinkhole. Emergency backfilling of the sinkhole was recommended and carried out shortly after the initial inspection. The backfilling was a short term solution as saturation of the backfill from surface water ingress would be likely to cause the soil to start settling under its own weight and drag the pipeline down.

Following the inspection, the sinkhole was immediately backfilled with loose spoils placed as an emergency measure for (i) safety; (ii) to prevent further concentration of surface water; (iii) to prevent enlargement of the sinkhole by choking the throat; and (iv) to provide support to the fuel line. Upon re-inspection of the site at a later stage, it was discovered that consolidation of the fill had resulted in a slight depression of the surface.

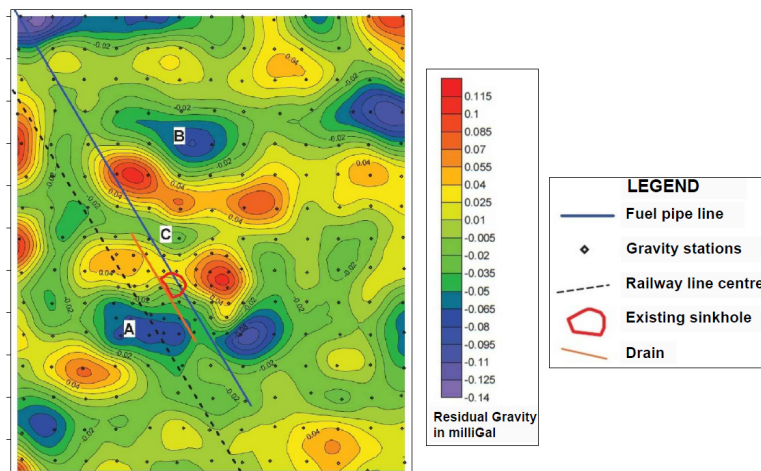
Figure 3 illustrates the results of the residual gravity survey highlighting three anomalies detected namely; Anomaly A – a very prominent gravity low, Anomaly B – a gravity low and Anomaly C – a relatively high gravity feature.

From Figure 3 it can be seen that there was no defined gravity low in the immediate area of the sinkhole that could be associated with a cavity. However, anomaly A suggested that, if anything, the cavity would be expected on the south western side of the sinkhole. A decision was taken to investigate this anomaly and the area immediately around the sinkhole by drilling percussion boreholes. It was clear that it would take an assimilation of the gravity maps, borehole information, as well as observations during the initial site visit, in order to properly classify the area.

Figure 3. Residual Gravity Survey

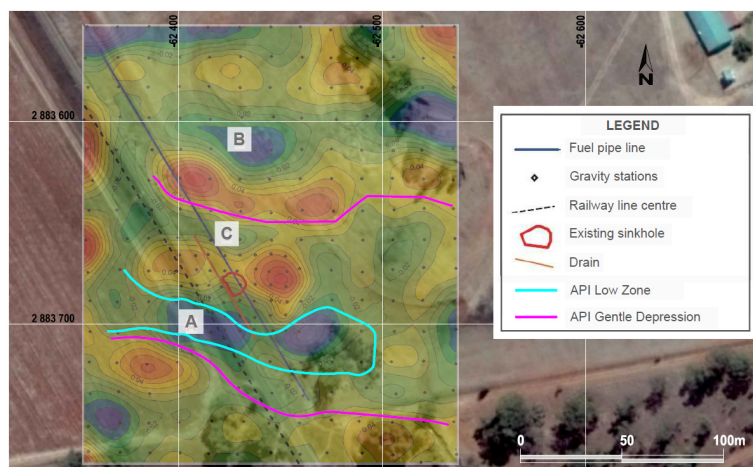
The API indicated that, within the area of the sinkhole, a defined linear depression is evident and has been there since 1968. The main section of this depression conformed well to the gravity lows recorded during the gravity survey as shown on Figure 4. The depression is characterized by a very gentle gradient that would typically not have resulted in excessive concentration and infiltration of surface water.

Figure 4. API Interpretation

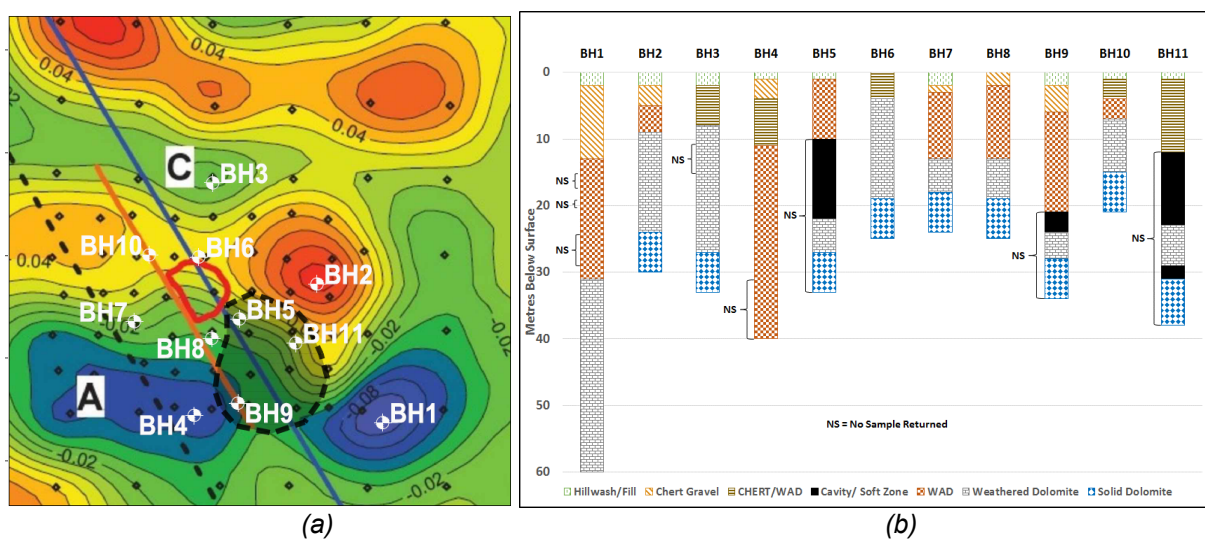
Following logging of the chip samples by an experienced engineering geologist, a profile log was compiled for each borehole including the drilling parameters. Figure 5(a) shows the borehole positions as well as the approximate position of the cavity, whilst Figure 5(b) shows a simplified profile summary for each borehole.

Figure 5. (a) Borehole Positions; and (b) simplified profile of material units within each borehole

From Figure 5 it is evident that the gravity survey was able to identify the shallow (BH3, Anomaly C) and deeply weathered profiles (BH 4, Anomaly A) in the bedrock. However, it was not able to identify the cavities/soft zones around the sinkhole identified in BH5, BH9 and BH11.

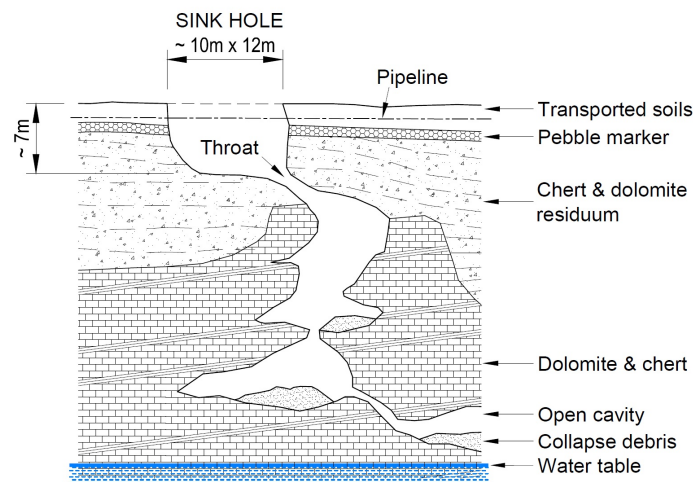
Based on the drilling information the approximate extent of the cavity and its position relative to the sinkhole was established. Figure 6 illustrates the extent of the sinkhole and the approximated locations of the underlying cavities.

Figure 6. Sinkhole and Underlying Cavities

An interesting and unexpected observation of this project was the offset and asymmetrical location of the surface expression of the sinkhole compared to the sub-surface cavity. In January 2004 a 20m deep, 30m wide sinkhole formed in Bapsfontein located in the east of Johannesburg. The sinkhole was also asymmetrically located from the throat; this shows that a throat asymmetrically located from the sinkhole is not a unique feature to the Tarlton Sinkhole. Most illustrations of a sinkhole model, e.g. SANS 1936, show the sinkhole developing directly above the mouth of the cavity. Recent centrifuge research at the University of Pretoria (Jacobsz, 2016) confirms the vertical chimney-like nature of the propagation of subsurface erosion mechanisms in cohesionless soils above the water table. It is important that we further develop our understanding of these mechanisms and the reasons for the sinkhole to develop off-centre with respect to the mouth or throat of the cavity.

Remedial works of the sinkhole are not discussed in this paper, suffice to mention that compaction grouting of the sub-surface void was carried out to prevent a repeat occurrence of the sinkhole. As part of this exercise, the “security” trench was backfilled and the surface levelled off to allow surface water to pass over to a nearby concrete-lined drainage channel.
