THE WALL THAT MOVED

Geoff Young

Principal, Douglas Partners Pty Ltd, Sydney Australia

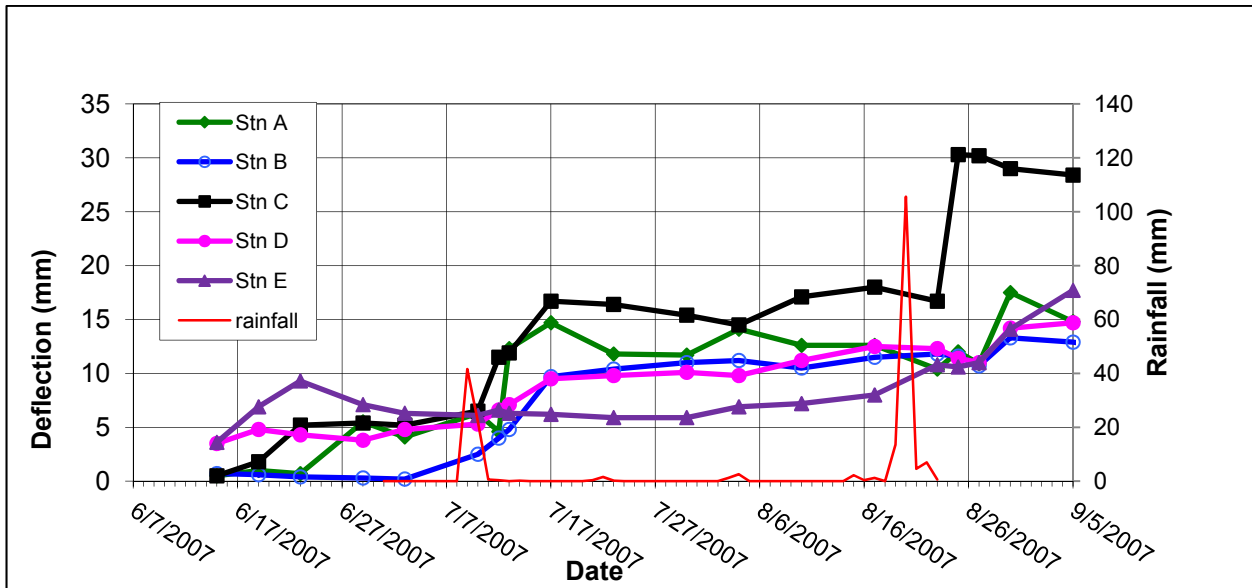
Based on the results of the survey monitoring, the first significant movement of the wall occurred about 12 July 2007 when movements up to approximately 10 mm were recorded. There was another significant movement about 23 August 2007 when movements at about the middle of the wall length increased from about 17 mm to 30 mm. The wall movements on selected days for survey points A, B, C, D and E have been plotted on Figure 1.

Figure 1: Survey of the Shoring Wall Deflections for the Period June to September 2007

Plotted on the same figure are the daily rainfall measurements for Sydney with most observations recorded from Observatory Hill. As can be seen from the plot, the significant rainfalls occurred on 9-10 July and 20-24 August.

For the period 7-17 July 2007 and in the area of piles 1 to 45, it would be reasonable to assume that the basement excavation was within 1 m of the final design level and was in rock before 9 July 2007 in order to construct the second row of anchors which are recorded as being grouted, but not stressed, between 12 and 17 July 2007. As noted above, a substantial period of rainfall was recorded on 9 – 10 July 2007. The anchors were not stressed until after 17 July 2007 by which time the movement had occurred.

A more substantial rainfall event occurred around the time of 18-25 August 2007. The second row of anchors for piles 46 to 61 were drilled and grouted by 30 August 2007. Based on the substantial amount of rain recorded during the week of 20 to 27 August 2007, it is likely that no major excavation work would have been carried during that week and the records show that the second row of anchors in piles 46 to 61 were installed during the following week. Therefore, excavation of the basement along this section of the wall (Station E) would probably have been nearly completed by 20 August 2007 which is before the heavy rain and before the second row of anchors were installed and stressed.

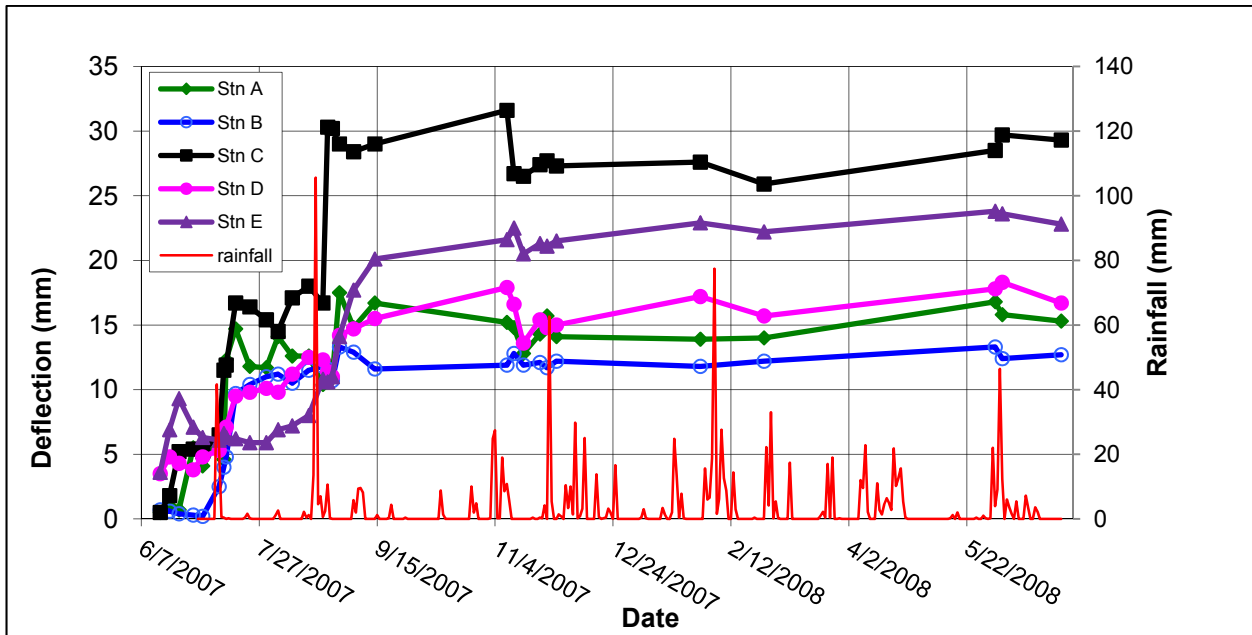
Survey monitoring continued after the shoring wall movement of August 2007 but there was no significant movement recorded after August 2007 even after some substantial rain events as is shown in Figure 2.

Figure 2: Survey of the Shoring Wall Deflections for the Period June 2007 to July 2008
