CASE STUDY OF RAILWAY EMBANKMENT STABILISATION WORKS AT MOOR PARK STATION WITH PROGRESSIVE SLOPE FAILURE

Chun Yean Tey

Coffey Geotechnics, Sydney, Australia (formerly Mott MacDonald, London, United Kingdom)

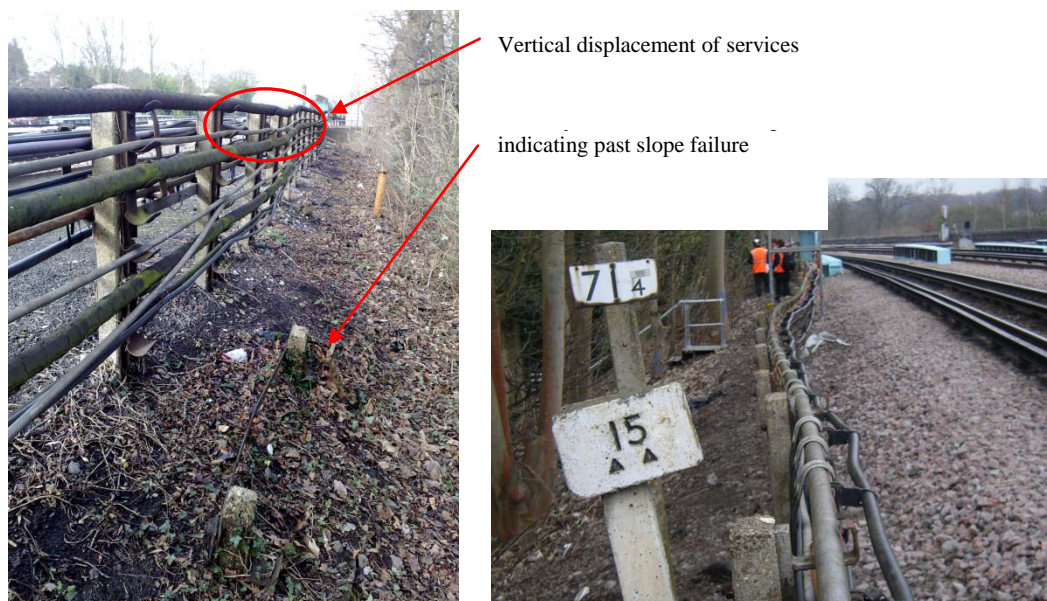
A site walkover was also undertaken at both embankments and shallow slope instability features were observed (see Figure 2). These features include ravelling of the ash upper slope at certain stretches of EM12 and EM13, exposing footing posts for the lineside services cable run and resulting in some ash build up against trees. Other instability features observed include creep terracing and exposure of downslope roots of many of the mature trees.

Figure 2: Signs of instability at crest: vertical displacement of services and partially buried cable (left photo) and leaning cable posts carrying cable runs (right photo).
