# PILES CREEK EMBANKMENT COLLAPSE – THE INVESTIGATIONS, THE EXPERT’S FINDINGS AND SUBSEQUENT IMPROVEMENTS IN ASSET MANAGEMENT OF CULVERT STRUCTURES ON MAJOR ROADS IN NSW

C. Shackell<sup>1</sup> and P. Retsof<sup>2</sup>

<sup>1</sup>Technical Director, <sup>2</sup>Geotechnical Engineer, Aurecon Australia Pty Ltd

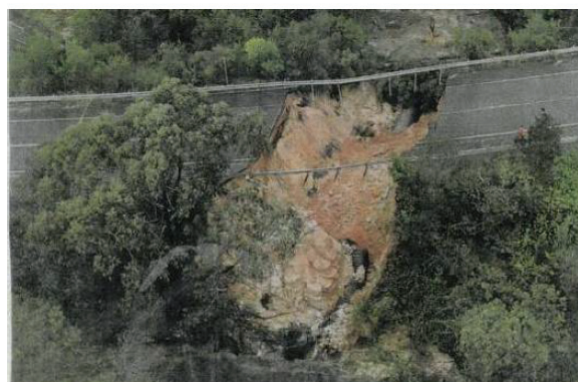
At approximately 15:30 hrs on Friday 8 June 2007, during a period of significant rainfall, a section of the Old Pacific Highway at Piles Creek, Somersby collapsed. A car subsequently drove into the void created by the collapse resulting in the death of all five occupants. See Figures 1 and 2.

Figure 2: Aerial photo of collapsed section

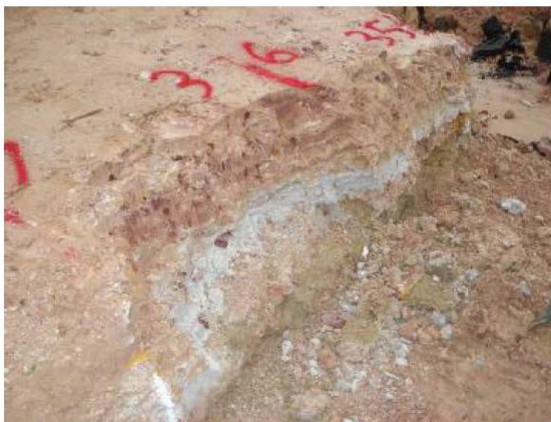
**Figure 6: Trench face exposing fill layering**

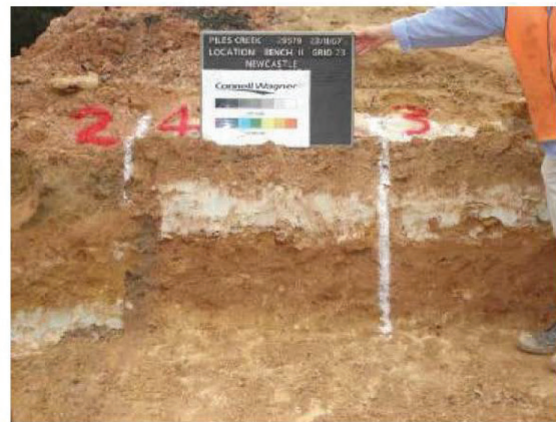
**Figure 7: Displacement feature seen in trench face**

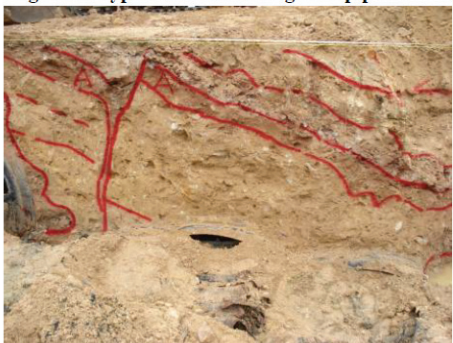
Figure 10: Section showing collapsed pipe

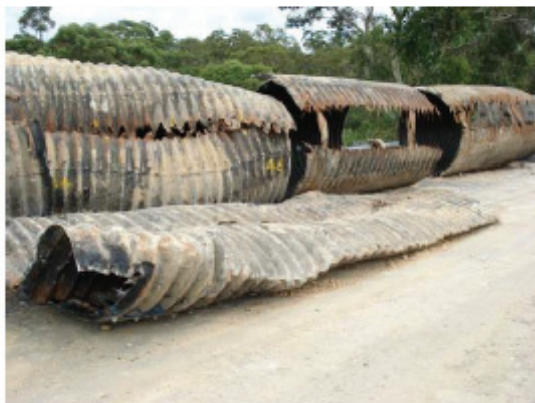
Figure 14: Deformation of pipe culverts

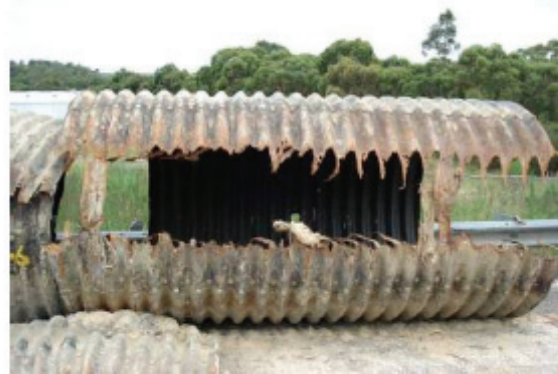
Figure 15: Perforation of pipe invert

- *‘The mechanism of collapse commenced with the abrasion/corrosion of the inverts of the corrugated steel pipes,*
- *Once the invert had been substantially perforated, the water flowing through the pipes began to wash soil out from around and beneath the pipes, causing voids around and eventually over the pipes,*

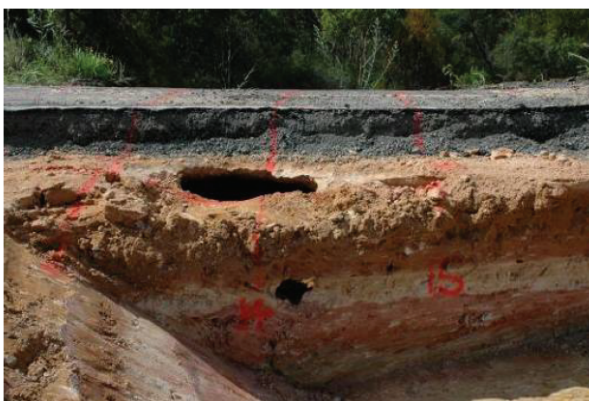
**Figure 19: Voids in the embankment fill beneath the road Pavement**

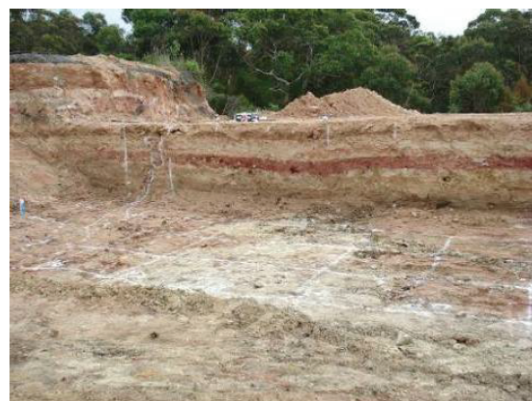
**Figure 20: Dip evident in embankment fill layering**

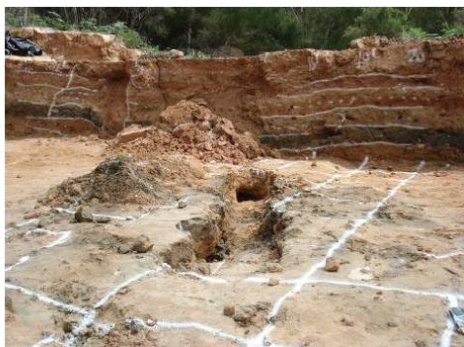
**Figure 21: Further dipping of embankment layering and voids present above pipes**

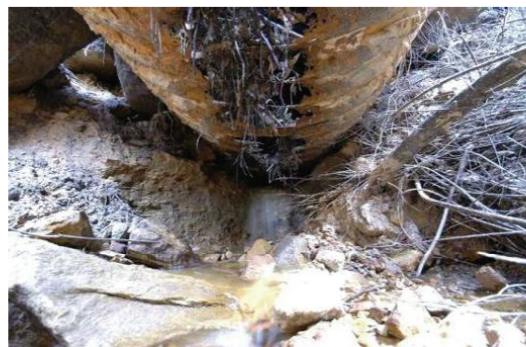
**Figure 22: Perforation of pipe inverts at Leask Creek**
