IMPACTS OF FRACTURING CAUSED BY VALLEY FORMATION AND PILLAR COLLAPSE ON THE HUNTER EXPRESSWAY PROJECT

R.J. Symington, D.J. Och and O. Stahlhut

*¹Parsons Brinckerhoff, GPO Box 5394, Sydney, NSW 2001, Australia, PH (612) 9272-5100;
email: rsymington@pb.com.au, doch@pb.com.au, ostahlhut@pb.com.au*

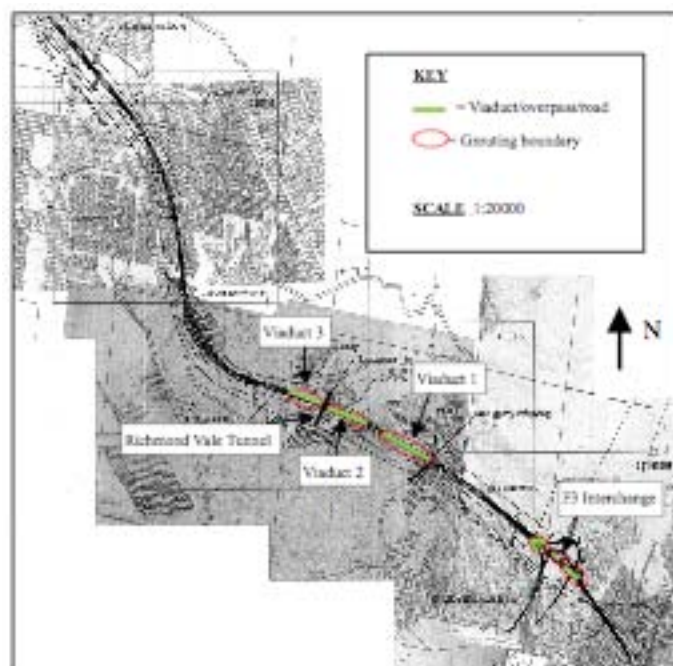
The expressway passes over an area where coal has been previously mined for over a century, as shown in Figure 1. The alliance is constructing 28 bridges, including three twin-bridge viaducts crossing valleys up to 40 m deep and 6 km of road pavement within the mined area, which will be the main focus of this paper.

Figure 1: Abandoned coal mine workings below Hunter Expressway

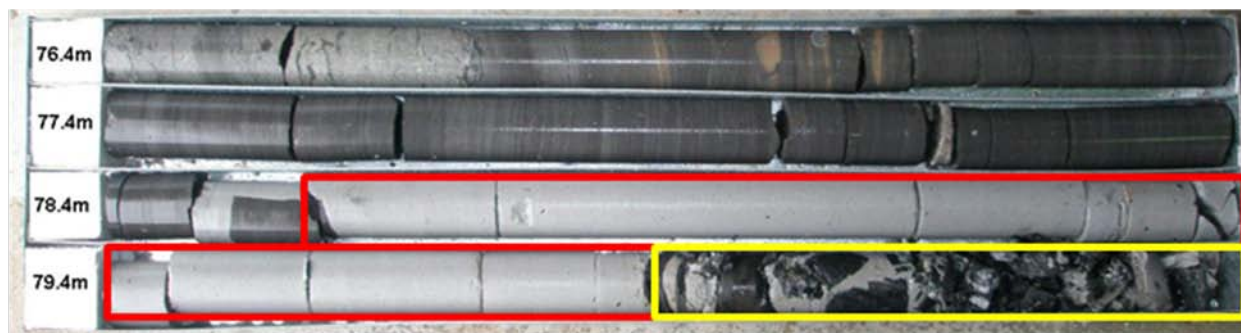
The validation involved in the mine-fill process was threefold — core logging, video and geophysical downhole monitoring. Video monitoring was very important because it gathered accurate footage of the fractures *in situ*. Then further footage was taken during or after the holes were grouted, showing the fractures being filled for a mine-fill process — even though fractures are less than 10 mm thick, very thin relative to the typical mine void thickness of 1.5 m. This is because the grout consists of a mixture of sand, fly ash and water; hence it can penetrate and form up into very small fractures or cracks. The core logging was necessary as it provided actual hard evidence of the material, and a rock and grout sample. Suspected hardened grout could be found and confirmed in the core sample, showing proof of hardened grout being retained in defects and mine voids, in amongst the rock profile. An example of evidence of hardened grout forming in a mine void and in fractures of collapsed material on the mine floor (fracture thickness is 10–30 mm) is given in Figure 2.

Figure 2: Core showing solid grout core (red) and grout permeation in fractured coal (yellow)

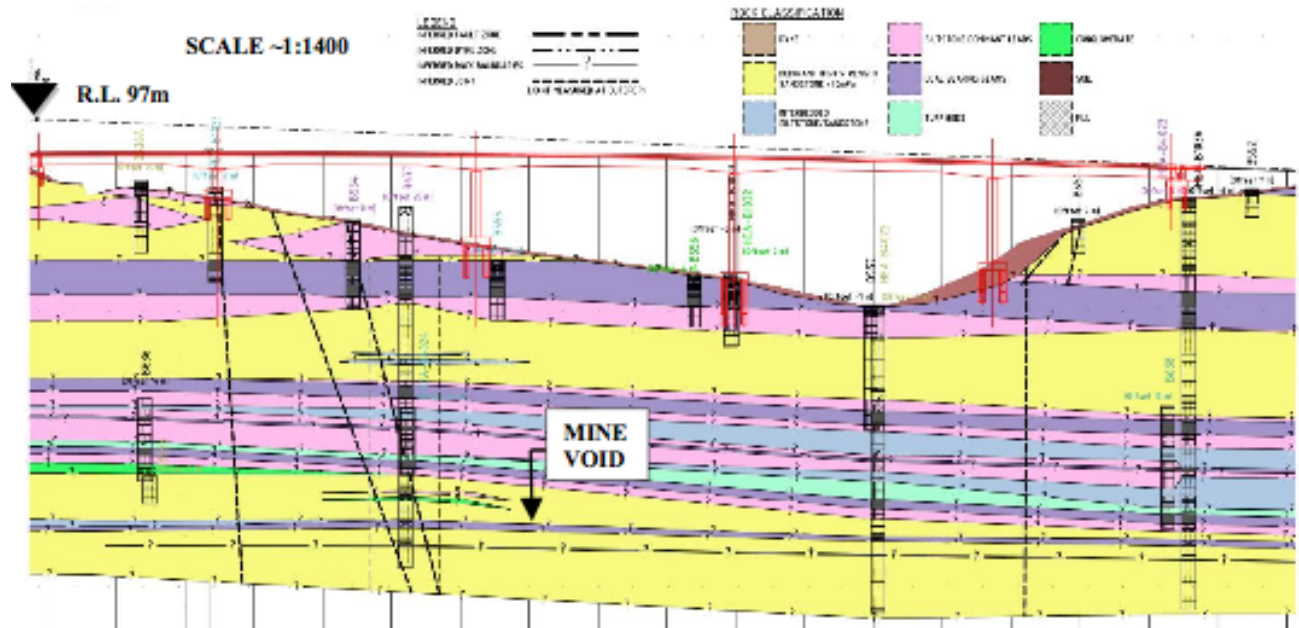
The fractures are differentiated by their source — stress relief fractures related to valley formation, fractures caused by pillar collapse, and fractures related to tectonic joint/fault systems. The valley-forming fractures were found in an upper sandstone layer (Figure 3). These fractures are consistent in the three viaducts where bridge abutments have been exposed. The fractures caused by pillar collapse were found in a sandstone layer about 40 m above the mined horizon, between two coal bearing layers.

The valley-forming joints are generally vertical, open and associated with massive high strength sandstone units (Figure 3). The joints dip between 70° and vertical, and strike between 25–30° in sandstone and 60° in siltstone parallel to valley direction. The joint sets are usually orthogonal, and are widely spaced (>3 m) in sandstone, and appear to die out when traced into the siltstone, most likely due to the differences in mechanical properties of the rocks. The joint openings are up to 200 mm wide (possibly jacked open by tree roots) in the sandstone, and at times filled with sandy clay and tree roots. No movement was anticipated and measured to date as there is a lack of any adverse dipping bedding or joint planes that can trigger further movement of this rock mass. An example of these joints is shown in Figures 4 and 5 during excavation and video monitoring respectively.

Figure 3: Geological long section of viaduct 1 – South facing

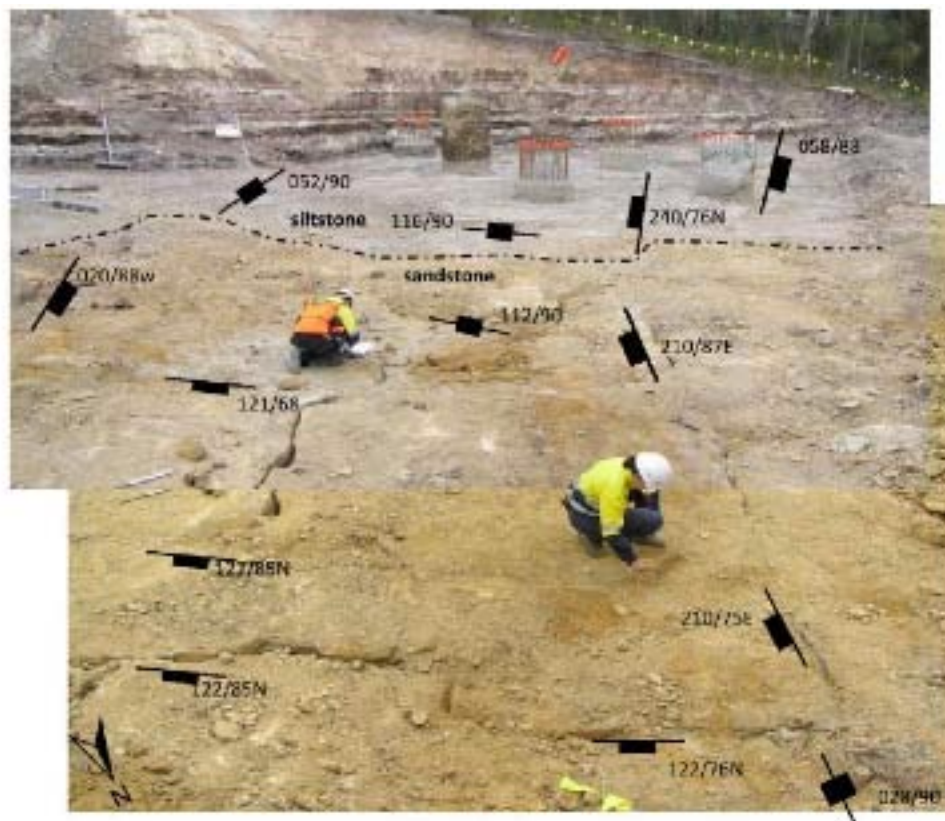
Figure 4: Viaduct 3 Abutment A excavation for abutment foundation

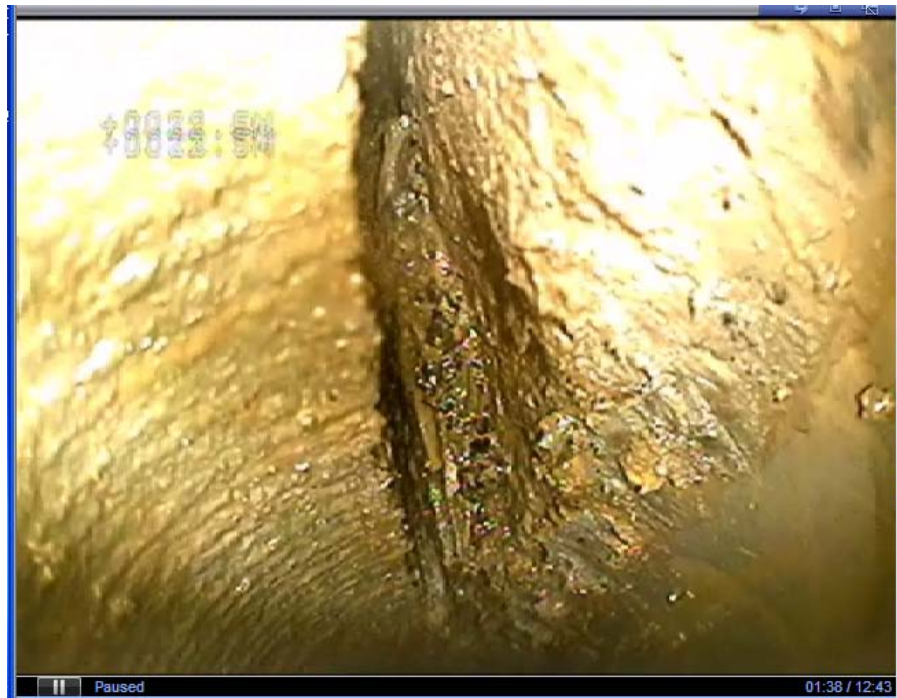
Figure 5: Vertical fracture in borehole beneath viaduct location

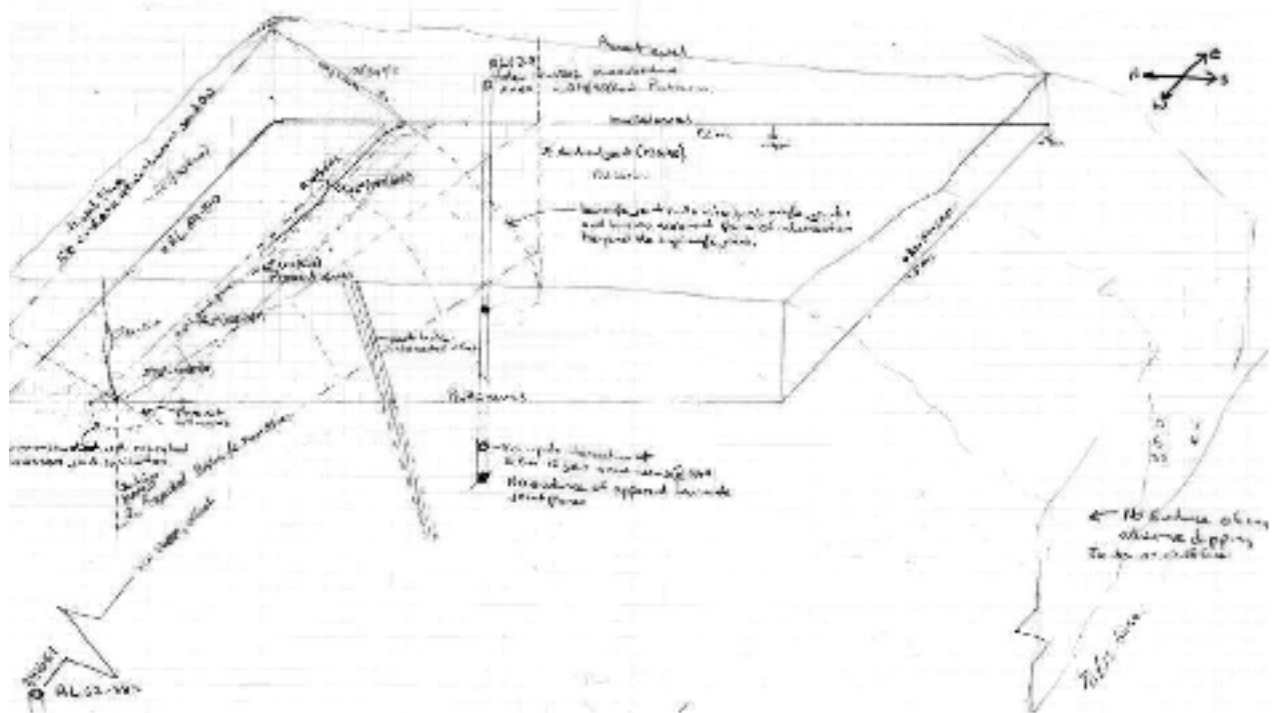
The other notable joint sets across the HEA site are the occurrence of steeply dipping (>70°) tectonic joints, with dominant strikes to the NNE and NW developing due to tectonic processes associated with the early stages of the rifting of East Gondwana. Further explanation of the tectonic event can be found in Och *et al.* (2009). These joint sets occur as dominantly widely spaced, but in some areas (e.g. Viaduct 1) zonally closely spaced joint sets (NNE and NW striking) are commonly observed now the site is being exposed. Where discrete joint sets (widely spaced) are observed, zones of transpression (cataclastic zones) have been observed, and as a result of lateral displacement along these joint or discrete fault systems vary in thickness from 0.5 m to 3 m. Figures 6 and 7 show detailed mapping of a joint system found in the

Figure 6: Mapping geological defects observed at Abutment B, westbound, Viaduct 3.

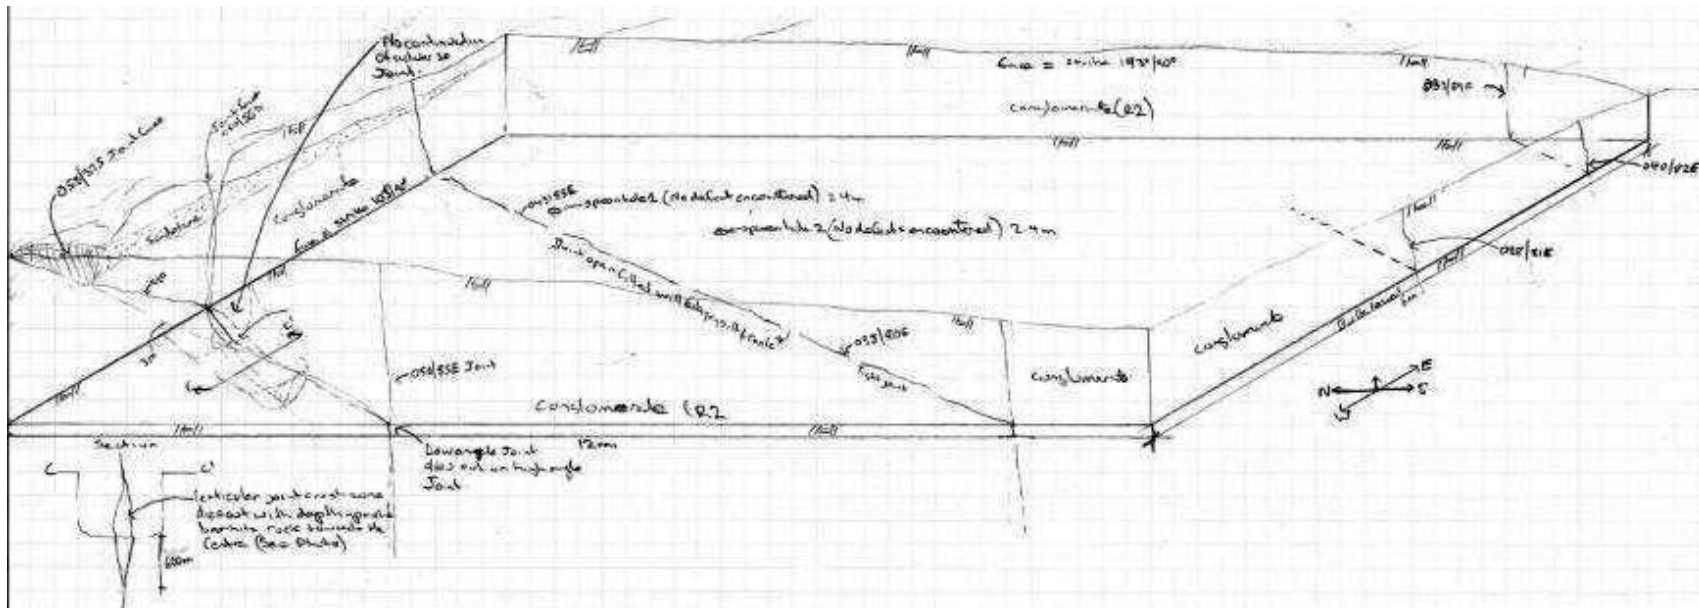
Figure 7: Mapping geological defects observed at Abutment B, eastbound, Viaduct 3.
