MONITORING OF CONCRETE GRAVITY DAMS

F. J. Carter

Metropolitan Water, Sewerage & Drainage Board

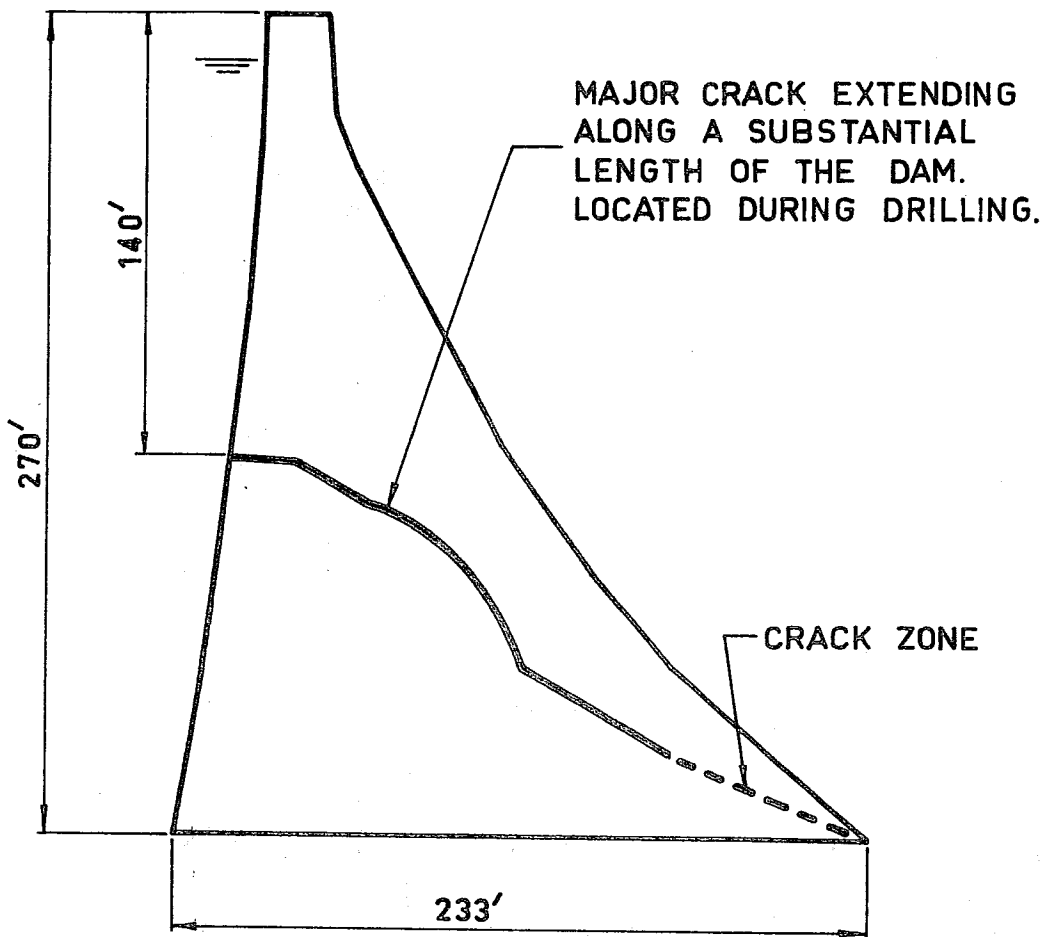
FIGURE 2

Immediately after the 1969 monsoon, excessive seepage and cracks were observed at the toe of the dam. Subsequent drilling showed a crack extensively developed as shown in Figure 2. This crack appears to follow partly the type of failure envisaged in the crack propagation analysis of the U.S.B.R. (6) and discussed by Leliavski (7) and partly the stage construction of the dam (5). It is difficult to imagine a dam closer to failure and the margin between the dam standing or falling was probably only inches of water height at the previous peak flood level. The dam was post-tensioned in 1970.

BHANDARDARA DAM - MAIN CRACK

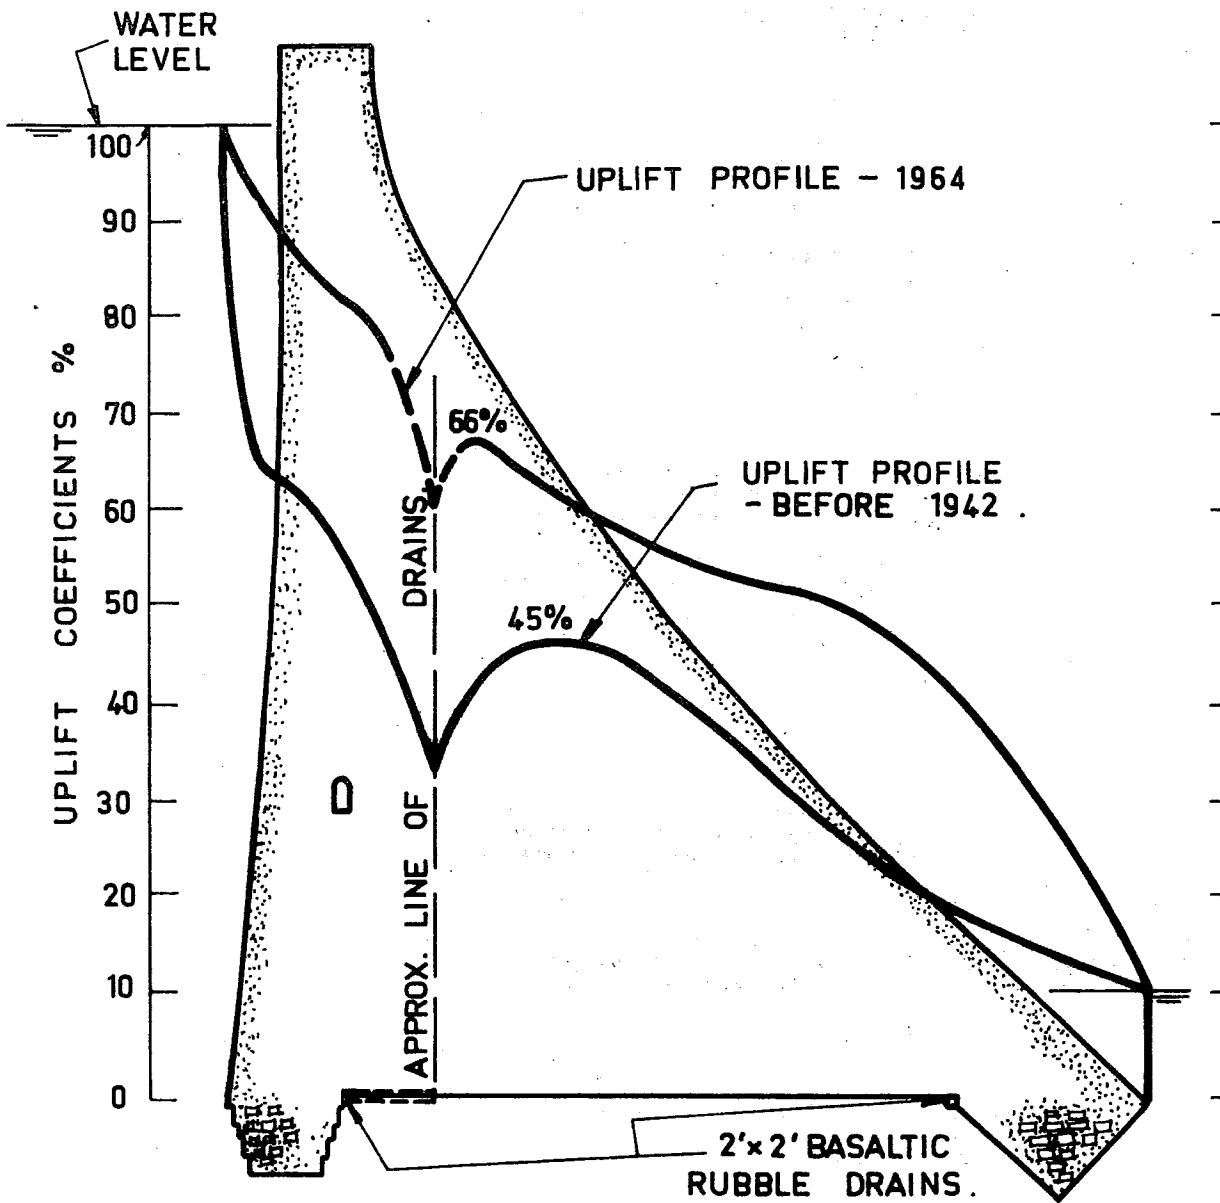
NEPEAN DAM
FIGURE 5

A typical profile of recent uplift co-efficients under Nepean Dam was plotted and compared with a corresponding profile recorded before 1942. The resultant profiles are shown on Figure 5. At first sight it appeared that considerable deterioration had taken place in the drainage system resulting in large increases in uplift.

When studied in greater detail it was found that the variation in uplift co-efficients had occurred primarily during the period 1936 to 1942.

It is probable that the increase in uplift co-efficients was due more to a prolonged initial adjustment of foundations than to any significant deterioration of the drainage system.

Since leakage flows were small and there was no evidence of removal of foundation material it was decided that additional drainage but no grouting would be provided. Reaming of existing drain holes was not possible since these were in the form of vertical pipes with horizontal connectors to the gallery.

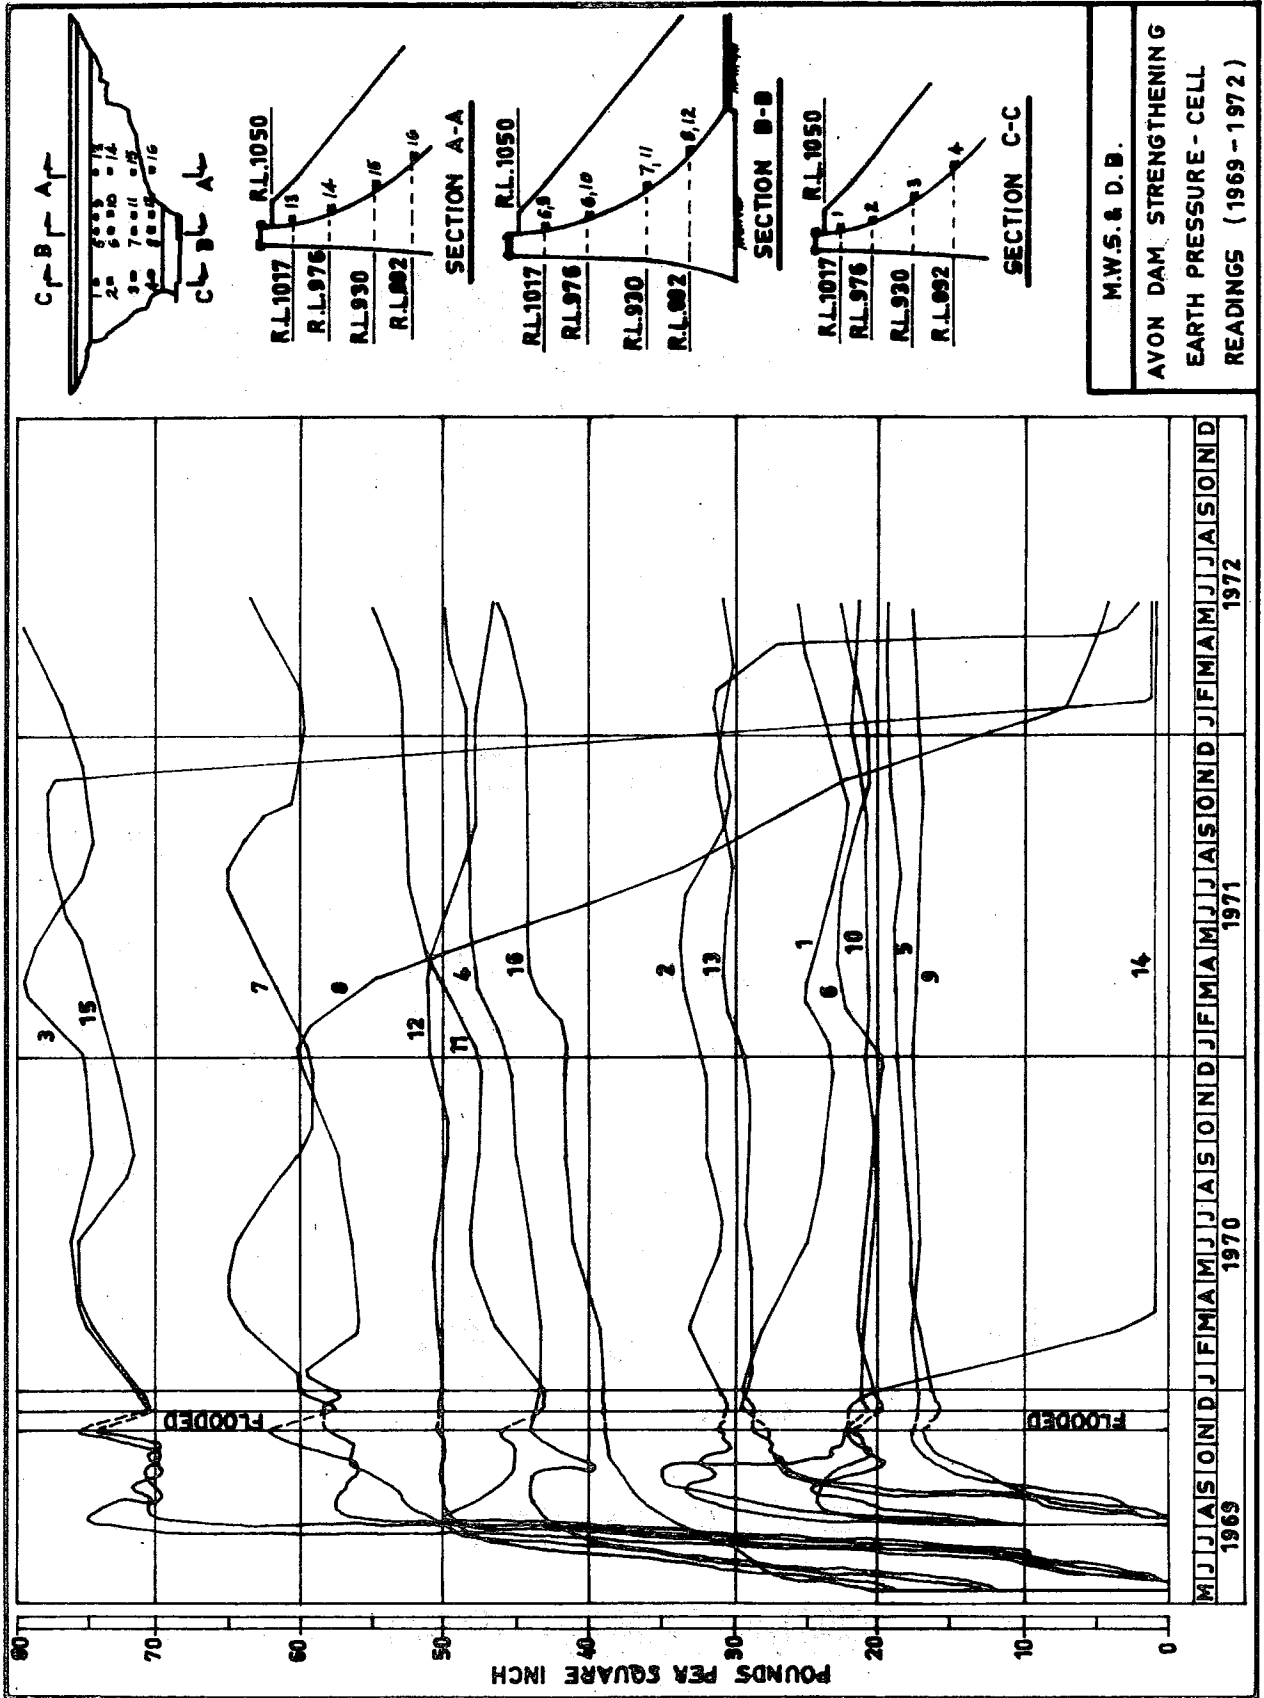
FIGURE 6

The monitored results of the earth pressure cells are shown plotted in Figure 6. Since completion of the embankment there appears to have been little movement of the fill. A number of gauges appear to have failed and now give zero readings although there is always the possibility that these gauges have become unweighted due to local movements of the fill.

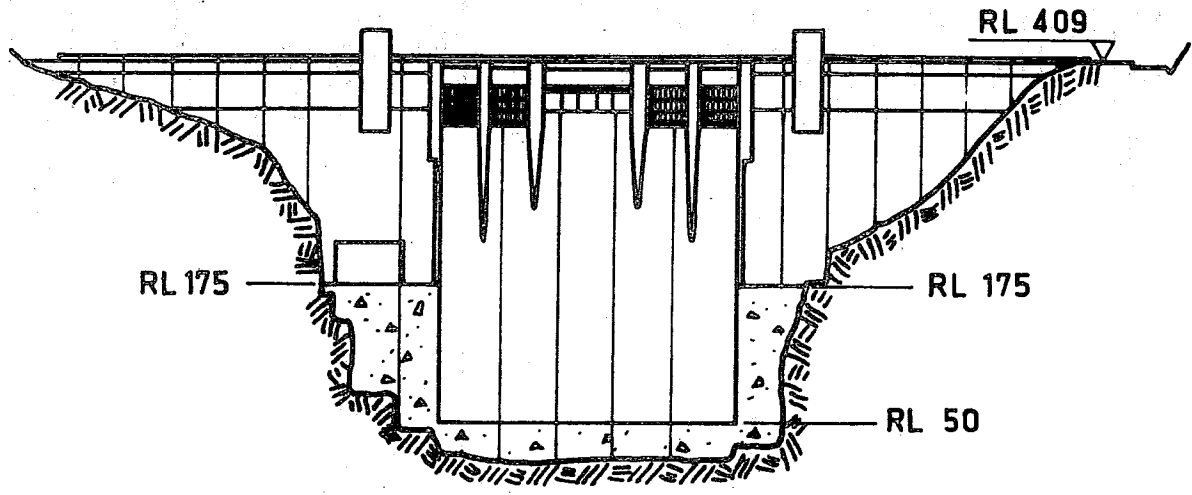
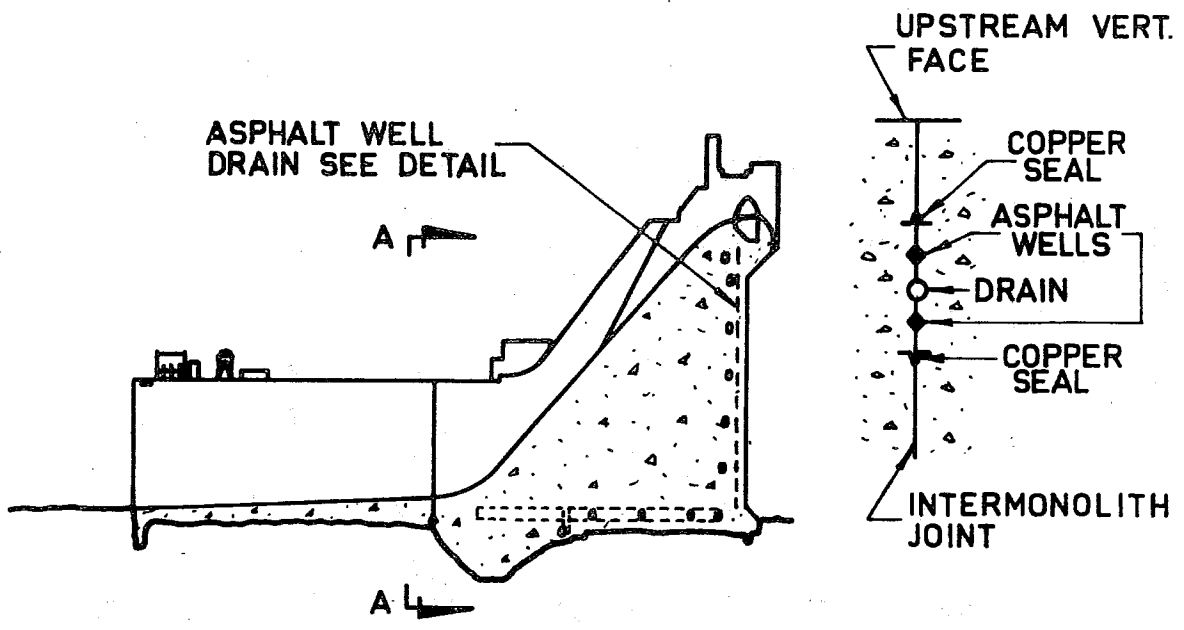
FIGURE 7

In September 1963 a sudden large increase of leakage into some of the asphalt well drains was reported. The location of these drains is shown in Figure 7. Flows from individual drains increased from zero to a maximum of 1029 gallons per hour. Investigation with a closed circuit T.V. camera lowered down the drainhole showed the leakage to be coming from a horizontal crack at approximately R.L. 175.

However, studies of foundation deflection showed that settlement had occurred over the spillway section while the abutment sections showed smaller settlement. Figure 7. also shows a pronounced change in the foundation slope at R.L. 175 on both sides of the gorge which could cause arching of the upper part of the dam tending to cause separation of the upper and lower parts of the dam when considered in relation to the rock movement mentioned above.

Another cause could have been the fact that a three months' delay in pouring concrete occurred in a number of monoliths at this level. It is possible that the lapse of time may have prevented an effective bond forming between successive concrete pours.

Although consideration was given to grouting the cracks it was concluded that this should not be attempted until the crack had reached maximum opening and it could be ensured that grouting would not propagate the crack.

It was finally decided that action would be deferred and the leakages read and forwarded fortnightly to Design Branch. Possible remedial action was to grout the drains and then re-drill them.

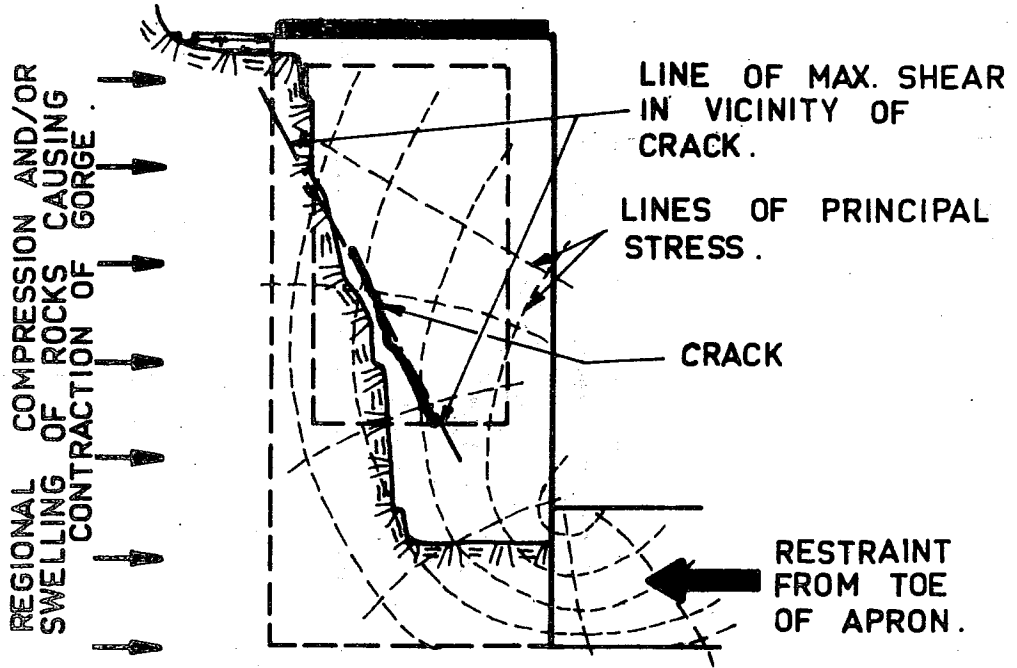
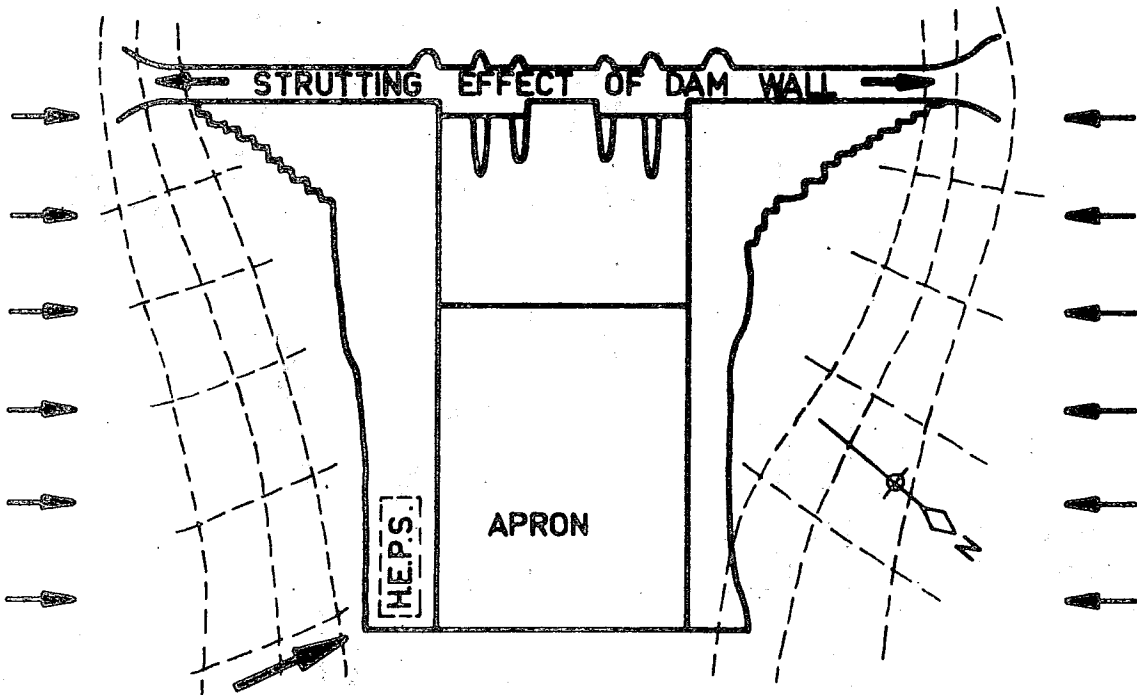
FIGURE 8

In April 1966 a diagonal crack (0.01" average width) was reported extending for some 50-ft. in the downstream wall of the H.E.P.S. as shown in Figure 8. The cracked section of wall is 10-ft. thick and heavily reinforced with 1¼" or 1½" diameter bars at 9" or 12" centres both ways on both faces. Checking found this reinforcement adequate for the normal loads that might be expected on the wall.

It was considered that the causes of the cracking are probably related to the dam and foundation movements that had taken place prior to April 1966. Investigation of these movements suggested three effects which may have given rise to the cracking.

A regional compression gives rise to a stress picture as shown in Figure 8 with the crack following the line of maximum shear.

The strutting effect of the dam wall across the gorge would tend to modify the regional stress picture in the vicinity of the dam itself. Instead of acting directly across the gorge in a S.E.-N.W. direction the principal compressive stress in the region of the H.E.P.S. would act in a more E - W direction as shown in Figure 8. This would tend to open up a crack on the inside of the wall and not on the outside.

END ELEVATION OF EAST BANK TRAINING WALL - CRACK FOLLOWS LINE OF MAXIMUM SHEAR

Since the cracks have occurred only on the inside wall of the H.E.P.S. deterioration due to corrosion of steel is not expected to occur. In its present state the crack is not considered to be serious but should it continue to open then remedial measures such as prestressing the wall etc. may have to be considered.

Eight measuring points were set out across the crack and these were monitored monthly for a period of two years. During this period the crack remained stable and no further action was taken other than to include its inspection in the annual report.

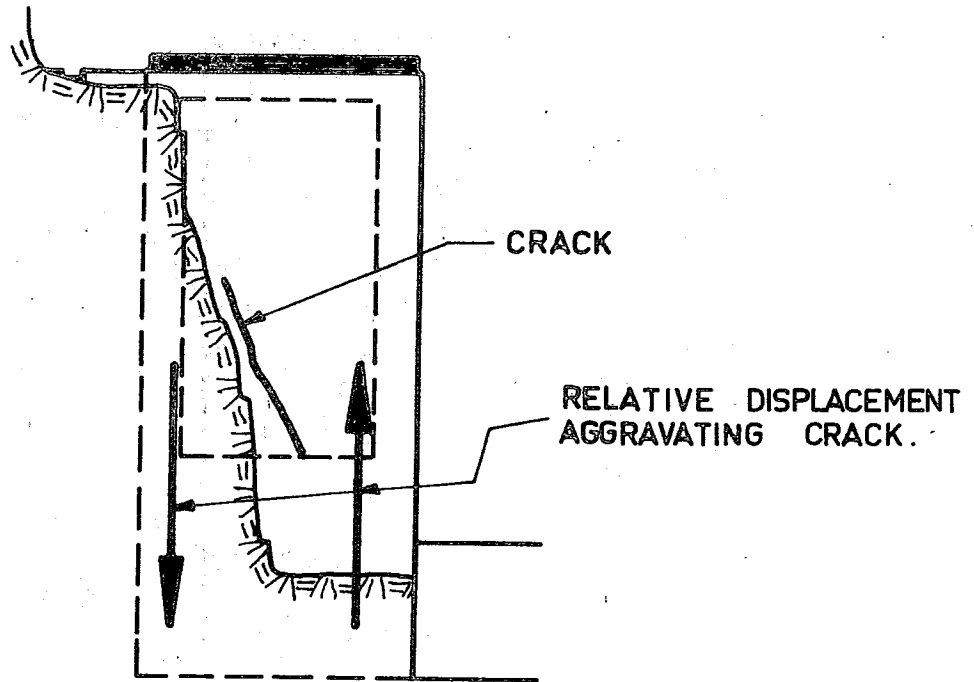
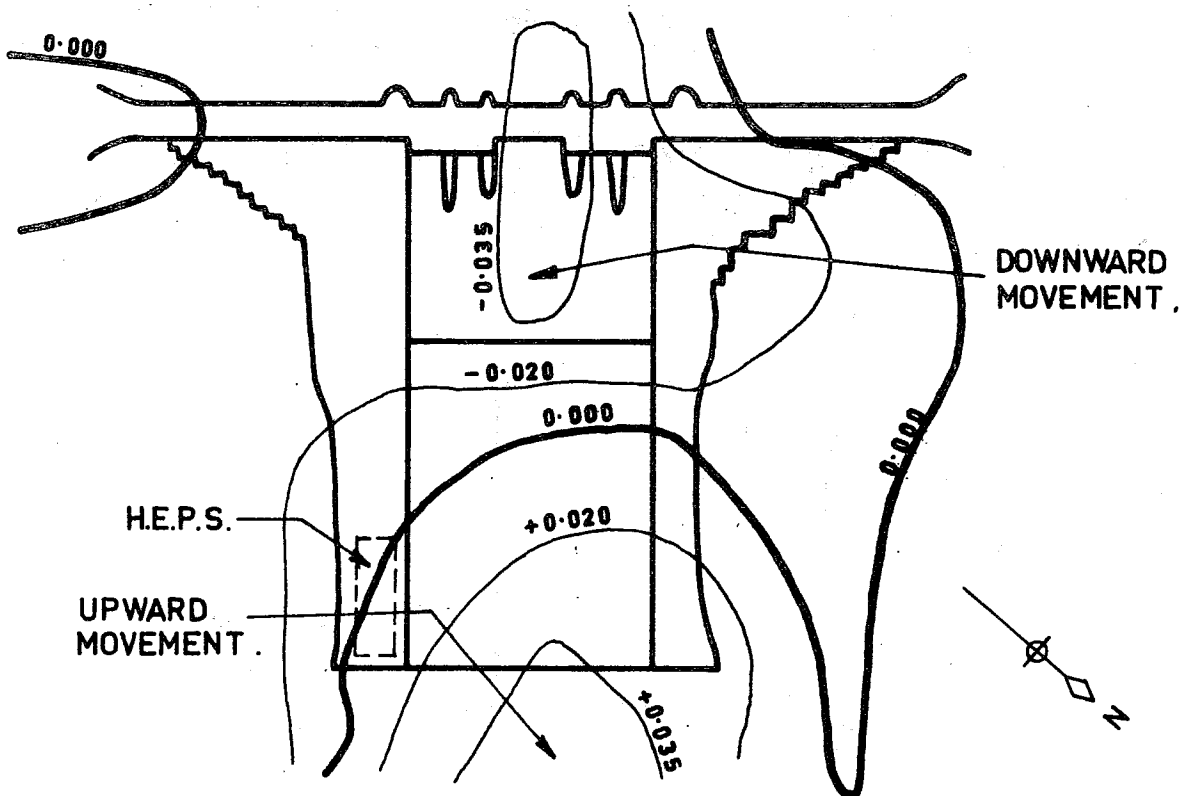
FIGURE 9

Consideration of measured upward and downward foundation movements in the vicinity of the dam also indicated that the crack may have been due to shear effects. Contours of foundation movements and the local effect at the downstream wall of the H.E.P.S. are shown in Figure 9.

FOUNDATION MOVEMENTS UNDER H.E.P.S.
