MONITORING OF EARTH AND ROCK DAMS

C. G. C. Coulter

Electricity Commission of N.S.W.

MONITORING ELECTRICITY COMMISSION OF NEW  
SOUTH WALES' DAMS

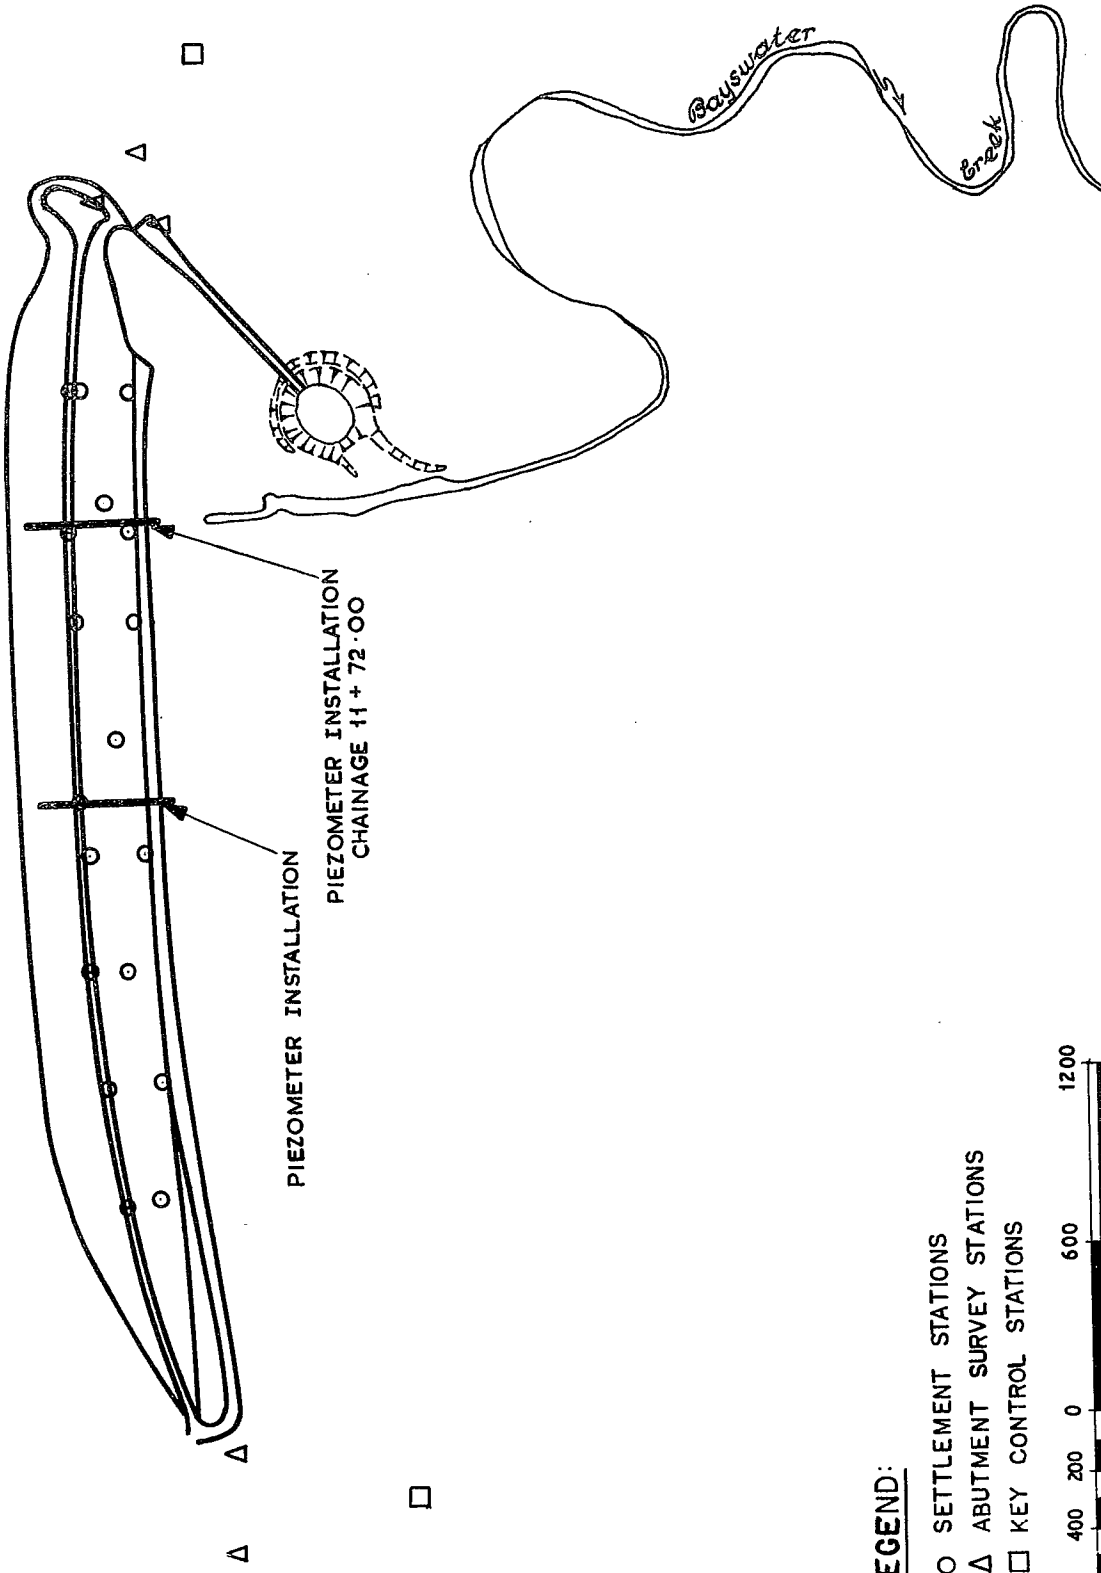
FIG. 1

A total of sixty-eight hydraulic piezometers were installed in the dam at the two sections shown on Figure 1. Twenty-nine ground water observation holes were installed in abutments and downstream of the dam. Four cross arm settlement installations were installed near the piezometer installations. A total of twenty three survey monuments were installed on the dam crest and on the downstream face of the dam to check settlement and horizontal movements.

Details of the survey net and procedures warrant special mention because of the difficulties which have been experienced in obtaining satisfactory results. The control stations and observation points are shown on Figure 1.

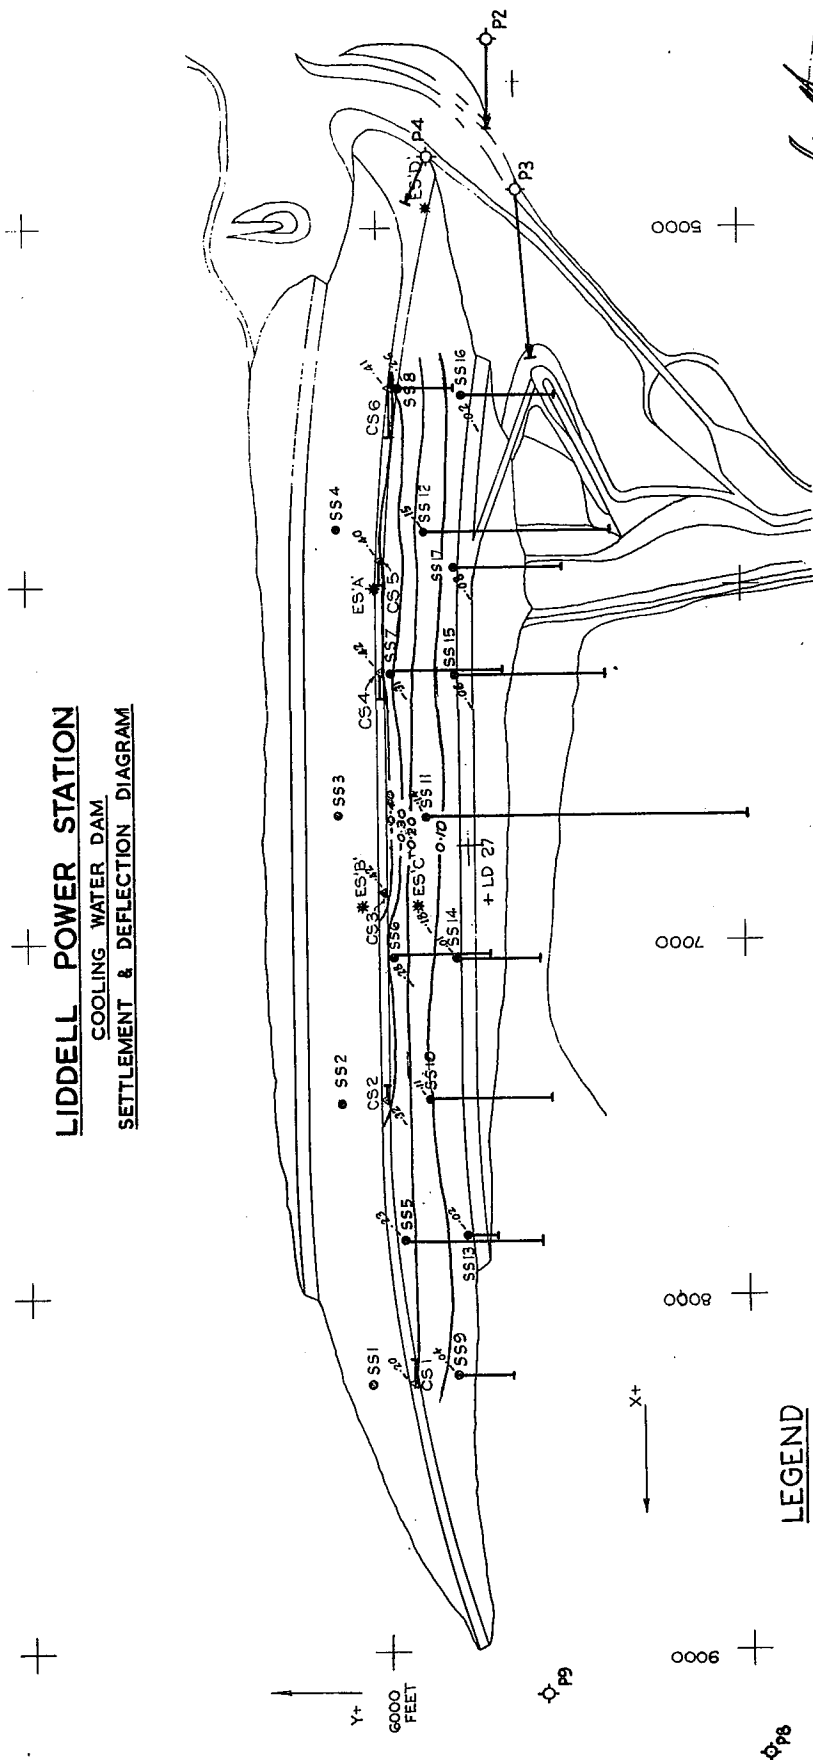
**FIG. 2**

Surveys are taken annually and the results of the recent survey are shown on Figure 2. Post-construction settlements and movements have been small and give no rise for concern for the stability of the structure.

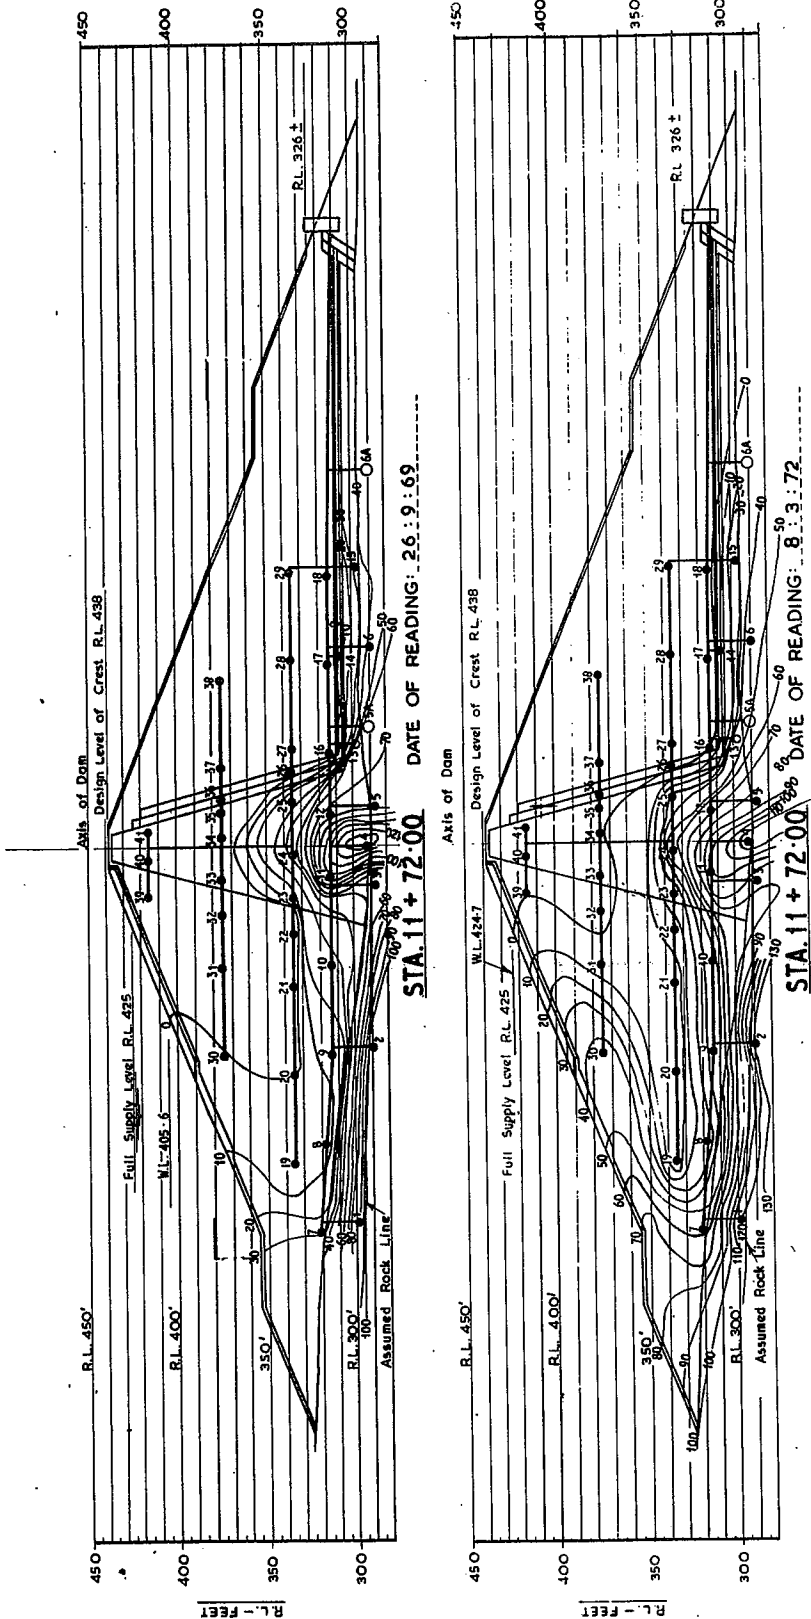
FIG. 3

The pore pressures measured at cross section chainage 11 + 72 are shown on Figure 3. Examination of these show that as of March, 1972, construction pore pressures have not completely dissipated and that steady

state seepage conditions have not been reached. The piezometer readings upstream and downstream of the chimney drain indicate that it is working effectively and piezometer readings in the foundation under the downstream slope indicate that the blanket drainage facilities are performing satisfactorily.

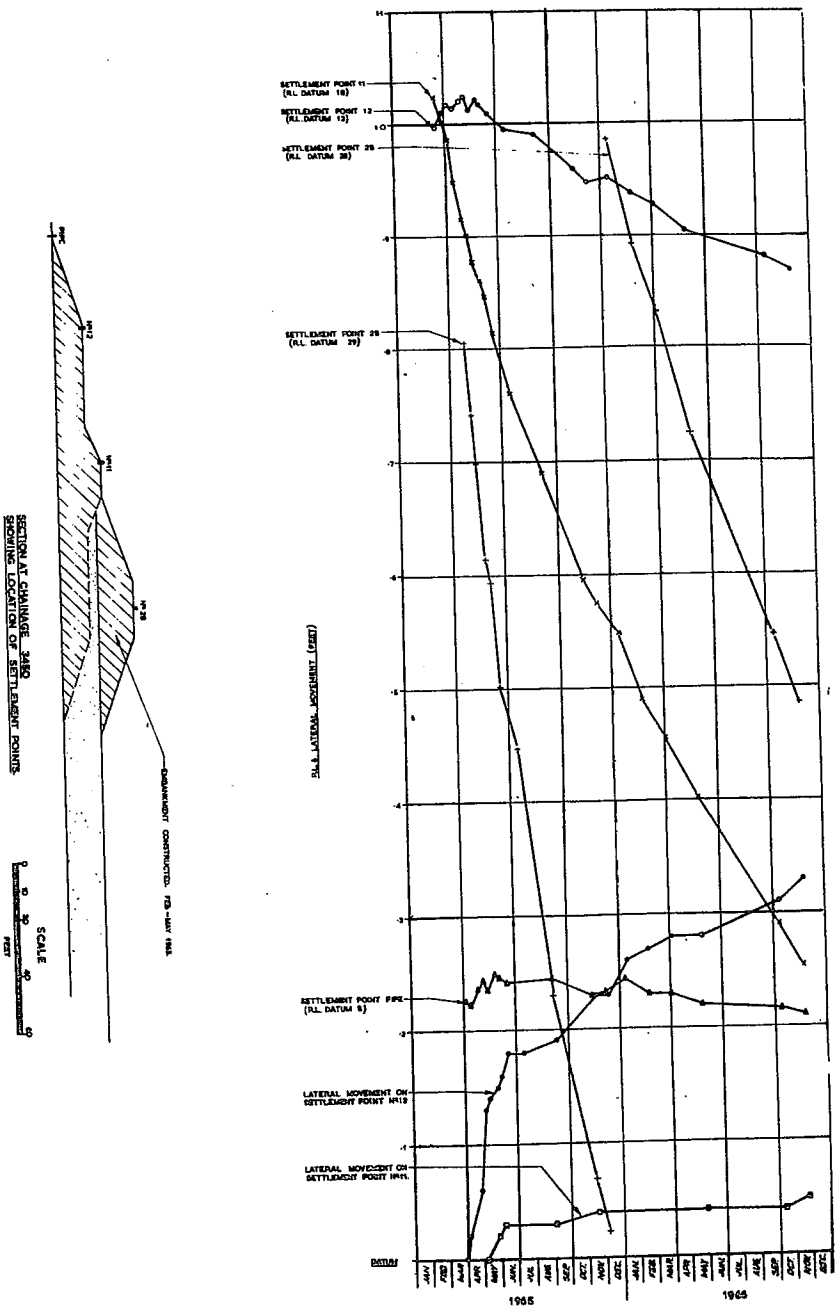
FIG. 5

The section of the dam of interest was built in stages as shown on Figure 5. The stages of construction were:

Figure 5 also shows the settlement and deformation observations obtained during the construction period (ending May, 1965) and through to the end of 1966.

The fill was placed in about 2 foot lifts during discrete time intervals and each period of fill placement was followed by a rest period of about a week. It was found that the addition of fill caused the settlement points on the lower berm and at the toe of the dam to rise (see Figure 5 - settlement point 12 and pipe). During the rest period, the level of these marks fell. Figure 5 clearly shows three periods of fill placement followed by rest periods. It was planned during construction, that if the reference marks did not fall during any rest period to cut down the previously

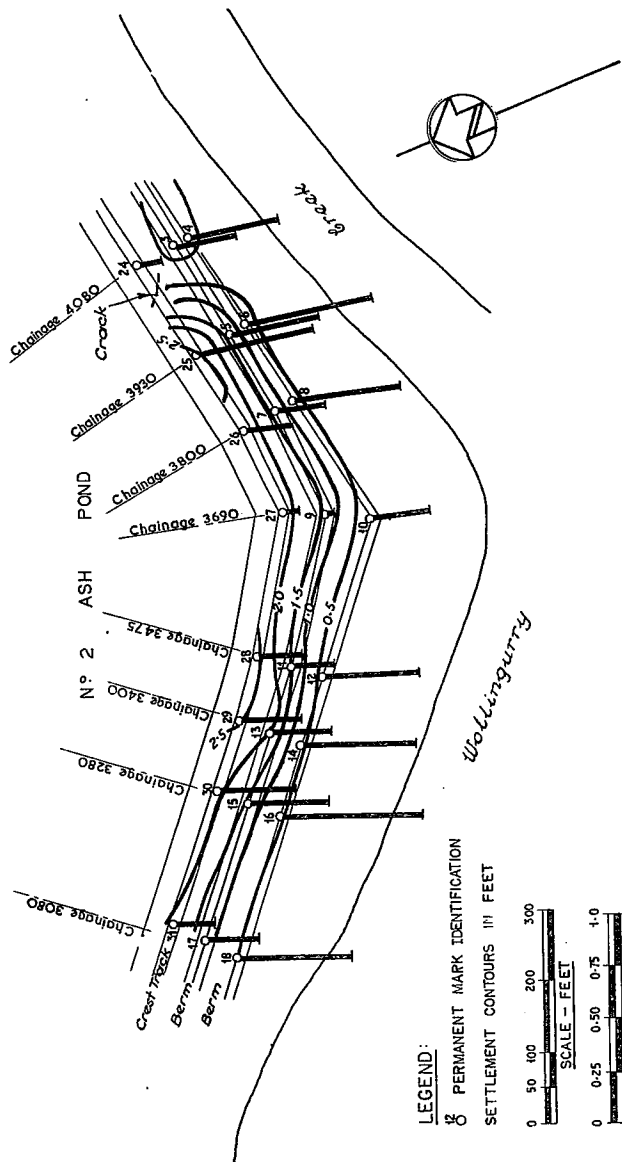
FIG. 6

Figure 6 shows the total settlements and lateral movements recorded between 1965 and 1972. Settlements have been reasonably uniform. There is a rapid increase in settlement (0 to 2 feet) over the 200 feet length of dam between settlement points 25 and 24 and this severe deformation has caused the dam to crack transversely at the location shown on Figure 6. The differential settlements in this area are caused by steeply dipping base-rock surface and a corresponding rapid change in the thickness of the compressible clay layer.

Horizontal movements have been much less uniform along the length of the dam shown on Figure 6. These range from 0.05 feet on survey mark No. 27 to 0.7 feet on mark No. 16. The small displacements at the bend in the dam are probably related to the spread (three dimensional) support provided at corner and also by the reduced thickness of soft material in this area. The effect of differences in thickness of the soft stratum has not been reflected in settlements at this stage of consolidation.

To the east of the corner (settlement point No. 27) the dam has moved generally about 0.6 feet laterally and the movements have been reasonably uniform throughout the cross section. To the west of the corner the transverse horizontal movements have been greater at the toe of the dam than at the centreline.

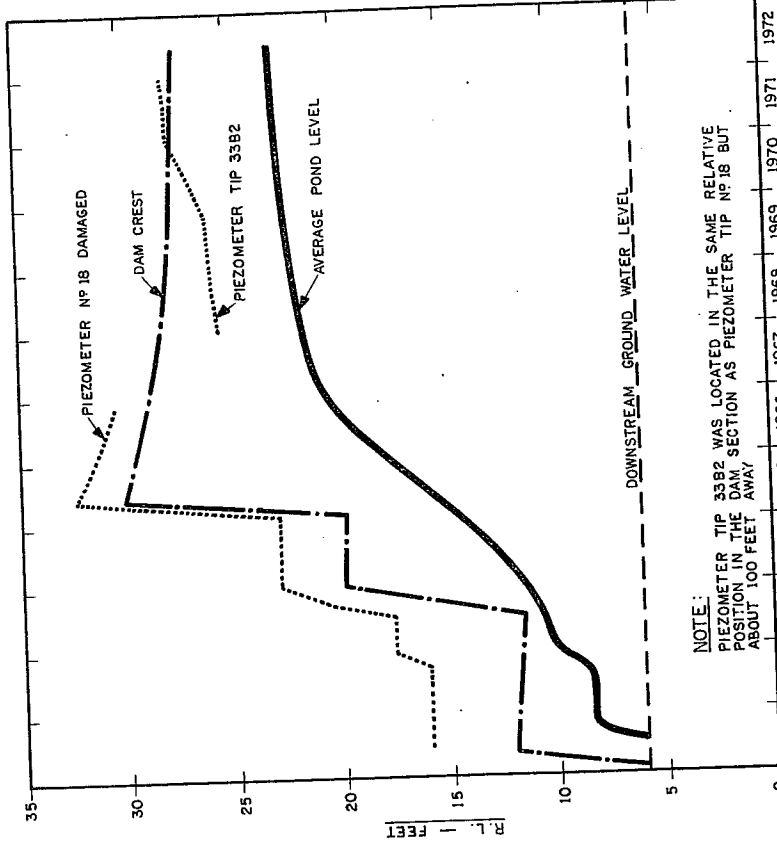
FIG. 7

A total of 31 piezometers (stand pipe type) have been installed in the soft clay foundations. Figure 7 shows typical piezometer records plotted against height of dam, ponding level and tailwater level. Piezometer tip No. 18 was located at chainage 3450 near the centre of the clay stratum and approximately under the centre line of the 2nd Stage west. Piezometer tip No. 33B2 is located in the same relative position at chainage 3350. The example shown is typical of our experience with these instruments. It has been found that the standpipes are readily damaged despite all reasonable precautions taken to protect them, and if replaced by new instruments located at virtually identical positions, the two records are often inconsistent.

As shown on Figure 7, pore pressures are still high in the centre of the clay layer but they have fallen in the upper and lower parts of the clay stratum. The increase in pore pressure reading observed by tip No. 33B2 from 1968 to 1972 is undoubtedly related to the increase in pond level. However, the relatively rapid increase during 1970 cannot be explained with any certainty.
