# REAL TIME MONITORING OF A ROAD EMBANKMENT SUBJECT TO COASTAL EROSION AND SLOPE INSTABILITY

Ground Engineering and Tunneling Team, AECOM Australia Pty Ltd (Sydney), Australia

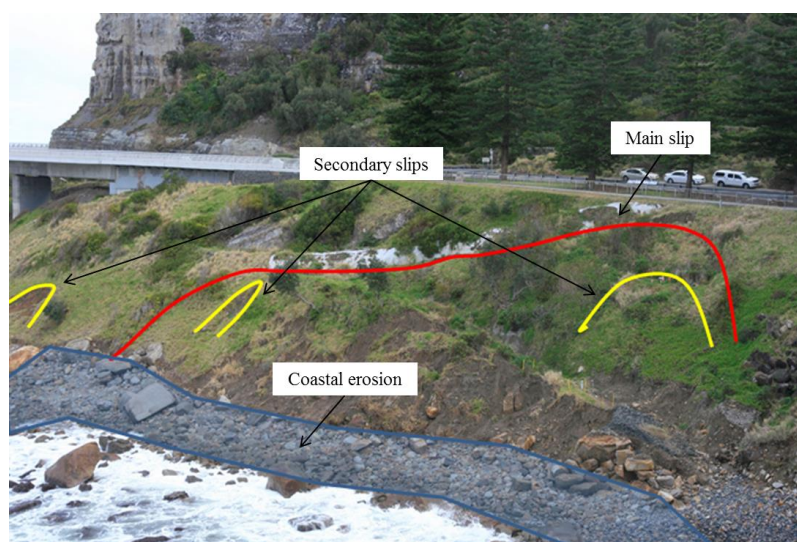
By this time a 2.5m back scarp had formed at the rear of the main slip and slope movements had become more severe. There was a concern that the instability would regress further back into the embankment and endanger first the footpath and rest area immediately behind the slope and ultimately the road itself. Geotechnical investigations and analyses were carried out and monitoring and slope management programs were put in place as an interim measure to allow the development of permanent stabilisation measures.

Figure 2: View of the main slip, showing secondary slip features and coastal erosion

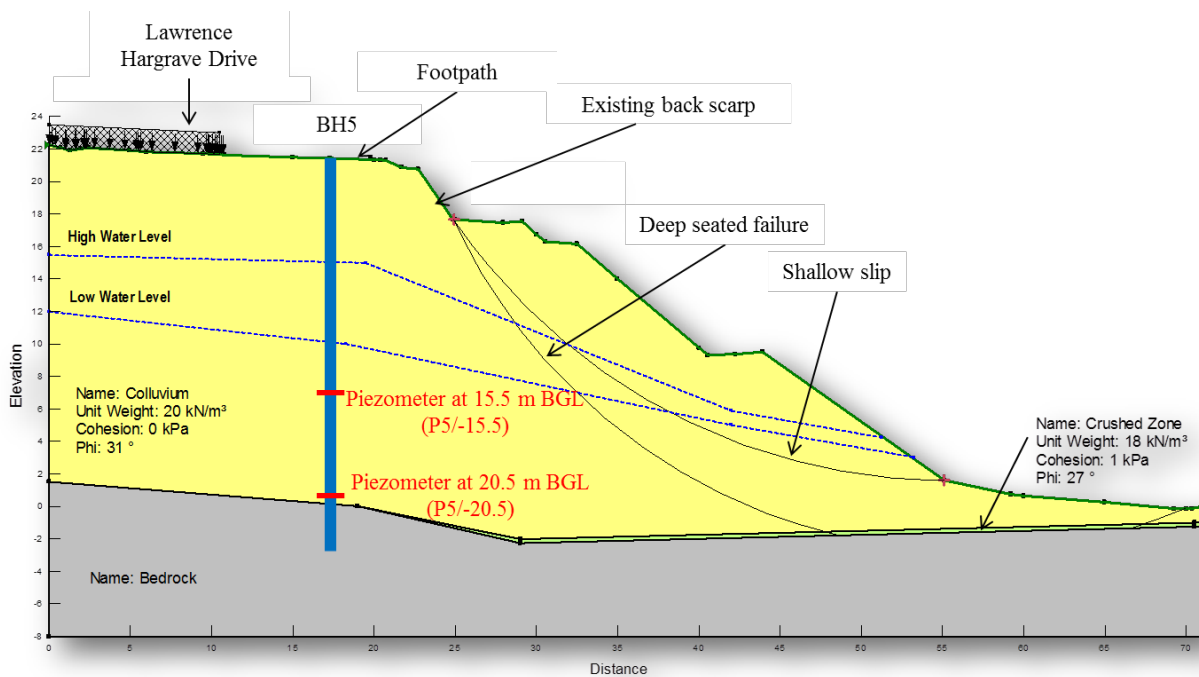
Back analyses were undertaken using the two failure modes described above. Both failure planes pass through the existing back scarp. The shallow failure plane remains within the colluvium. The deep seated failure plane passes through the previously identified crushed zone at the base of the slope. The ground model and geometry of the failure mechanisms is presented in Figure 3 below.

Monitoring, investigations and analyses combined to confirm that the shallow failure mode was more likely to occur. This was an important outcome as it suggested that other than local instability at the 2.5m high back scarp, there was a relatively stable zone behind the main slip. This zone could be managed by monitoring in the short term whilst stabilisation measures were developed. Stabilisation measures were likely to include substantial marine protection measures.

**Figure 3: Ground model of main slips**

The analyses also indicated that slope stability could be improved by lowering the piezometric pressures in the slope. This provided an option to include depressurisation wells as an option for interim stability management of the slope. However, lower piezometric levels alone did not offer sufficient improvement in stability to meet the target design safety margins. Hence, drainage measures in isolation were not considered to be a feasible long term remediation option.

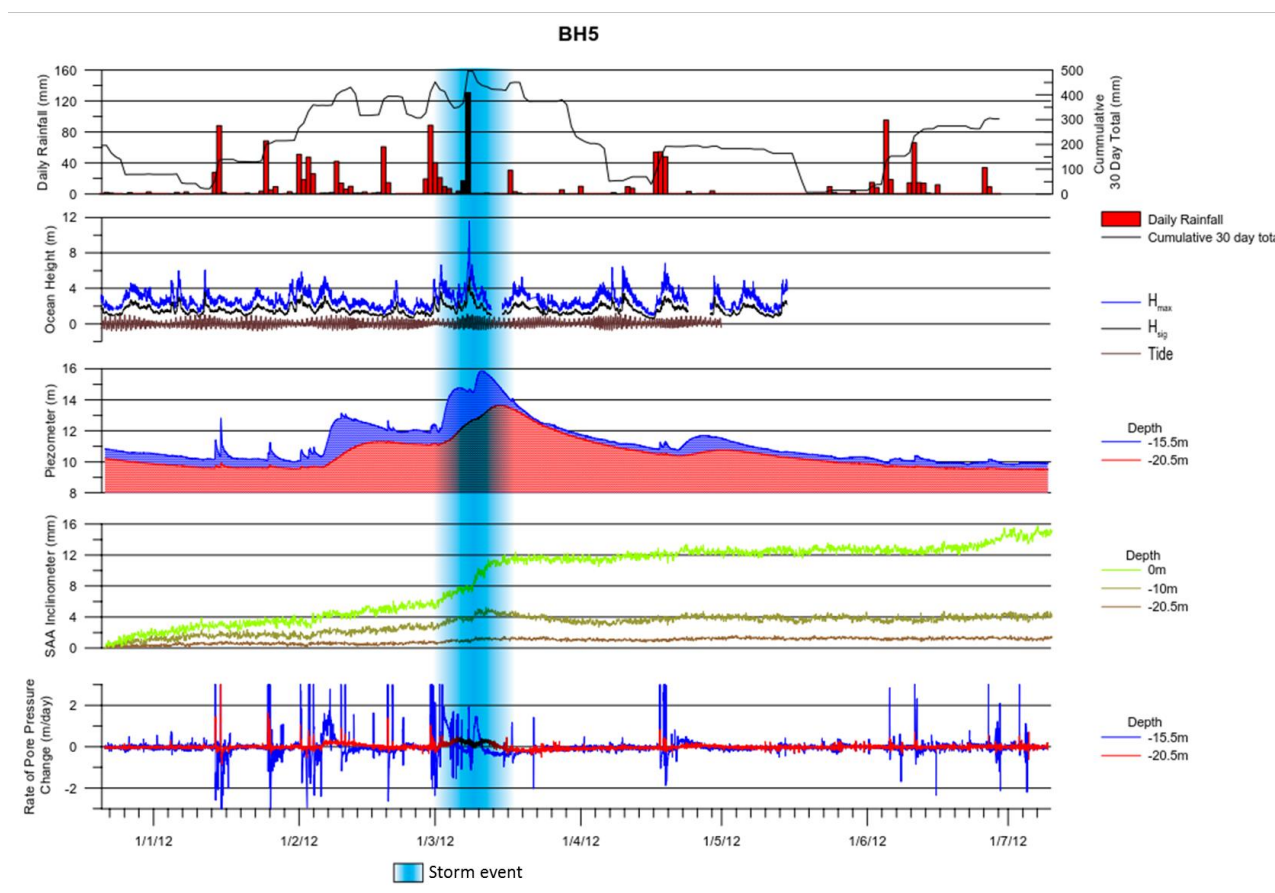
Following rainfall, pore pressures rise rapidly at the piezometer at P5/-15.5 with very little lag, suggesting the recharge is close to the slope. The effect of surface water ingress can be clearly seen with sharp spikes in piezometric pressure associated with rainfall. It would not be practical to accommodate these spikes in a response plan. However, after relatively simple upgrades and repairs to surface drainage, it can be seen from the figure that these sharp spikes were

eliminated after February 2012. It illustrates graphically the importance of surface water management in slope risk management. After this time the rate of pore pressure rise associated with rainfall is approximately 1.4 m/day.

Lower piezometric pressures and flatter and smoother recharge curves lagging approximately three days behind rainfall were recorded at the piezometer at 20.5m BGL suggesting a longer flow path for groundwater at this level. The rate of piezometric pressure rise after rainfall at 20.5m BGL is approximately 0.4m/day, a significantly lower rate of rise than at P5/-15.5, and less critical in terms of response planning.

It can be seen from Figure 5 that there are a number of distinct patterns of movement in the inclinometer at the three levels plotted in the figure.

At the rock interface (-20.5 m) there is distinct inclinometer movement of approximately 1 mm at the time of the storm event. From review of the full height time displacement curves for this inclinometer, this movement was interpreted as shear movement within the crushed zone at the base of the colluvium as a result of elevated piezometric pressures. It can be inferred from the data that once piezometric pressures at P5/-15.5 exceed approximately 14 m, there was a possibility of deep seated failure occurring. There was no further significant movement in this zone during the monitoring period.

At the slope mid-level (-10 m), piezometric pressures during the storm event once again result in mobilisation of the slope with movements in the order of 2 mm. Whilst there is some oscillating movement in the inclinometer after the storm event, the slope remains stable.

At the surface, the inclinometer records indicate that movement can occur at less severe rainfall events such as that in February 2012. However, the greatest sustained movement occurs during the storm event when piezometric pressures are in excess of approximately 14 m. These movements cease once piezometric pressures drop.

Further surface movement occurs during sustained rain in April. This movement was considered to be the result of saturation of the ground surface and subsequent movement towards the back scarp of the main slip as a result of lack of restraint at the free face of the scarp.

Surface movement occurred once again in June/July but with very little rainfall and without any associated rise in piezometric pressure. This was attributed to further ground movement within the main slip and subsequent movement of the ground behind.

**Figure 5: Temporal relationship between monitoring data at Borehole BH5.**

Piezometric pressure peaks in P5/-20.5 generally lag approximately three days behind those in P5/-15.5 and the curve is substantially smoother. It is considered that this was due to recharge from further behind the slope or slow percolation through the slope.

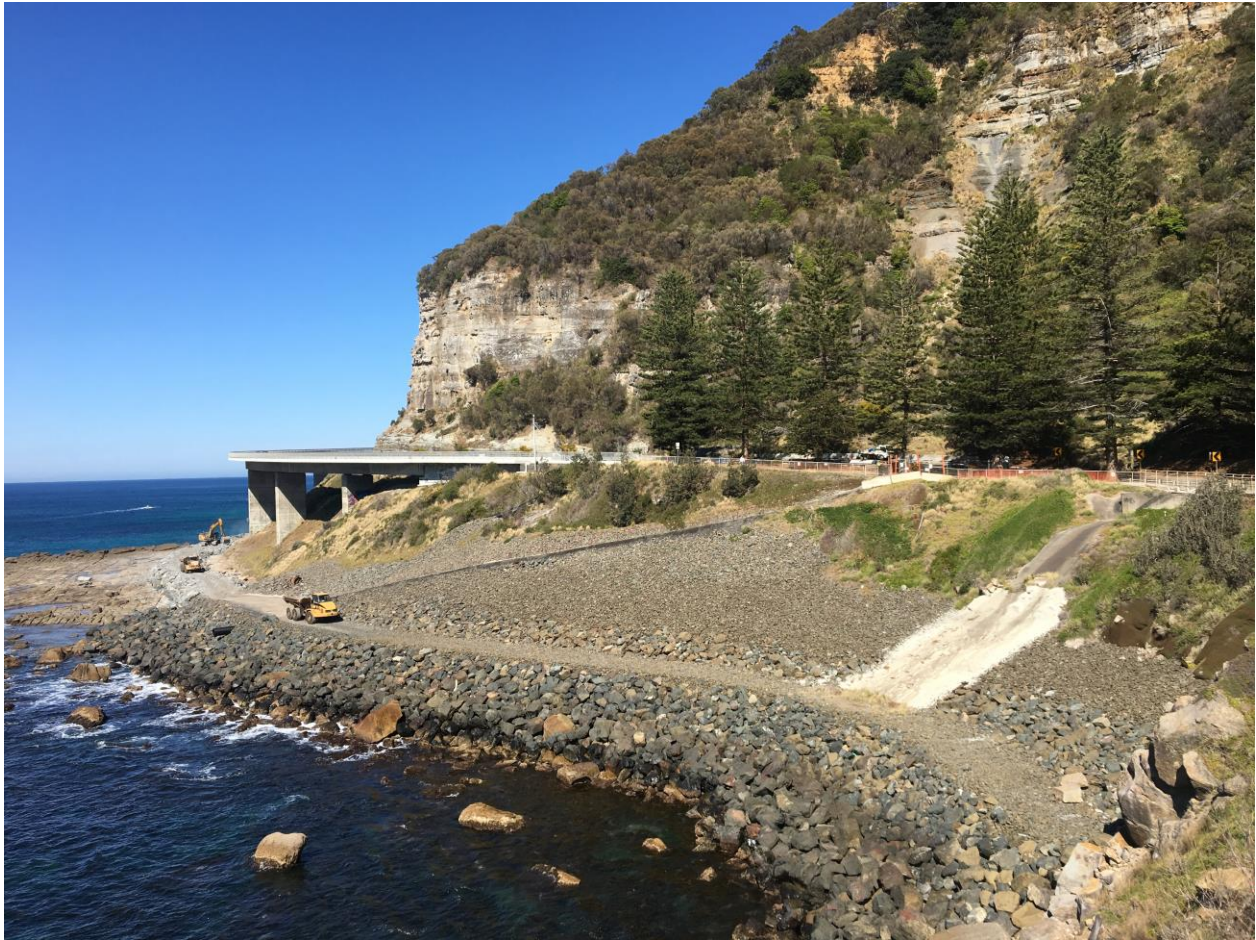
**Figure 6: Slope showing rock revetment at the base of the slope, surface drainage measures and slope protection.**

Management of the slope under the TARP has been a success and a permanent solution consisting of a rock revetment at the base of the slope, surface drainage measures and slope protection have now been installed. These measures are illustrated in Figure 6 below.
