CONTINUOUS MONITORING OF LANDSLIDES AND INFRASTRUCTURE FOR ASSET MANAGEMENT

Phil Flentje¹, David Arnold², Dhammika Ruberu³, Andrew Monk⁴, Peter Tobin⁵, Kevin Bogie⁶ and Raymond Piatek⁷

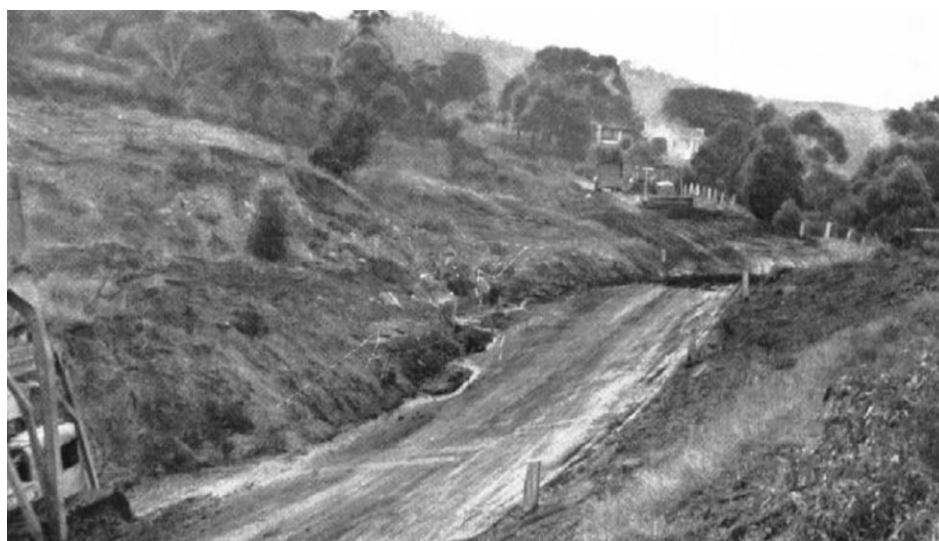
Mount Ousley Road was built during World War 2 as a special defence route in response to the fear of war operations arriving on the east coast of Australia and the need for better, faster and more direct transportation routes. The main route between Sydney and Wollongong up to that time was the Princess Highway via Bulli Pass. Construction proceeded throughout 1942 whilst the attendant property boundaries and acquisition were determined later. Landslides were noted (locations not specified) in 1949 and 1950, but a major movement of this landslide was reported in 1952 and Figure 4 shows a photograph of the landslide area at that time (Main Roads, 1952). The road was officially 'opened' in 1955. Interestingly, the 1904 Parish of Wollongong County of Camden 1904 map shows a sympathetic deviation of the original Mt Pleasant Road alignment around this landslide (the green dashed line below the landslide in Figure 5), suggesting the landslide may already have been active in 1904.

Figure 4: 1950 Landslide displacement reported as 30ft laterally with 6ft of subsidence.

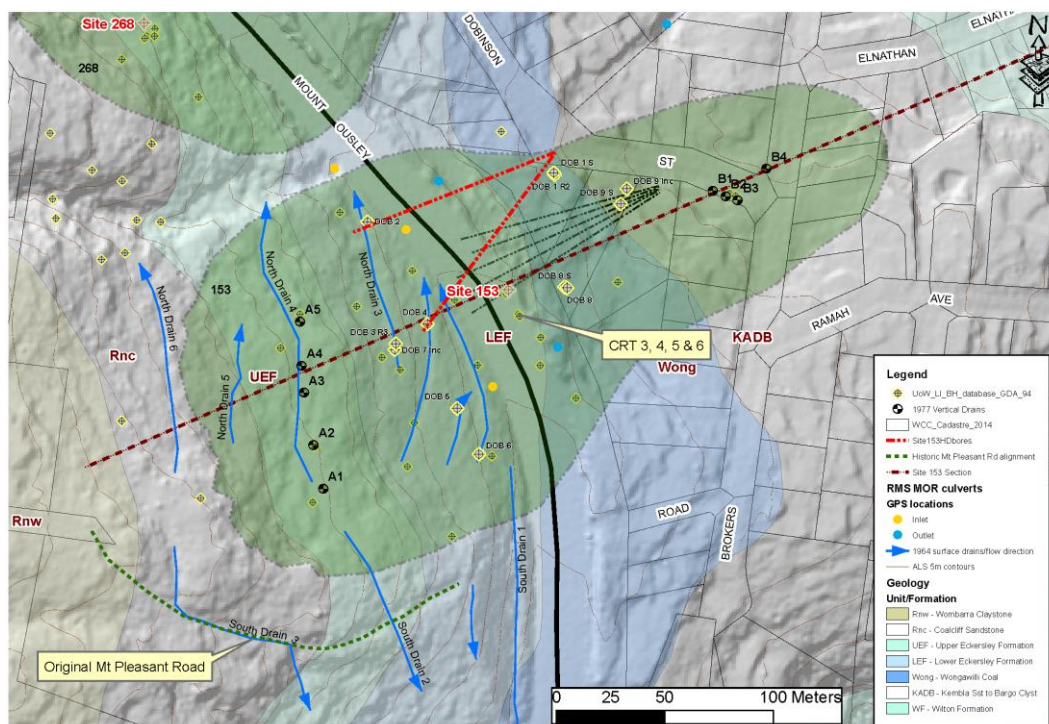
Figure 5: The Mount Pleasant landslide, Site 153 on Mount Ousley Road.

In 1964, portions of the ground surface within the upper half of the landslide area were reshaped to promote better surface drainage, including the ‘cutting’ of a series of six surface contour drains (Figure 5). From 1972 up to 1977 the Department of Main Roads investigated this site, and another landslide in the Razorback Ranges area (Nyland, 1977, Suine, 1978, Forrester and Nyland, 1980) and opted to install a series of horizontal drains at both sites. At the Mt Pleasant landslide, geotechnical investigations had shown the 10m plus depth of the colluvium across the head area of the landslide would make the installation of a trench drainage system difficult, such that horizontal drains were seen as the ‘only possible treatment’. The concept rational involved installing a subsurface drainage system that enabled the ground water to flow more quickly through the landslide site. This was achieved by drilling a series of larger diameter 32m deep vertical drains upslope of the rear main scarp (the A wells, to intercept ground water, Figure 5) and allowing the ground water to flow vertically into the underlying Wongawilli Coal Seam. The intention was that the coal seam was to be targeted by the ~100m long horizontal drains thereby allowing the groundwater to flow into the drains to their outlet. Another series of six vertical drains (the B wells, Figure 5) were planned below the horizontal drain outlets to intercept groundwater across the toe area of the landslide (not clearly identified) allowing it to flow vertically down to a lower coal seam. During the 1977 remedial works, in addition to the A wells, four vertical B wells were installed, and five horizontal drains were drilled from an undeveloped, albeit urban, block facing Dobinson Road, downslope of Mount Ousley Road, into the landslide area, as shown in the black dashed lines in Figure 5. The horizontal drains reached the road (one actually exited the pavement) and two showed good initial flows (drains 3 and 5 flowed at 25 and 40 and litres per minute in September 1977), but both had dropped substantially by the end of the year (to 1.5 and 12 litres per minute respectively). Four vertical wells were drilled below the horizontal drain outlet, but it was never clear how the link between the horizontal drain outlet and the lower B vertical wells was to be achieved. The upslope extent of the horizontal drains was also approximately 80m short of the five vertical A wells, although both (A wells and the horizontal drains) targeted the same coal seam. The PVC lining of the drains was also reported to be of insufficient strength during installation and some of the holes were collapsing during the monitoring period.

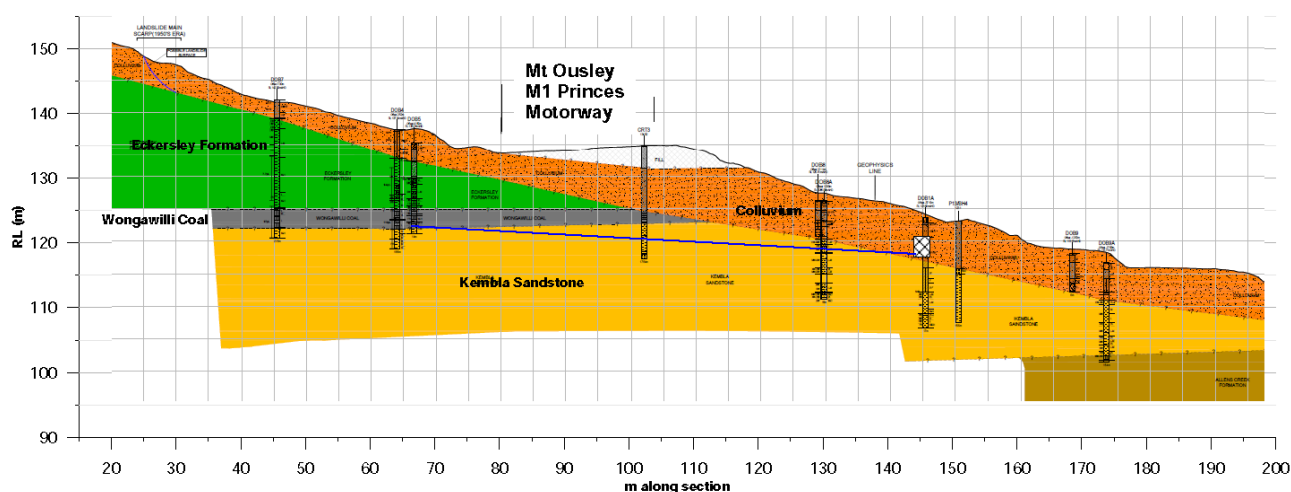
Figure 6: Central cross section of the Site 153 landslide, after Coffeys (2016) and showing the offset Dobinson Street Pit and schematic trend of the micro tunnels.

To summarise, the investigations clearly defined the subsurface profiles, hydrogeology and target permeability zones and identified that a precise laser guided micro tunnelling technique would deliver the required horizontal bores of approximately 100m length. The two micro tunnels (MTs) were bored from a 4.5m deep pit, founded in colluvium on the side of Dobinson Road in May and June 2018 as shown in Figure 6. The results of the hydrogeological investigation and drilling operations will be discussed in a more detailed and focused paper in the future, but the total costs of these works was approximately \$1.7 million including the mid-term purchase of two properties, which will likely be sold in the future.

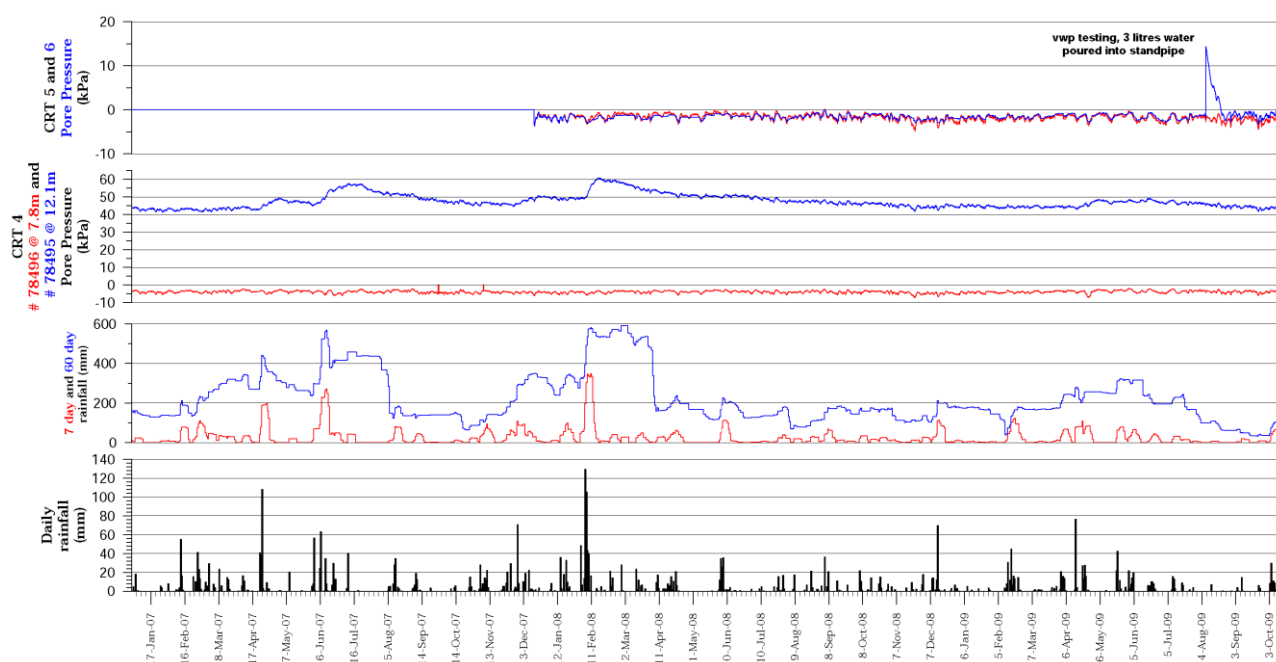
Figure 7: Site 153 hourly monitoring record from 1st January 2007 to 30th October 2009.

drains. CRT 5 and 6 were positioned 10m further south, away from the horizontal drains to see if any pore pressure was indicated along the colluvium bedrock interface (whilst also noting, at that time and even still today we have no confirmed indication from the inclinometers as to the depth of sliding). As Figure 7 shows, the boreholes CRT 5 and 6 show no pore pressure at all. In early August 2009, 3 litres of water was poured into the 50mm standpipe (and again in late June 2014) and this resulted in the ~ 1.5m (15kPa) rise of water in the standpipe and in the indicated pore pressure, confirming that the vwp instruments are indeed working and that this area is just dry. The vwp instruments were also checked using the Campbell Scientific Device Configuration Utility spectrum analysis, and they were found to be working, and other vwp instruments were connected to the same ports and tested with various water levels in a PVC casing and the results confirmed the system to be working. This indicates that this central area of the landslide and this section of the subsurface profile are likely located within the zone of influence of the five 1977 horizontal wells.

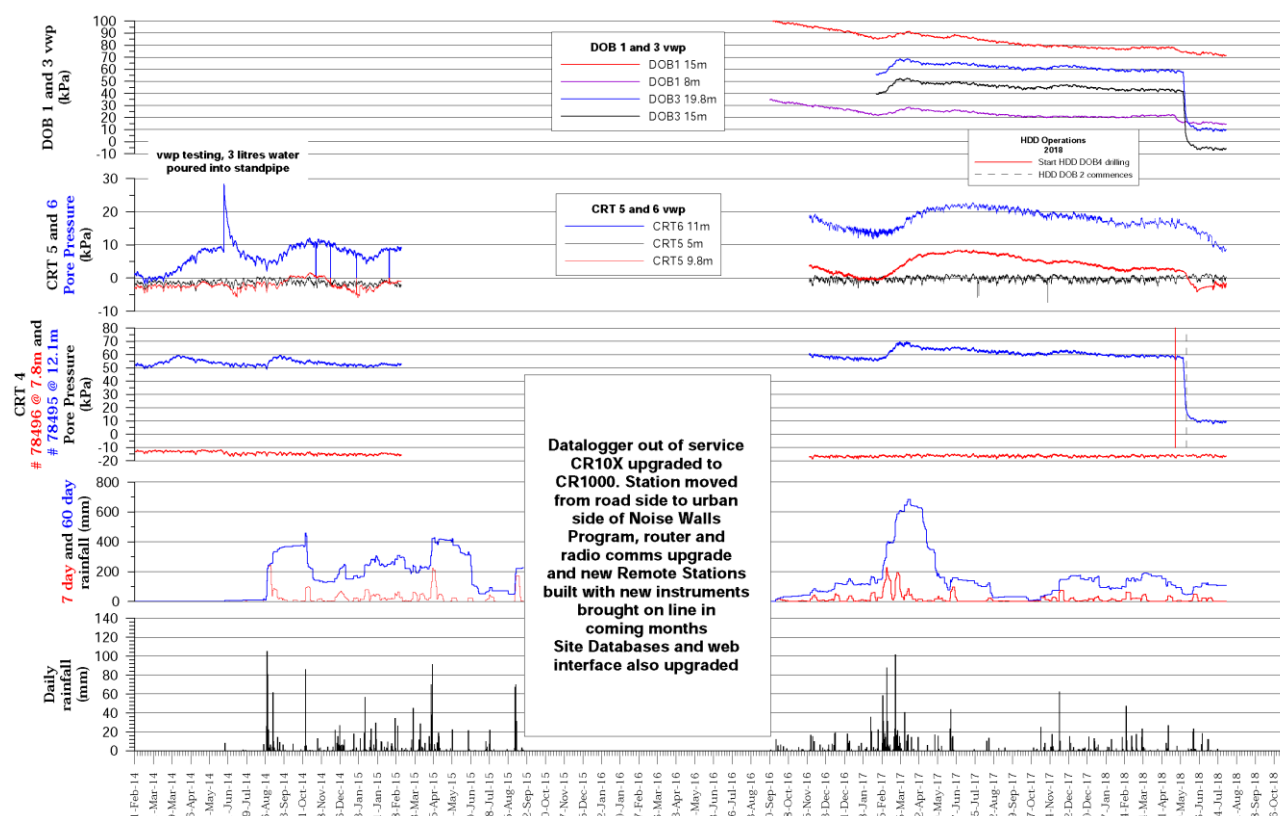
Figure 8 shows the hourly monitoring record from Site 153 from the 1st February 2014 to the 30th October 2018. Firstly, this period shows an extended data outage between August 2015 and September 2016. Before the outage period, a period of vwp data was lost, and troubleshooting investigations commenced. The site became infested with ants which were cleaned out on several occasions, but each time they returned in greater numbers ultimately damaging the router and several of the components. After the repairs, reconfiguration and relocation to the outside of the noise wall, including updating the cabinet from a fibreglass enclosure, to the latest style vermin proof stainless steel cabinet, the system was reactivated in time for the upgrades contributing to the hydrogeological investigation and impending remedial works – although at this stage we did not know exactly what form the remedial works were going to take. This graph highlights the wet weather experienced during February and March 2017, with the 60 day cumulative rainfall reaching almost 700mm, and the corresponding CRT 4 deep vwp pressure reaching 70kPa. For the first time since its installation the borehole CRT 5 vwp at the colluvium bedrock interface also showed a rise to 8.5kPa, almost 1m head of pressure on the slide surface at this location, if indeed that is where the slide surface is located. The top axis in this graph shows the borehole DOB 1 data stream from September 2017 and DOB 3 vwp data from mid February 2018 – after a significant troubleshooting experience with this remote station. Prior to the micro tunnelling works, the DOB 3 pore pressures in the bedrock intervals below the head area of this landslide are significant, with the deeper vwp at 15m reading pressures between 60 and 70kPa, and the shallower vwp at 8m (the base of colluvium here is at 6.5m) reading pressures between 50 and 60kPa. The deeper vwp in DOB 1 reading the highest pressures on the site at between 80 and 100kPa and the shallower vwp at 8m, just in bedrock below the base of the colluvium reading pressures of between 20 and 35kPa.

Figure 8: Site 153 hourly monitoring record from 1st February 2014 to 30th October 2018

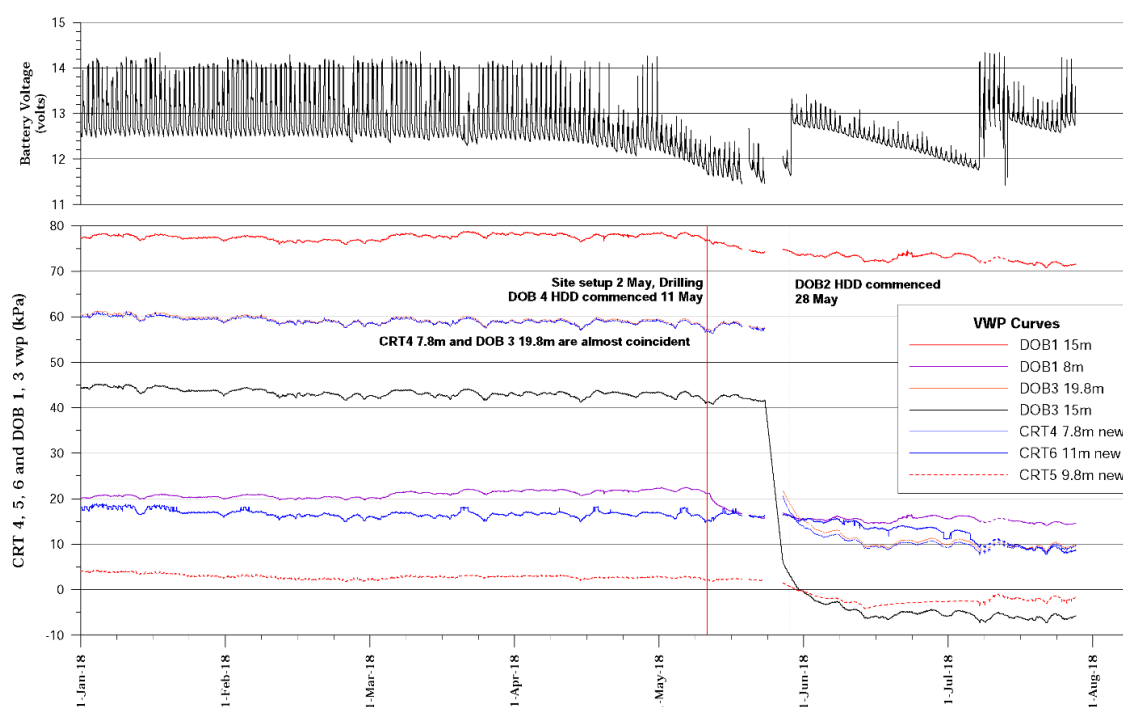
Figures 8 and 9 highlights the commencement of the micro tunnelling works with a vertical red line, and a vertical dashed black line when the northern mico tunnel was commenced. The pore pressure drawdown shown in Figure 8, and highlighted in Figure 9 are the results of the pit excavation and the micro tunnelling works, and these drawdowns are significant. Figure 8 shows these vwp traces as continuous curves. As the pit excavation was completed and the MT commenced, battery voltage on site was struggling with the low winter sun angles, and a Eucalyptus tree had started to shade the 65 Watt solar panel. Figure 9 highlights the faltering battery voltage over this period. A new 75 Amphour deep cycle battery solved the initial problem, but not the shading issue. Swapping and cycling batteries over the next month allowed the site to continue logging without significant further interruptions until the offending tree was trimmed. Figure 9 has the vwp curves as discontinuous (other than the DOB 3 15m vwp) showing the interruptions where battery voltage dropped below the radio transmitter operational frequency. The DOB 3 15m vwp shows simply exceptional response the drilling operations dropping over the 3 day outage from 45kPa to approximately 5kPa and continuing to drop since to small negative values.

Figure 9: Site 153 hourly vwp monitoring record throughout 2018, highlighting the MTs installation and the effect this has had on the groundwater, and also the impact of site power on the operations.

The drops in pore pressure are clear in Figures 8 and 9, but one of the key issues, is the spread of the drawdown effect across the site. The DOB 3 borehole is 14m upslope from the upper end of the DOB 4 MT, and the CRT 3 borehole is 20m south of the DOB4 MT. DOB 1 is located 10m south of the MT outlet pit and the shallow vwp is approximately 0.5m below the base of the pit and the deep vwp is at 15m and both have shown 5 – 10kPa reductions in pore water pressures. The real test of the success of these works will be seen into the future during prolonged and intense wet events of the 20, 50 and even 100 year Average Recurrence Interval magnitudes. It is clearly hopeful that these works will have successfully remediated this site for the long term into the future. The RMS are currently sorting out easements across the subject sites to ensure the 1970’s experience of development encroaching upon the installed remedial works is not repeated.

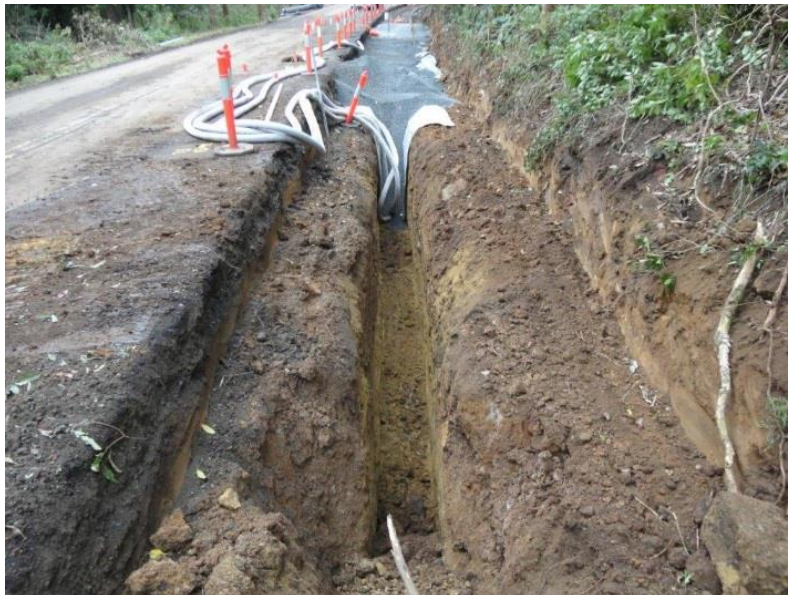
Figure 11: 2013 Excavation of a 4m deep cut-off drain along the road, with a concrete swale gutter above

were completed in 2013 which included installation of a longitudinal subsurface cut-off drainage slot (that intersected claystone bedrock at all of the inspected locations) with a concrete swale drain above along the uphill side of the road, road stabilisation works and re-paving (Figures 10 - 13). The adjoining landowner (NPWS) would not permit any works on their land, so all the remedial works were restricted to the road easement. The road has once again begun to undergo some deformation, due to landsliding after a number of rainfall events since the completion of the remedial works.

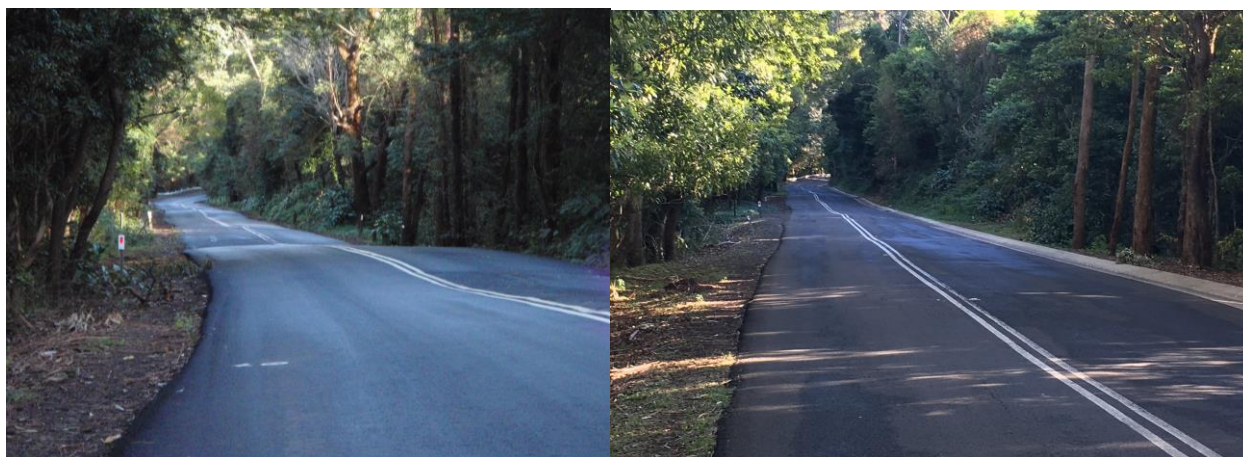
Figure 12: The image on the left shows obvious undulations on Mt Keira Rd at site 229 in 2012 (WCC, 2012) whilst on the right image the undulations are beginning to return in August 2017, 6 years after the work

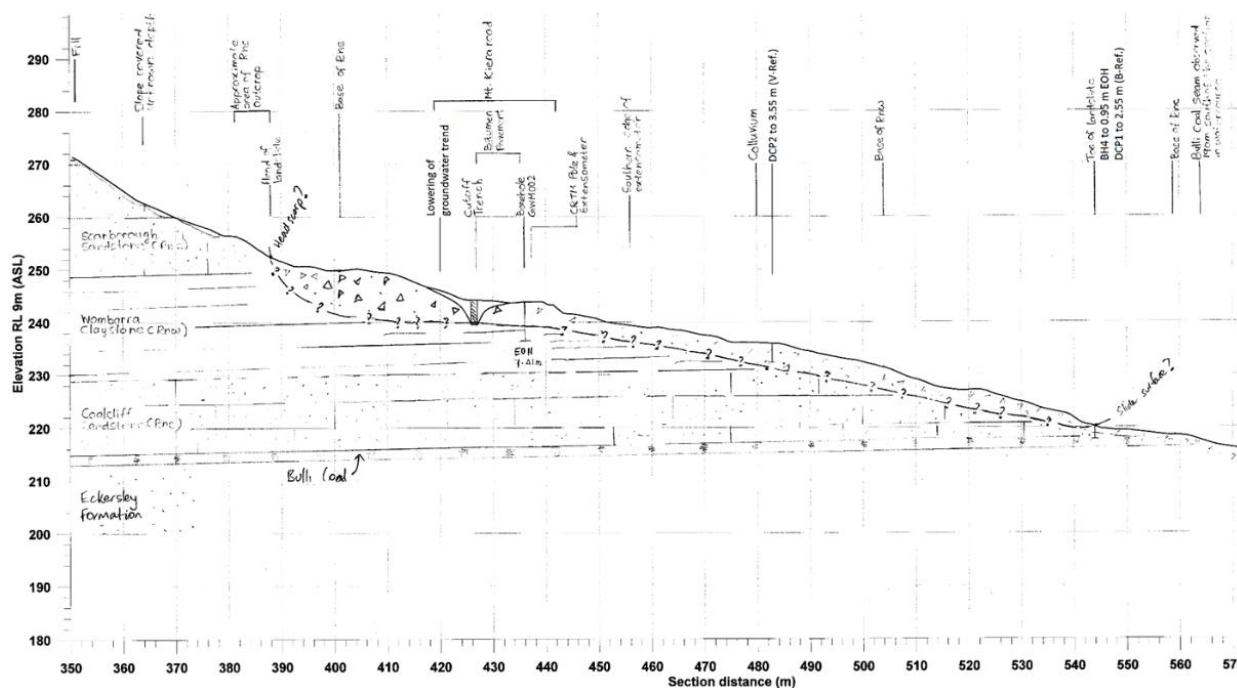
The inclinometer displacement data shows that the landslide has moved 73mm in boreholes GWM001 between November 2000 and November 2006, 62 mm in GWM002 between November 2000 and July 2017 (Figure 14) and 37 mm in GWM003 between June 2012 to July 2017, with average rates of 12mm/year, 4mm/year and 9mm/year respectively (Table 2). Using the AGS (2007) landslide velocity scale, the Site 229 landslide velocity is classified as extremely slow. In BH2, the sliding plane is located at a depth of approximately 4.5-5.0m, and in BH1 and BH3 (1m apart) sliding occurs from 4m to 5m.

Figure 13: Site 229 cross-section developed by Flentje, Palamakumbure, Piatek and the Newman (Piatek, 2016)

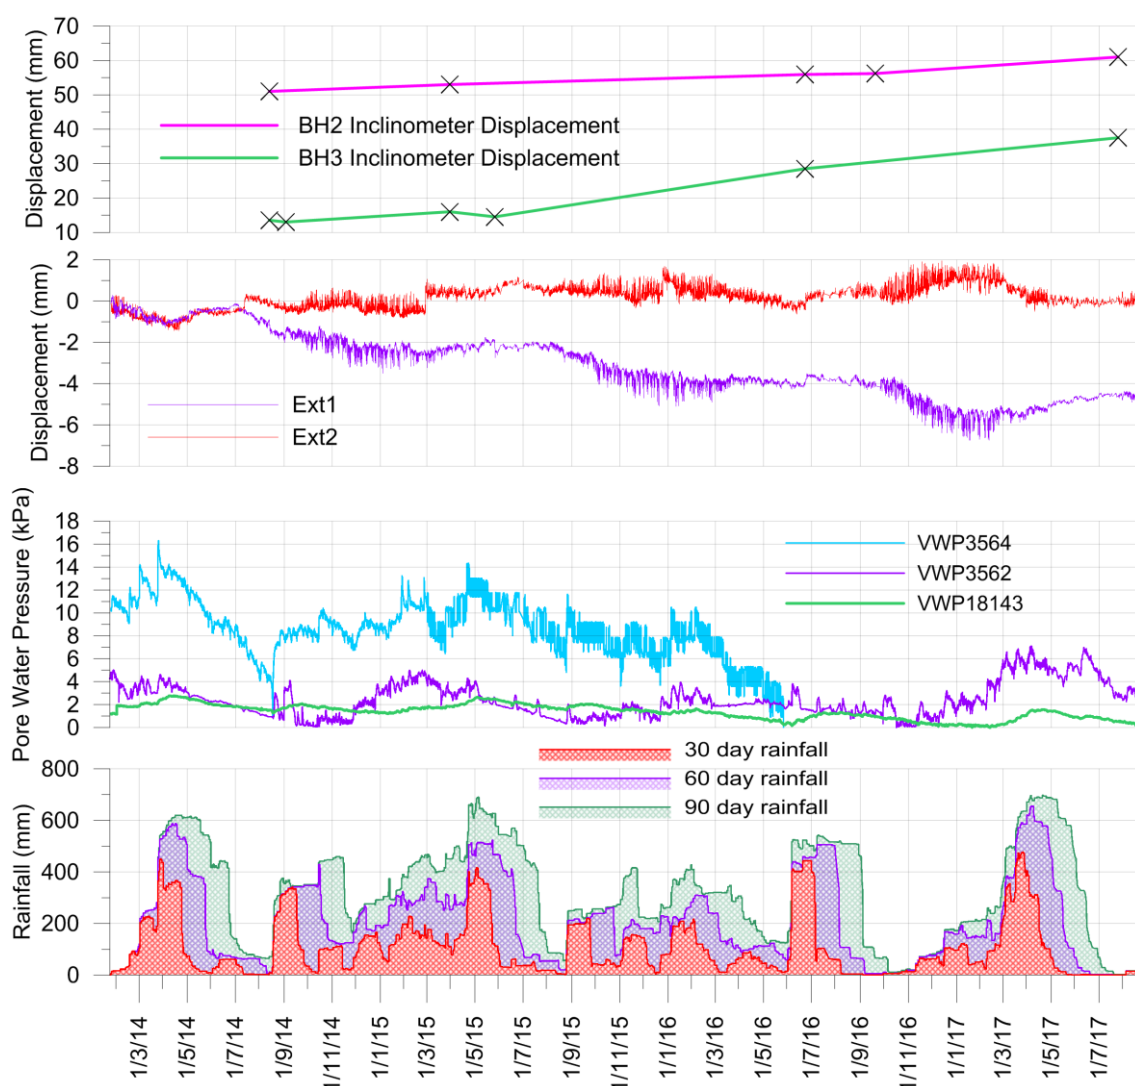
The Site 229 monitoring summary shown in Figure 15 includes a comparison of rainfall, pore water pressure (pwp), extensometer displacements and BH2 and BH3 inclinometer displacements. The pwp response to rainfall events is

proportional to the size of the event but is relatively small. Vibrating wire piezometer (vwp) 3564, located in BH1 at a depth of 4.3 m, shows the greatest pwp of the three vwp's. This high pwp may be the cause of the significant landslide displacement at this location which has caused the inclinometer casing to shear and sever the cable connected to vwp3564. vwp18143, located in BH3 adjacent to BH1 at a depth of 6.2 m, shows very low pwp values and doesn't follow the same trend as vwp3564. This may be due to the vwp being placed in bedrock at a point where groundwater pressure is not well expressed. vwp3562, located in BH2 at a depth of 4.9 m, follows a similar trend in pwp as vwp3564 but is consistently 5kPa lower. The lower pwp at BH2 may help explain the lower rate of displacement of the landslide at BH2 compared to BH3.

Figure 15: Site 229 Monitoring Summary 1/1/2014 – 1/8/2017

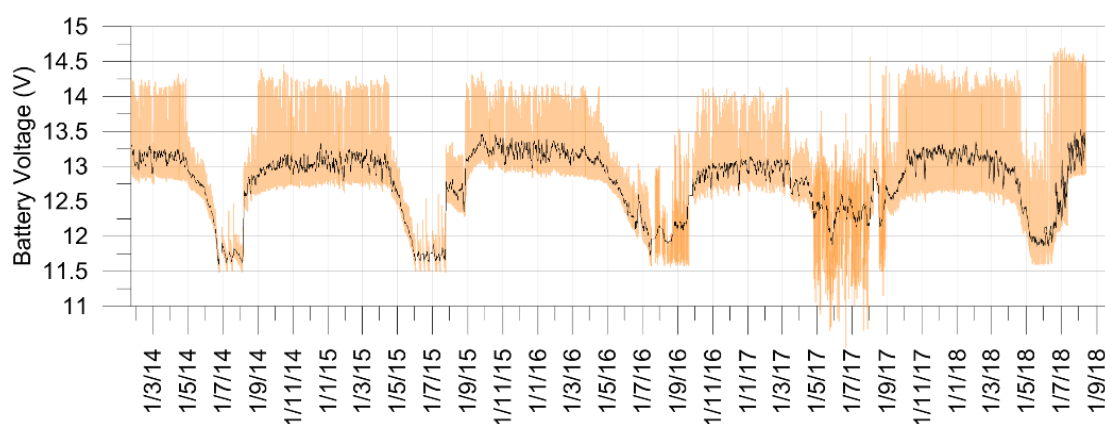
Battery voltage data is important as the site battery is solar charged and it indicates the health of the power components of the monitoring system. Figure 16 shows the battery voltage from 24/01/2014 to 12/08/2018 where it can be seen that during the winter solstice the battery voltage drops to under 12 volts at times. The router does not work with power less than 12 volts thus resulting in the station being offline. If the voltage drops below 9.6 volts, the logger will cease working and data is actually not recorded. Whilst this has only happened occasionally, the drop on voltage is certainly an issue that needs addressing. Some logger program modifications have been made to switch the power off to the router, from the logger 12 volt power ports, between 7pm and 9am, outside of available sun hours, only during the winter months to help prolong the daily power supply, and the life of the battery. A new 75 Amphour battery was installed during the 2018 winter period and the night time switching off of the router has definitely reduced the sites power consumption. The site is located within a forest environment and trimming the nearby trees is not an option. The rain gauge and the solar panel have been mounted on a 10m high folding pole, but unfortunately many of the surrounding trees are 15m plus in height, so its likely to be an ongoing issue at this site. We may even install a small wind turbine generator on the pole to compliment the charging options.

Figure 16: Site 229 monitoring station battery voltage
