AGS VICTORIA 2017 SYMPOSIUM
Reactive clays and light structures

Methods of investigation and repair of light construction on reactive soil not complying with expectations

R. I. Brown

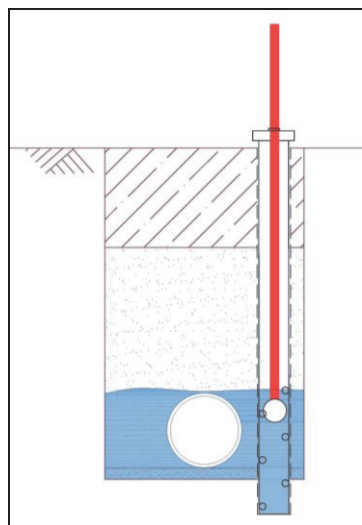
If doubt exists after moisture levels are taken (during borelogs) and the above plumbing test has been implemented, a float device/probe should be installed to determine whether the trenches on site and adjacent are flowing water intermittently. See Figure 1.

Identifying if there is a moisture source external to the site may be investigated via a float device/indicator with an infrared motion detection camera as per Figure 1. This device reacts to free water in the trench. Upon conclusive evidence that water exists, the builder/plumber can initiate preventative and corrective measures via an engineered design.

Figure 1. Float device for monitoring water in trenches

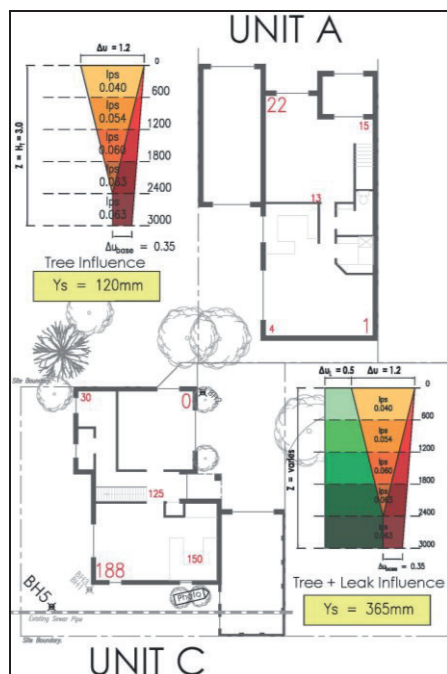
Figure 3 presents the degree of differential movement observed in Units A and C. Unit A is quite nominal [$22\text{mm} \pm 2\text{mm}$]. The front of Unit A had some vegetation and was poorly watered. At the rear was a set of trees, some quite mature and reasonably large. These trees were the same distance from Unit A as they were from Unit C, however, the differential movement in Unit C was $188\text{mm} \pm 2\text{mm}$ as measured.

Figure 3. Levels, bore log location, Y_s calculation.

An additional suction value of 0.5 is added to the total change of suction due to the wetness of the soil (as noted in Figure 3, the soil was wet to depth). This has been justified by research undertaken by Swinburne University of Technology, whereby the surface suction increases to 1.60, not limited to 1.20 as per AS2870 (2011).

Adopting AS2870 (2011) to estimate the characteristic surface movement provides contradicting results to that observed in the field. There has been no ongoing research performed by AS2870 (2011) to verify the alpha (α) value and its relationship to Y_s . A total Y_s from an originally wet site to a dry site (abnormal) is 112mm. However, a total Y_s from an originally dry site transitioning to a wet site (abnormal) is in the order of 365mm (see Figure 3).
