**AGS VICTORIA 2017 SYMPOSIUM**  
**Reactive clays and light structures**

# Two case studies of movement and damage in relatively new domestic dwellings

This paper presents cases of damage in two dwellings in Victoria that occurred because of soil movement. The paper explains the mechanisms of movement that lead to the damage, based on site specific geotechnical investigations.

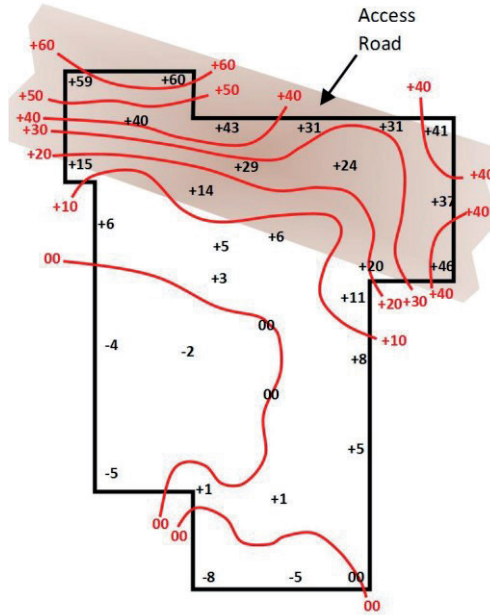
As can be seen from Figure 1, which shows the floor levels, significant heave has developed beneath the front section of this building. The contours are closely spaced at the front of the house indicating movement. The floor level contours across the rest of the house are meandering and spaced well apart, indicating that the remaining sections of the slab are performing within normal seasonal expectations.

The distress in this building manifested in the form of internal, diagonal plaster tears, distortion of internal door frames perpendicular to external walls, separation of cornices and ceilings and horizontal brick work cracking.

Figure 1. Floor Levels, Case Study 1

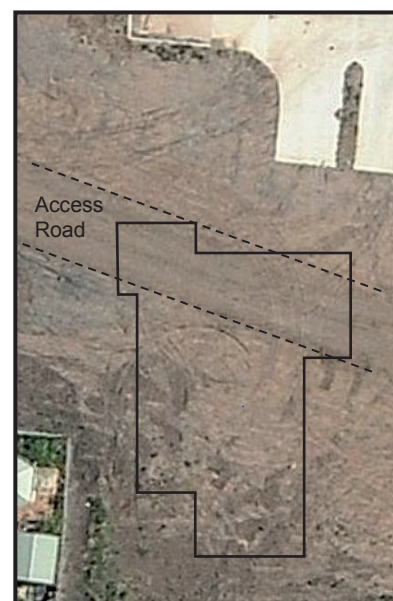
Machinery traffic over the access roads beneath the front of the slab (refer to Figure 2) is likely to have over compacted the highly reactive clay filling in this area, making it more susceptible to heave, or swelling upon re-wetting, than the reactive clay filling beneath the other sections of the slab. This susceptibility is explained in more detail below. It is possible that the soil re-wetting may have been compounded by the establishment and maintenance of gardens around the newly constructed domestic dwelling.

Figure 2. Image from Nearmaps, showing the location of the access road with respect to the subject building.

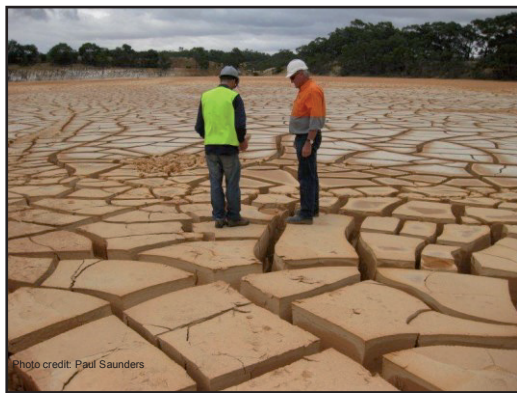
In addition to the above, it is likely that the heave has been compounded by the effective removal of the cracked zone from the reactive soil profile. This aspect is shown in Figure 3 below.

Figure 3. Photograph of the “Cracked Zone” (courtesy Paul Saunders). This image is not of the subject site it is for illustration only.

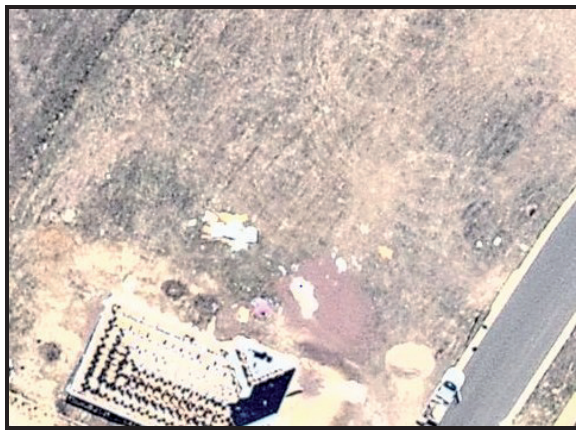
The site slopes relatively steeply from back to front and required significant site levelling works to facilitate the construction of the slab. These works included a cut at the front and fill at the back (refer to Figures 7 and 8 below). It is apparent that the fill material is site derived from the cut area. Dynamic Cone Penetrometer testing indicated that while the fill may have been tracked rolled it was not placed under controlled conditions. The site levelling was undertaken just prior to the construction of the slab. The front section of the slab is located in the cut and has been designed and constructed to be founded directly on the highly reactive clay exposed in the cut area. The rear of the slab extends into the filled area and has been designed and constructed to be fully suspended and supported on piers founded well into the underlying natural clay soil below the filling.

Figure 6. Case Study 2 subject site, just prior to construction.

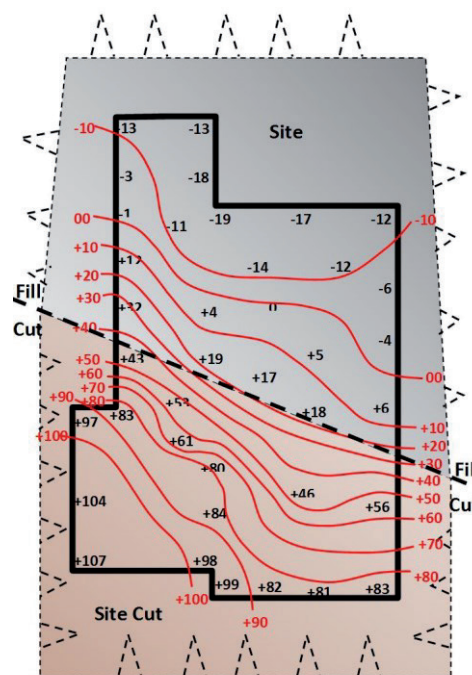
As can be seen from Figure 9, which shows the floor levels, significant heave has developed beneath the front section of this building. The contours are closely spaced across the mid to front section of the building, which is located within the site cut. The floor level contours across the rear of the house are spaced much further apart, indicating that the remaining sections of the slab are performing within normal seasonal expectations. While the floor levels at the rear of slab are slightly lower than the central sections, this degree of difference is not considering to be outside of the normally expected construction tolerances. The lack of any distress in this area suggests that this difference is likely to be due to initial construction differences.

The distress in this building manifested in the form of internal, diagonal plaster tears and distortion of internal door frames perpendicular to external walls.

Figure 7 - Floor Levels, Case Study 2.

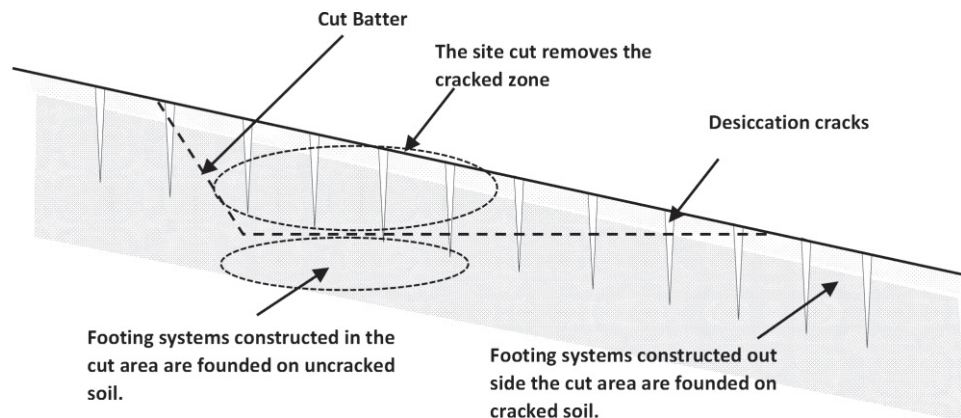
Figure 8 – Removal of Cracked Zone of soil profile due to site cutting

In addition to the above, the site cut at this property removed virtually all of the cracked zone from the soil

profile within the site cut. The section of the slab in the cut area was therefore constructed on uncracked clay, which has reduced capacity to absorb soil swelling, upon re-wetting. Similar to Case Study 1, the effective removal of the cracked zone of the soil profile beneath affected sections of the slab is likely to have significantly increased the potential for heave to occur in these areas.

With respect to sites that are subject to significant site levelling works, the sites should be re-investigated by a suitably experienced geotechnical practitioner, after the site levelling works have been completed. The purpose of this re-investigation, is to determine if the original site classification and/or footing recommendations contained in the original geotechnical report remain appropriate, or if they need to be re-considered.
