**AGS VICTORIA 2016 SYMPOSIUM**  
**Excavations and slope stability**  
**in Melbourne geology:**  
**experiences and recent developments**

## MT ELIZA – SLOPE STABILISATION

Triggered by excessive water, a landslide occurred on the cliff face of this bayside suburb with the potential to repeatedly slip and undermine beachfront residences located at the top of the cliff. Stabilization was imperative.

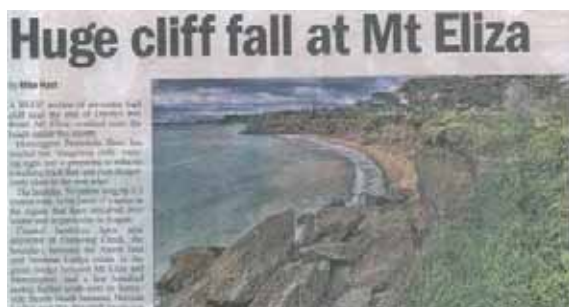
Landslips in the coastal foreshore cliff area of Mt Eliza are often triggered by wave erosion at the toe of the cliffs causing under cutting and toppling failure.

Figure 1 - Typical landslide in area

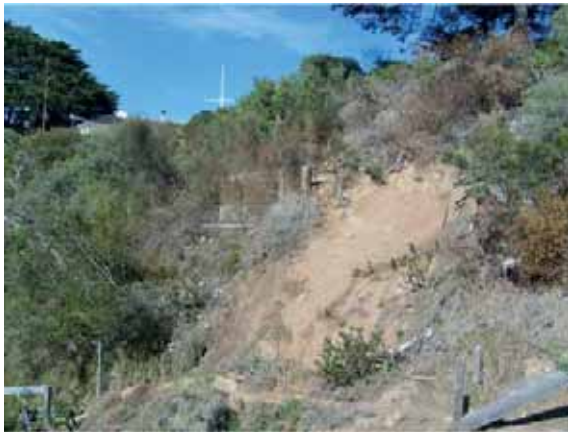
The exposed sandy clay and clayey sand faces are metastable and are essentially reinforced by surface vegetation. The steep slope often experienced surface erosion and minor surficial slips after:

- a) periods of wet weather with direct exposure of the faces to rainfall and runoff;
- b) periods of dry weather drying and desiccation of the soil, vegetation die back, and denuding of areas.

*Figure 2 - Typical denuded area*

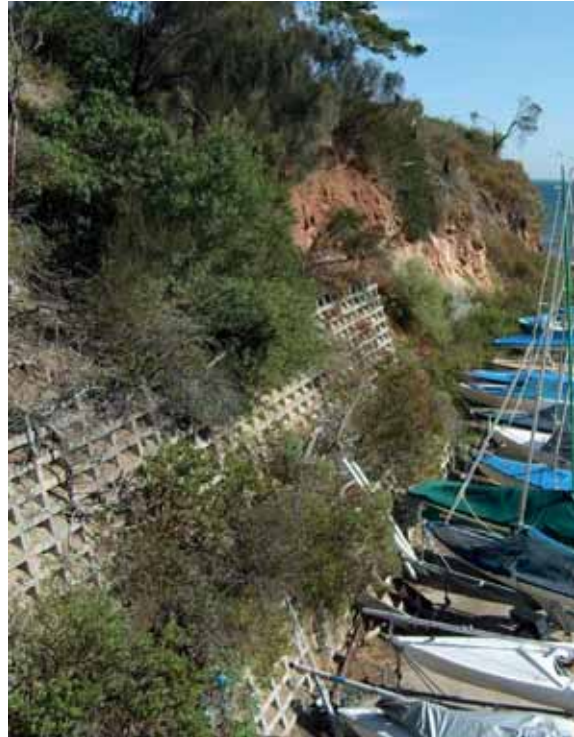
the horizontal varies between approximately 40 degrees to more than 60 degrees; with the steeper areas being largely dependent upon the presence of iron oxide rich cemented zones for stability.

*Figure 3 - Steeper area of slope including cemented zones*

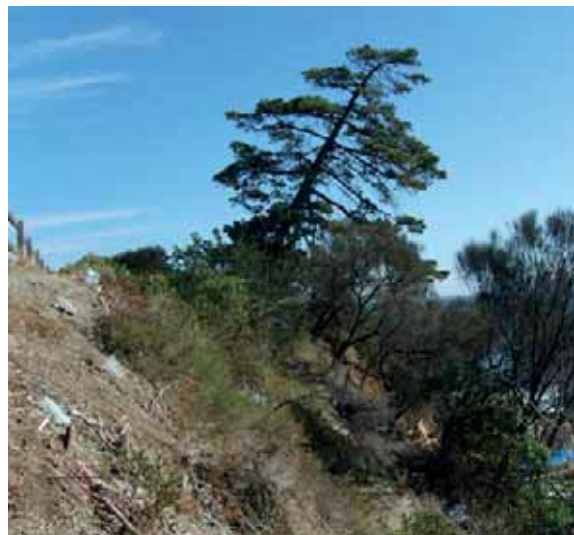
*Figure 4 - Slope instability indicated by leaning trees*

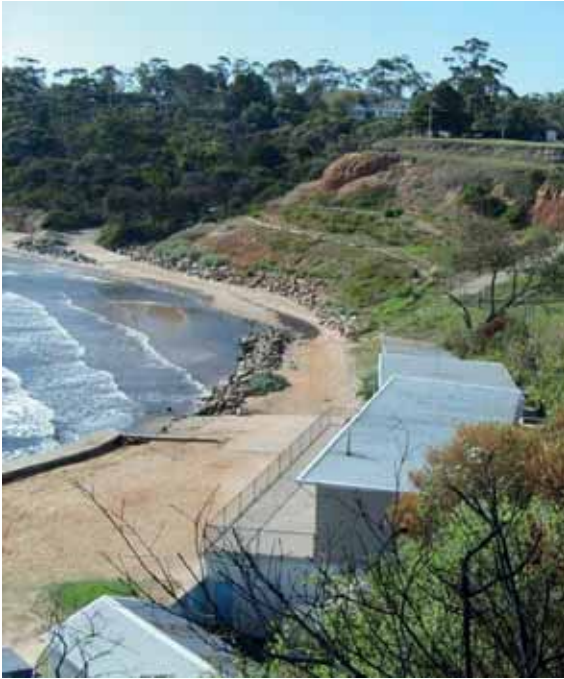
Access to the slope to install the soil nails was not straight forward. Typically soil nails are installed using a top down method whereby the nails are installed from benches as an excavation is deepened. In this case the 15 m high nominally 40-degree slope was already formed. Access was only available from the base of the slope. To complicate the situation further, the access to the base of the slope was only available across a narrow beach on the foreshore and only at low tide.

Figure 5 - General view of the site showing the access over the foreshore at low tide

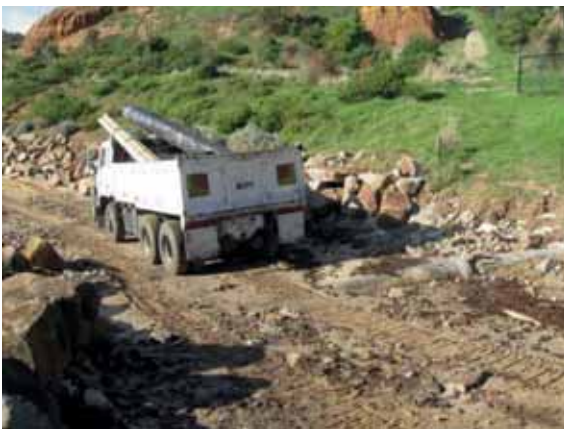
Figure 6 - The problematic access over the foreshore at low tide

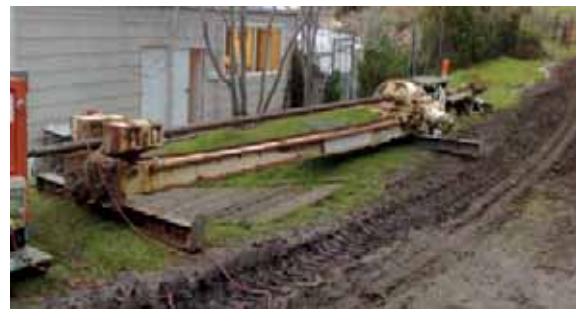
Figure 7 - The drilling rig mast separated from the drilling rig

It was a drilling contractor, thinking out of the box, that suggested removing the mast from a remote control drilling rig and lifting the mast alone with a smaller, but still substantial all-terrain crane. The concept was to attach a frame to the mast to lift it and hang it at the required soil nail installation angle, support it laterally and hold it against the face to provide a reaction to the drilling loads.

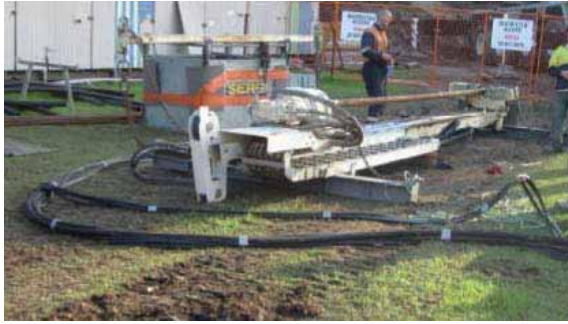
Figure 8 - The drilling rig mast with umbilical cord of hydraulic hoses attached

A long umbilical cord of hydraulic hoses connected the mast to the rest of the remote control rig, which was left at the toe of the slope.

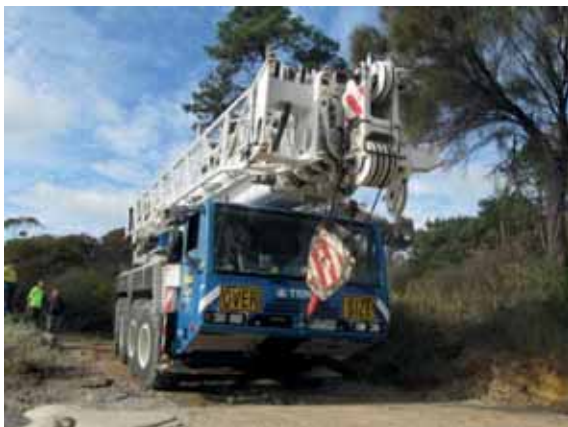
Figure 9 - The 70 tonne all terrain crane entering the site

The weight of the mast alone and the maximum required reach was within the safe operating range of a nominal 70 tonne all terrain crane.

A 70 tonne all terrain crane was used to access the site and to safely reach all soil nail locations.

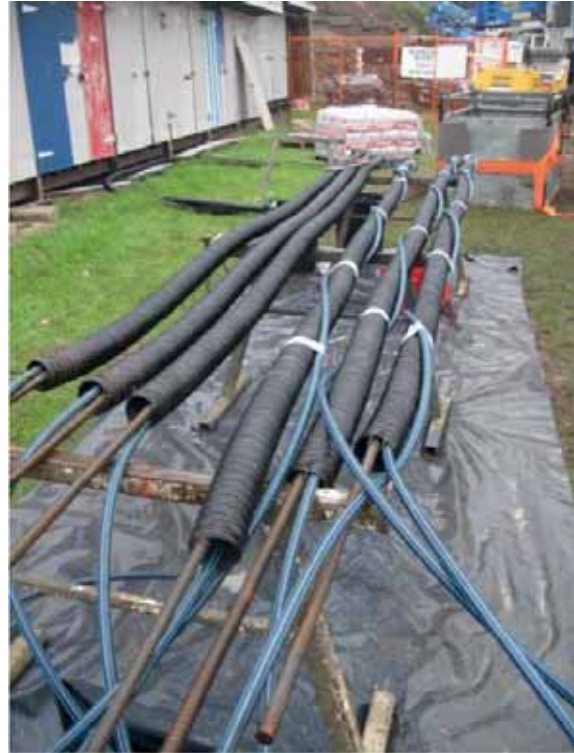
Figure 10 - Soil nail preparation on site

All nails were assembled on site to maintain quality control and limit transportation and handling issues.

Nail design provided for three levels of corrosion protection, including pressure grouting inside corrugated HDPE sheathing using centralizers and pressure grouting the annular space around the outside of the sheathing. Nail heads consisted of grout filled HDPE sheathing to the surface and grease filled caps at the surface. A comprehensive program of test nail testing ensured that the design expectations would be met.

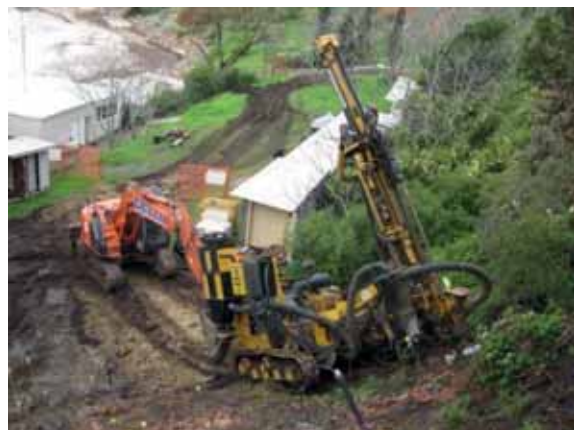
Figure 11 - Soil nail installation on the lower section of the slope

The soil nail installation on the lower section of the slope was carried out with a conventional drilling rig with the aid of an excavator for support.

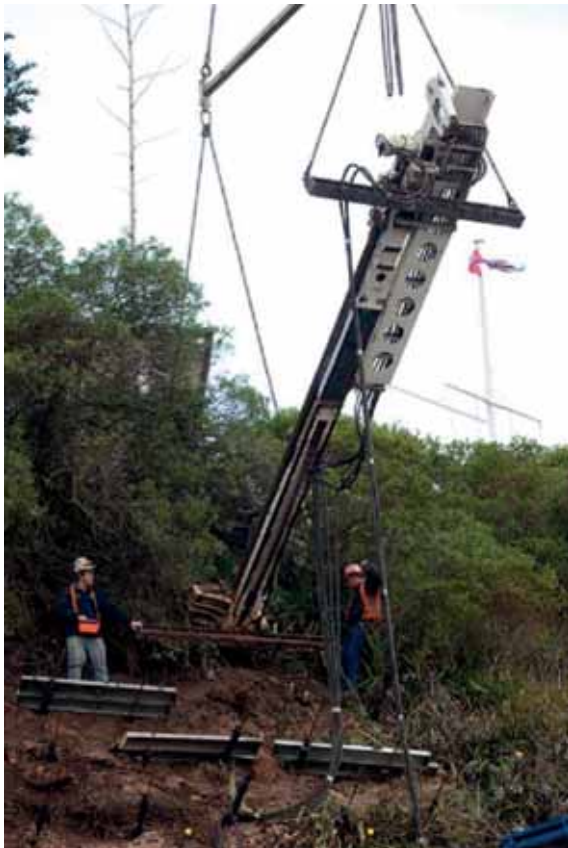
Figure 12 - Soil nail installation on the upper section of the slope. Note; driller operating the remote controlled rig on the left.

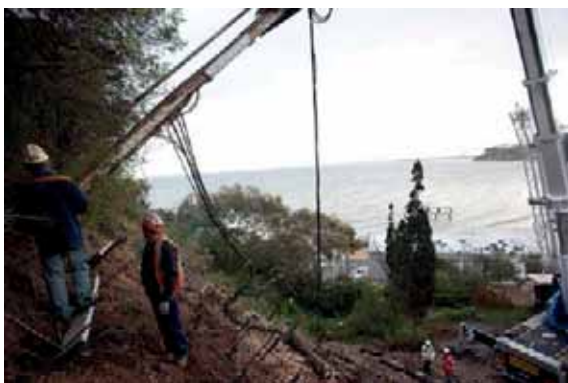
Figure 13 - Soil nail installation on the upper section of the slope

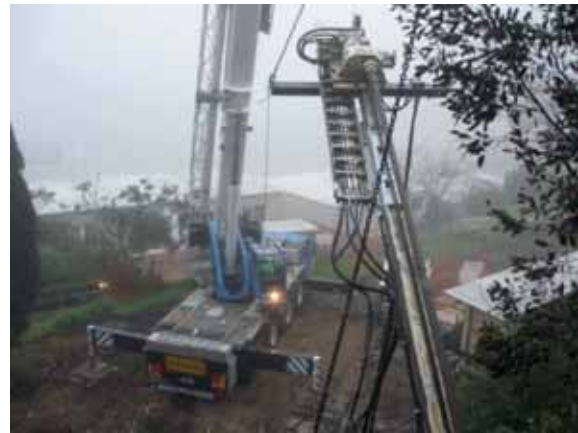
Figure 14 - Soil nail installation on the upper section of the slope

The soil nail installation was carried out without major issues for the entire project on the steep and uneven slope. In total 137 soil nails were installed and the cliff was adequately stabilized.
