Landslide Damage to Road Networks in the 2021 Marlborough Storm

ABSTRACT

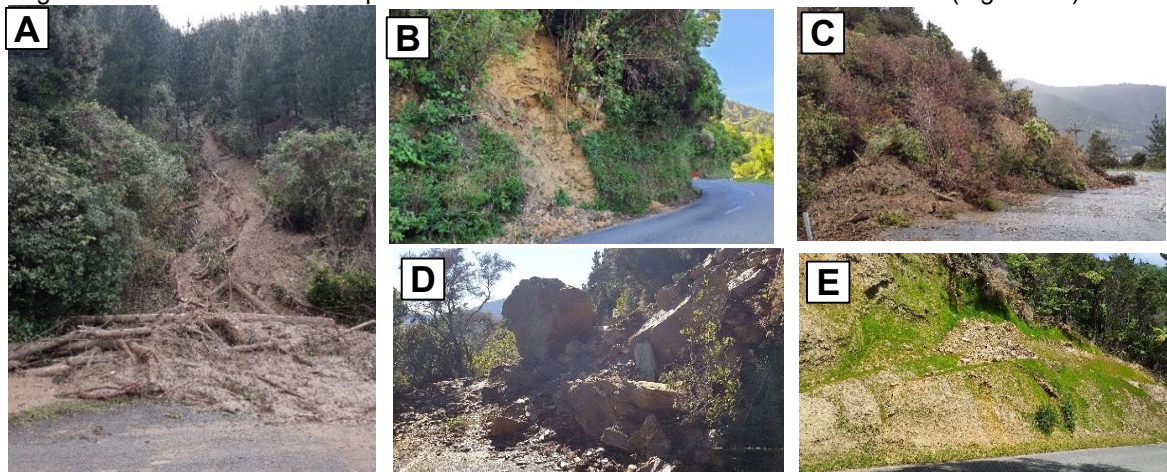
Debris and mud flows occurred in high steep catchments, most frequently on the western end of QCD (Mahakipawa hill) and along Kenepuru Road (Figure 2A). Flows occurred in both clear-felled, mature forestry and native bush catchments. The liquefied flow material frequently blocked culverts and redirected surface water where they crossed the road corridor, consequently triggering underslips and scour damage below the road. Large volumes and high saturation of the debris resulting from flow failures meant these sites took longer to clear than any other form of overslip.

Rock falls were common from steep cut slopes formed in the weathered schist bedrock throughout the Sounds. These failures tended to have a minor impact on the road network overall as they resulted in smaller volumes of debris and often only extended partially into the road lane (Figure 2B). One significant exception to this was 'the Rock' site, where a car-sized boulder toppled and blocked the road (Figure 2D). Clearing the boulder took several weeks, however this site was part of an extended unstable slope and was closed to all traffic till November while additional earthworks were carried out.

There were a variety of mechanisms seen in sliding failures of overslips above the road. Some examples include planar slides along soil-rock interfaces and along dipping foliation planes, rotational slumps in over-steep cut slopes and compound slides in rock slopes (Figure 2C). Slides on high hillslopes would often transition into debris and mud flows by the time they intersected the road corridor. The impact of overslips typically depended on their size and location, rather than failure mechanism.

Small to medium volume overslips occurring from steeper natural slopes and cut batters were fast to clear but often failed again, depositing small quantities of debris on the roadside regularly after rainfall. Larger failures in locations with thicker soil deposits and deeper weathering profiles often required more extensive initial earthworks as the slopes would regressively fail as the slip debris was removed from the toe. Benching slopes was an effective way of reducing the quantity of debris that reached the road, though benches would often 'fill up' with debris and lose their effectiveness over time (Figure 2E).

Figure 2. Typical examples of overslips. (A) Debris flow. (B) Small rock fall from a cut in weathered schist. (C) Undifferentiated slide (D) Large rock fall at The Rock (E) Ongoing failure of benched slope.

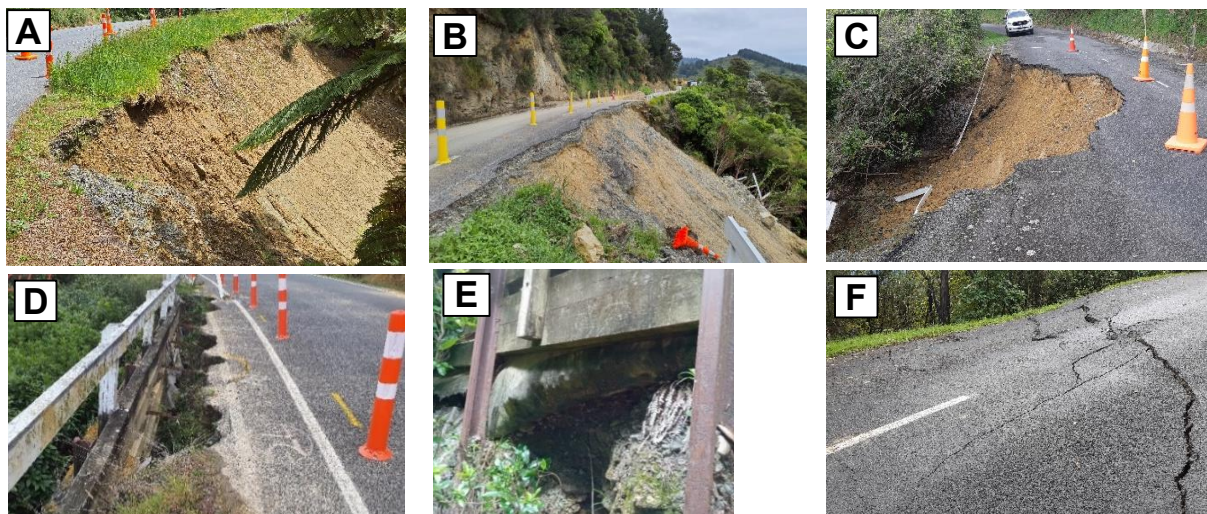
Shallow planar slides typically occurred on slopes $>30^\circ$ and involved the surficial layers of colluvium and residual soil with an estimated depth of $<1\text{-}2\text{m}$ (Figure 3A). The debris from these slides frequently developed into flows, often extending down to sea level. These types of failures typically occurred in road shoulders and showed minimal signs of regression after the initial event, though the exposed soil was vulnerable to scour.

Typically developing as planar slides, side-cast fill failures occur in the outer road lane, often developing initially as cracking and subsidence at the edge of seal where water runoff saturates the soil. Side-cast fill failures can be difficult to differentiate from planar slides occurring on natural slopes, as the resulting damage is similar, however, these slips tend to extend further into the road corridor resulting in greater impact on the road network. In 12 months, 3 sites that initially consisted of cracking and subsidence of the road edge developed into fully evacuative failures (Figure 3B). The evacuation occurred rapidly following rainfall, with no notable deterioration of the site pre-rainfall which would have predicted the failure.

Rotational soil slides are characterised by semi-circular head scarps that have developed in the shoulder or road lane. Most of these slips tend not to have not fully evacuated, with the bulk of the slip mass is still in place with a steep semi-circular head scarp. Where the slip extended into the road, they tend to remain un-remediated 12 months after the storm with single lane closures still common, particularly on Kenepuru Road. Regular inspections showed that the slip masses settled and cracks widened in the

first few months following the July storm, however, over summer the displacement ceased. At the sites that did evacuate (Figure 3C) the deep slip surface resulted in steep slip scarps greater than 3 m which limited heavy vehicle movement on the narrow road for over 6 months.

The most common form of retaining wall in the Sounds, rail-iron walls are formed from driven rail iron piles with timber lagging. They have a typical height of 1.5-3.5m and are frequently tied-back to a deadman pile below the road. Where tie-backs were present, these walls typically performed well during the storm. The primary form of damage was the formation of large voids behind the timber lagging. This was initially attributed to scour, however following inspection it was found that voids were forming below the base of the timber lagging due to underslips in front of the wall (Figure 3D & 3E). These voids allowed the loose backfill to migrate out from behind the wall. At several retaining walls, the geotextile wrapped around the base of the backfill was the only thing preventing further creation of voids behind the wall.

Figure 3. Typical examples of underslips and wall failures. (A) Planar soil slide. (B) Side-cast fill failure into a planar slide. (C) Rotational slide at MBR RP3.0. (D) Void behind rail iron retaining wall. (E) Loss of backfill below lagging. (F) Global slope deformation.

Deformation related to large, deep-seated movements of hillsides encompassing the whole road bench were noted in 11 locations after July 2021. Common damage observed was transverse cracking across the road, with large vertical distortion in the pavement, indicating a slip surface which passed below the road (Figure 3F). Often these slips were accompanied by smaller overslips or underslip / toe failures, while culvert disjuncting and tomo-formation was also common. None of these slips were seen to have fully evacuated, and the slope deformation consisted of limited displacement of the landslide mass. These movements were traversable by 4WD vehicles immediately after the storm, and due to the scale they are typically managed by re-leveling and monitoring the road. These slope deformation features were typically located in areas mapped by GNS as Pleistocene-Holocene landslide deposits. The movements are expected to reflect re-activation of lobes of large relict landslides, occurring due to elevated ground water after prolonged rainfall.
