RISK ASSESSMENT AND EARTHWORKS MANAGEMENT PROCEDURES FOR CONTROLLED INFILLING OF A DISUSED QUARRY PIT

Peter J. Waddell and Peter J. Burgess
Coffey Geotechnics Pty Ltd

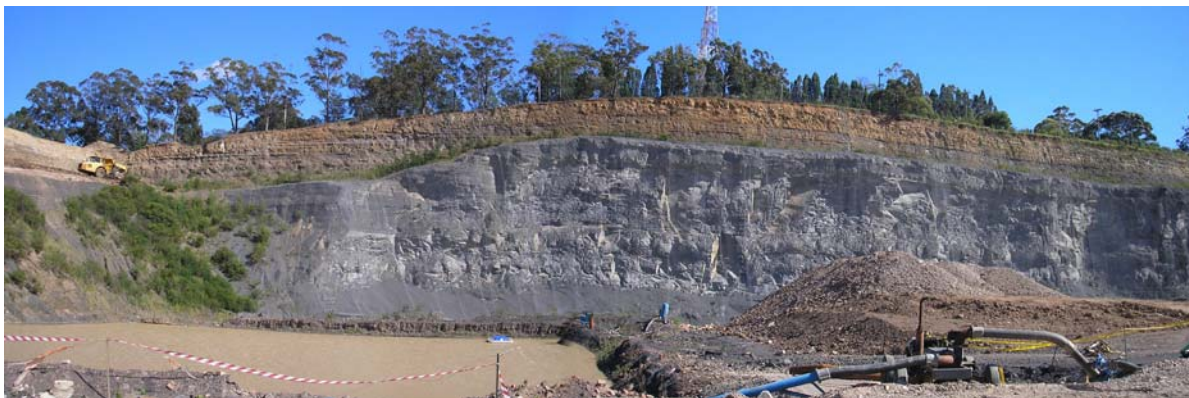
Figures 2 and 3 show typical views of the north and east pit walls.

Figure 2: View of western half of north pit wall.

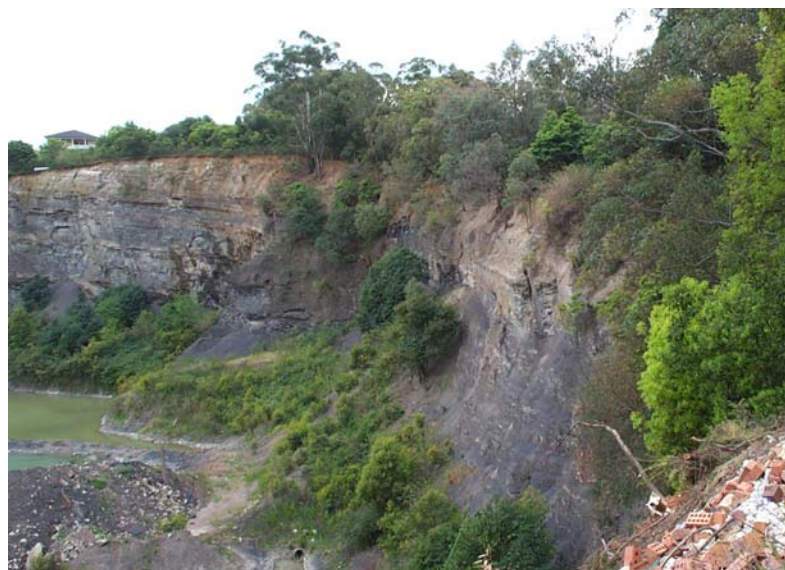
Joint Set	Features
1 North South	<ul style="list-style-type: none"> • These joints were noted principally along the eastern pit wall where they are near vertical ($\pm 20^{\circ}$). • Form a swarm of closely spaced joints along the eastern pit wall where the joints had opened up by as much as 200 mm, presumably due to toppling movement in the rock mass along the joints. These joints are also exposed in the northern face of the quarry. • The dip of the joints in this area appeared to be either near vertical or dipping steeply back into the cliff face. The joints were not quite parallel to the pit wall but were seen to persist for distances as much as 20 m.
2 East West	<ul style="list-style-type: none"> • These joints were noted principally along the northern pit wall. • Appeared to be discontinuous and trended sub-parallel to the quarry face. • The dips associated with this joint set were towards the south (out of the face) at angle of 45° to 60°. • There was a general tendency for the joints to form small wedge type potential failures in conjunction with the Set 1 joints.

Figure 3: View of east pit wall.

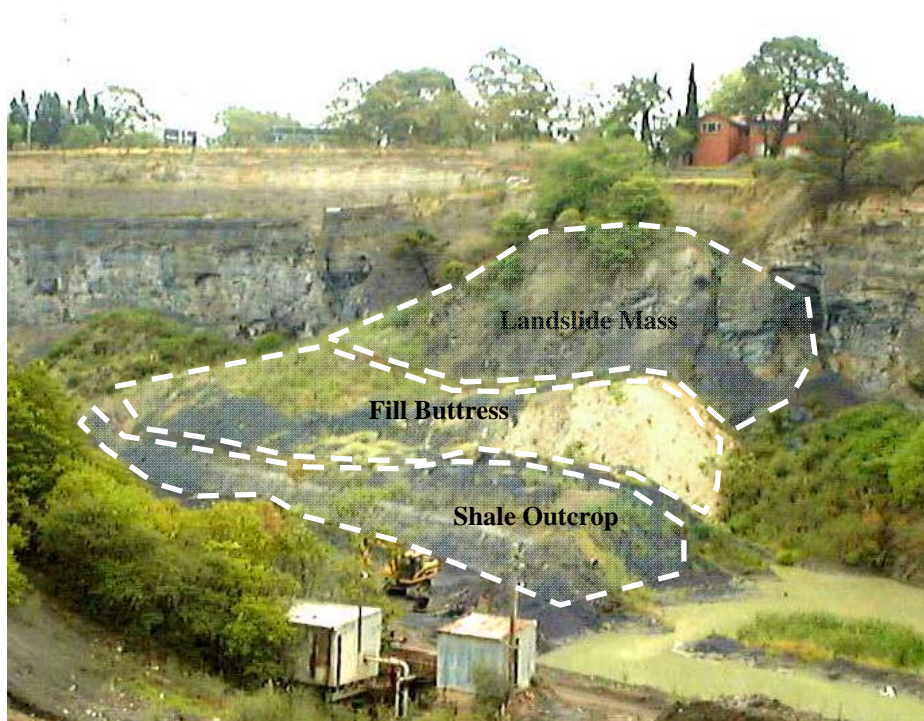
The back scarp of the failure formed along two separate steeply dipping rock mass joint planes, one dipping at 65° into the pit, and one dipping at about 90° – being part of Joint Set 1, with a release plane being the east west Joint set 2. A joint plane at about 10° sub-parallel to the bedding apparently acted as the basal plane to the slide.

The failure model for the pit wall failure infers the presence of significant hydrostatic water pressures acting on the near vertical joints. The trigger mechanisms for the failure were inferred to be a combination of factors including the history of excavation of the drainage ditches at both the top and bottom of the pit walls combined with the change of drainage and groundwater conditions resulting from the construction of a house above the failure and its related drainage absorption trench constructed during the dry period prior to a wet period.

The back scarp was considered to be buttressed by the failure mass and not likely to slide further without disturbance. Figure 4 shows a view of the landslide with the buttress in place.

Figure 4: View of slip looking north west.

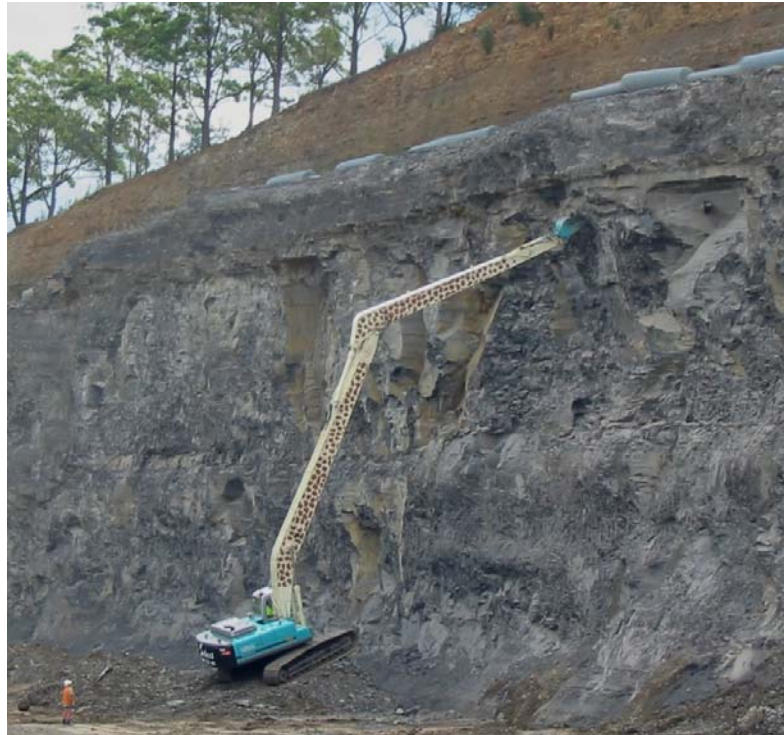
It was impractical to scale the whole of the surface of the pit walls due to the height of the pit walls which reached 30 m in places. However, by using a long reach excavator it was possible to scale to a height of over 20 m. Figure 5 shows the long reach excavator scaling.

Figure 5: Scaling using long reach excavator.

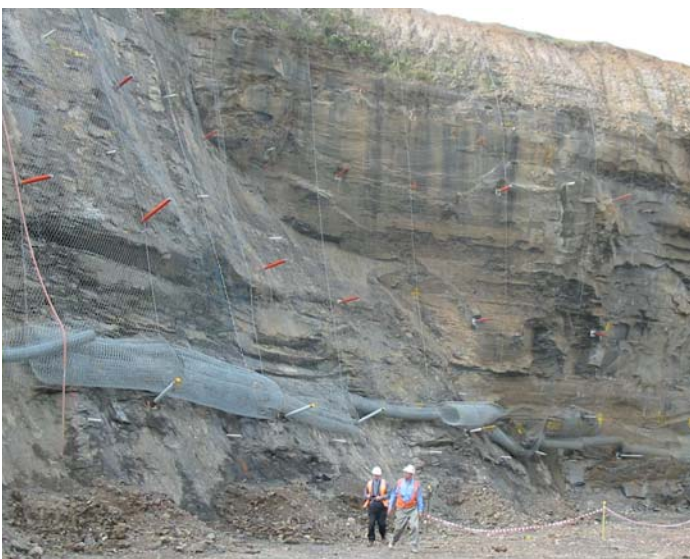
Figure 6: Batter mesh installed on north pit wall.

Figure 6 shows the draped batter mesh after lacing to form a continuous layer across the pit wall. The mesh was fixed at the crest using two, 20 mm diameter, 3 m long rock bolts per roll. Figure 7 shows typical material that is retained on the pit face by the mesh.

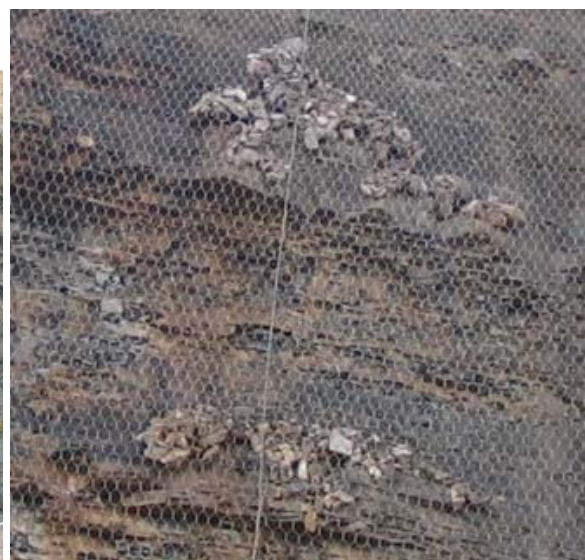
Figure 7: Rock fall captured by mesh.

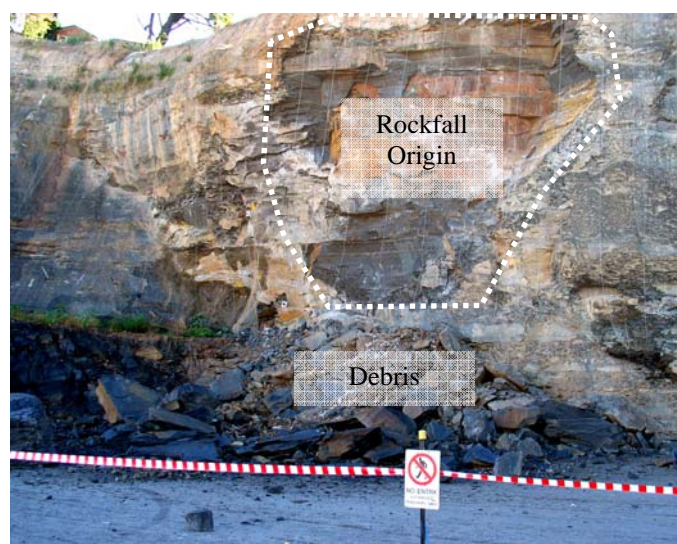
Figure 8 shows a large fall that occurred adjacent to the 1999 landslide. The run out zone was limited to about 5 metres from the pit wall.

Figure 8: Large rock fall from north pit wall.

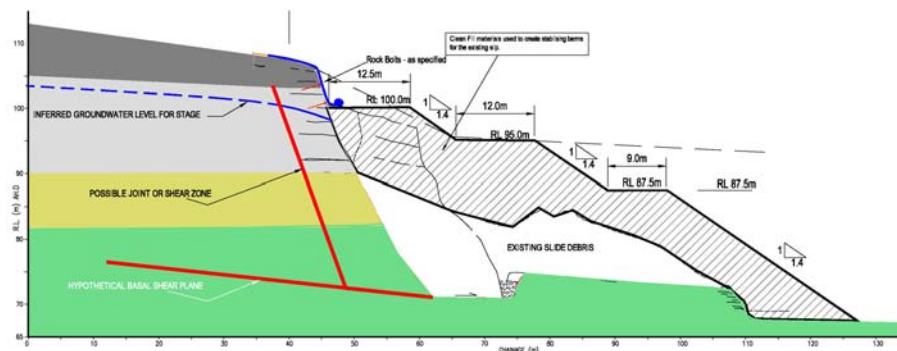
Figure 14: Stage 1- Construct access ramp and shape buttress.

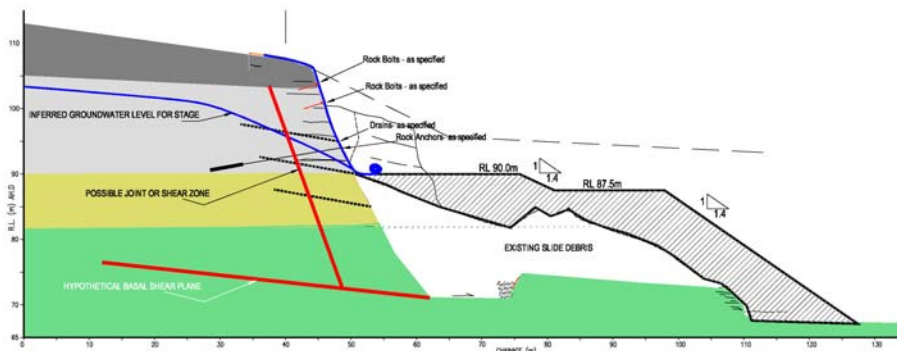
Figure 15: Stage 2 - Excavate landslide and install mesh, drains and 1 row of rock anchors.

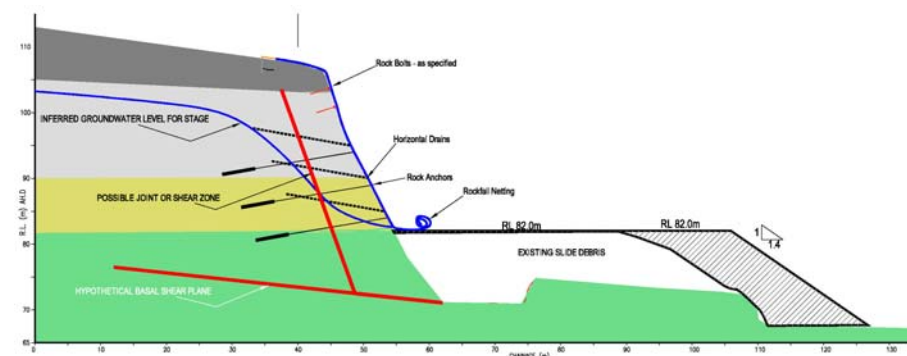
Figure 16: Stage 3 - Excavate landslide and install mesh, drains and 2 rows of rock anchors.

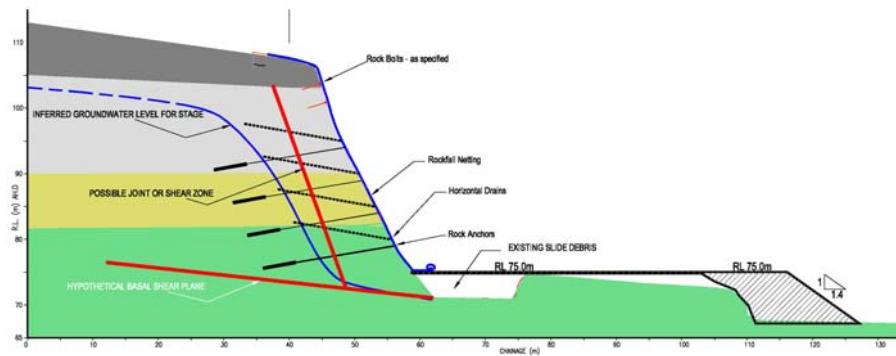
Figure 17: Stage 4 - Leave landslide debris where possible and buttress with engineered fill.

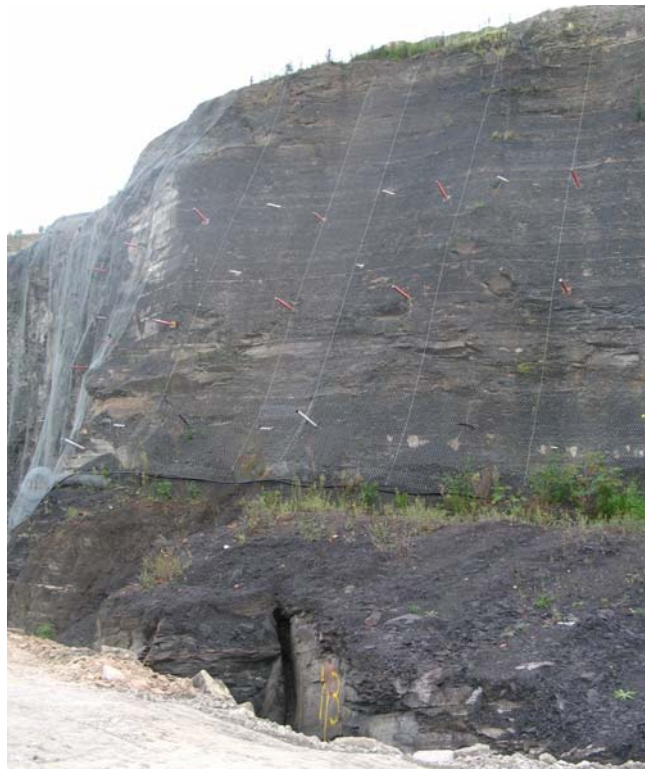
Figure 18 shows the remediated landslide area with three rows of anchors and with some landslide material left in place and buttressed by fill.

Figure 18: Remediated landslide with remaining slip material left at base.
