Sinkhole threats management in urban developments

I. Alvarez¹ and R. Rodriguez²

ABSTRACT

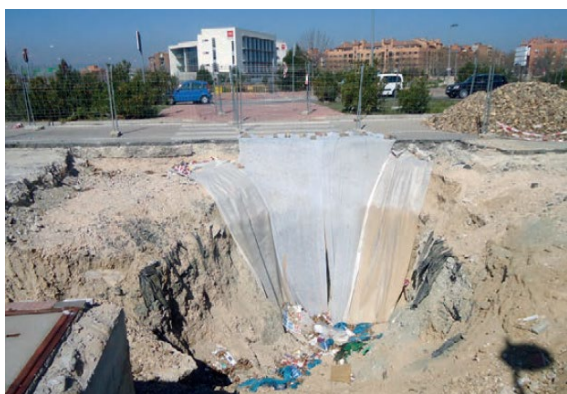
In the last quarter of the year 2019, a series of sinkholes and depressions occurred in the roadways of La Gavia Avenue at its intersection with Cerro Milano Avenue in one of the Southern's land development areas in Madrid.

The contractor awarded was required to address the issue by removing the pavement debris to fill in the sinkhole, where a large cavity was detected. As a result, traffic on the roadway was halted until a thorough understanding of the causes and feasible solutions could be determined.

Figure 1. A sinkhole discovered on La Gavia Avenue, situation in March 2018.

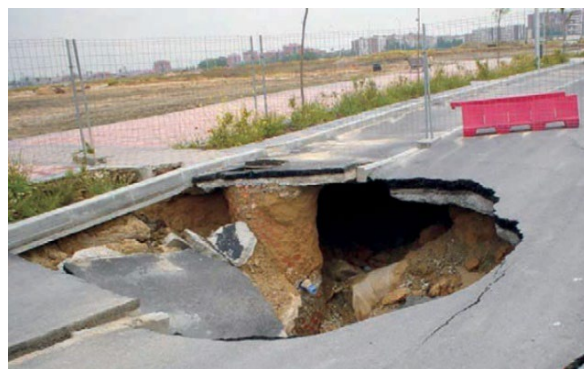
Figure 2. Sinkhole discovered on V-5 roadway, May 2006.

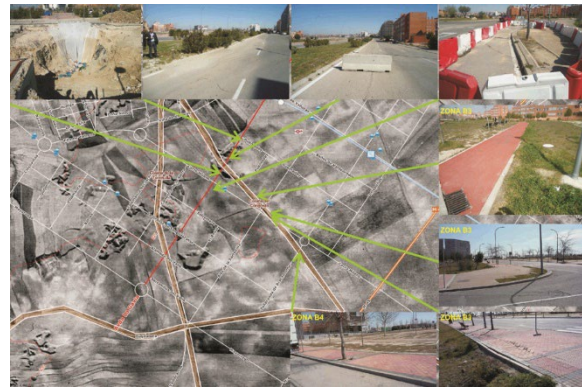
The comparative photogeological study of aerial photos from 1946 to 2020, as well as their corresponding cartographies and historical topographies, allowed the detection of old gypsum mining operations. These operations favoured previous ground collapses and incision by a tributary stream of the Arroyo de la Gavia Creek, which was located over an old cattle path and is now filled.

Figure 3. Damage Inventory, over 1956 aerial photo, showing ancient gypsum excavations, collapses, and linear incisions in the study area.

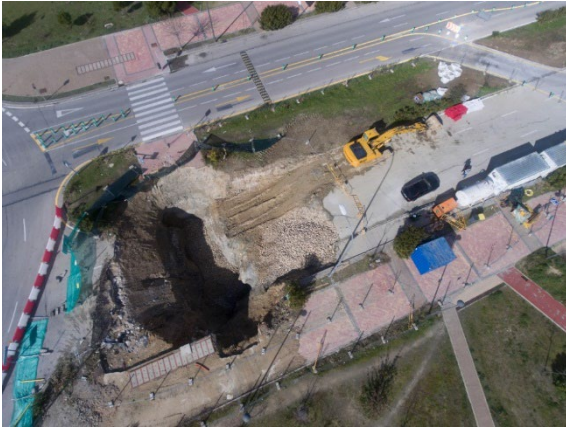
Figure 5. Start of the works. Treatment type A.

- Proposal of generic solutions for ground improvement. Based on the findings, generic solutions for ground improvement will be proposed, tailored to the geometric and geotechnical characteristics and depth of the anomalies.
 - Treatment A: For anomalies at depths between 0 and 6m (shallow): opening, partial clearing of the embankment, replacement, and reinforcement.

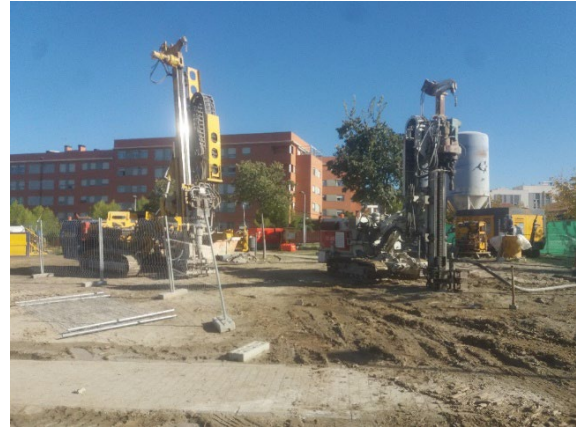
Figure 6. Test area for injections. Treatment type B.

- Treatment B: For anomalies at depths between 6 and 12m (deep, with a maximum point of -19.50m): dry mortar injections by gravity, sleeve-type injections (SRI), and slight clearing of the embankment.
- Treatment C: For small anomalies at depths between 0 and 6m (shallow): opening, slight clearing of the embankment, replacement, and reinforcement.
- Detailed analysis with the scope of the solution that will encompass a comprehensive study of the proposed solutions, ensuring they effectively address the identified issues and are feasible for implementation.

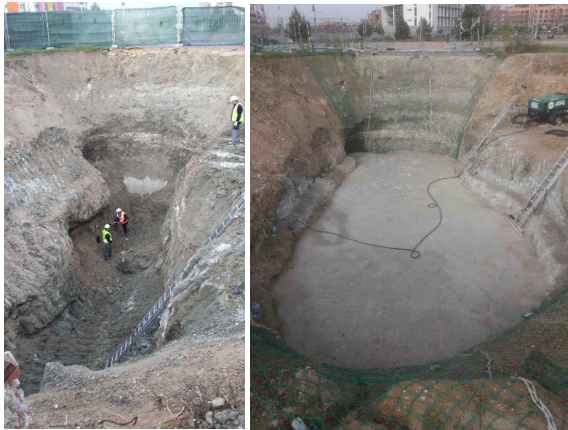
Figure 10. Treatment Type A progress.

Level 1 geotechnical supervision allowed for adjustments to match the actual ground conditions. The work involved clearing to depths of up to 8m, constructing intermediate berms and buttress of 0.5x0.5m with slopes varying from 1H:1V in soils to 1H:2V in rock. Fluid concrete mortars to fill cavities. Adapt the geometry of the reinforced slabs on-site and adjust the positions of the 100kN/m reinforcement geogrids.
