# CHALLENGES IN CONSTRUCTION MONITORING – ADAPTING TO UNFORSEEN CONDITIONS: A CASE STUDY IN RICcartON, CHRISTCHURCH, NEW ZEALAND

**Lauren Foote and Ana Pereira**

*NZGS and Engineering New Zealand*

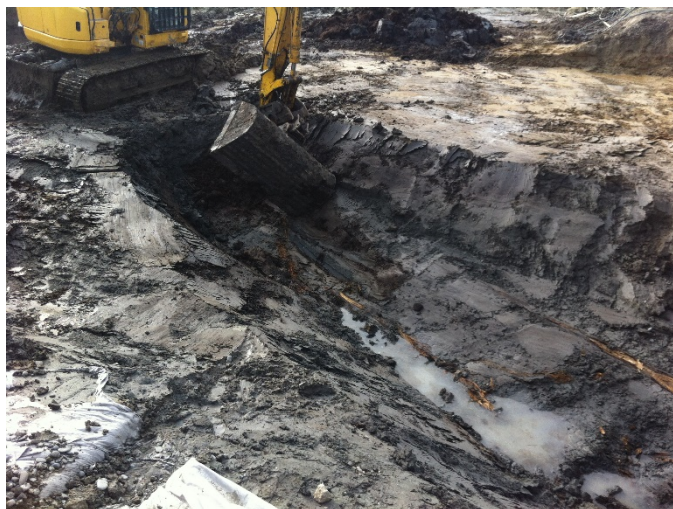
During the over-excavation process, the peat was found to be more continuous than anticipated and included intact logs (Figure 2). Excavation continued to remove the peat, until an excavation measuring approximately 3 m below ground level (2 m below the base of the proposed gravel raft), 4 m wide and approximately 10 m long had been made. Through removal of this material, the geological model for the site was further developed to include a historic stream channel trending across the site, in which the organic matter forming the peat was deposited (Figure 3).

**Figure 2: Excavation of peat, including intact logs.**

It was deemed appropriate to backfill the over-excavation with ballast to achieve the required level for construction of the gravel raft. Ballast was selected for this backfill over the sandy gravel (AP65) proposed for the gravel raft, as the interlocking form of the angular ballast gravel requires minimal compaction and would allow the project to proceed with the least time delays, while still providing the required geotechnical Ultimate Bearing Capacity of 200 kPa.

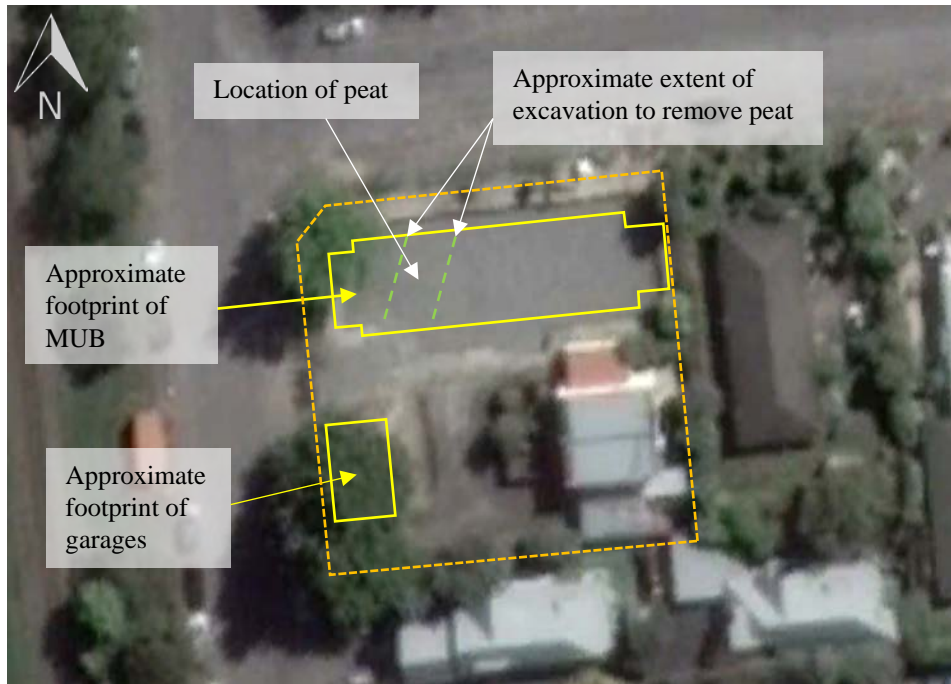
**Figure 3: Location of encountered peat material (October 2017 aerial imagery sourced from Google Earth, not to scale).**

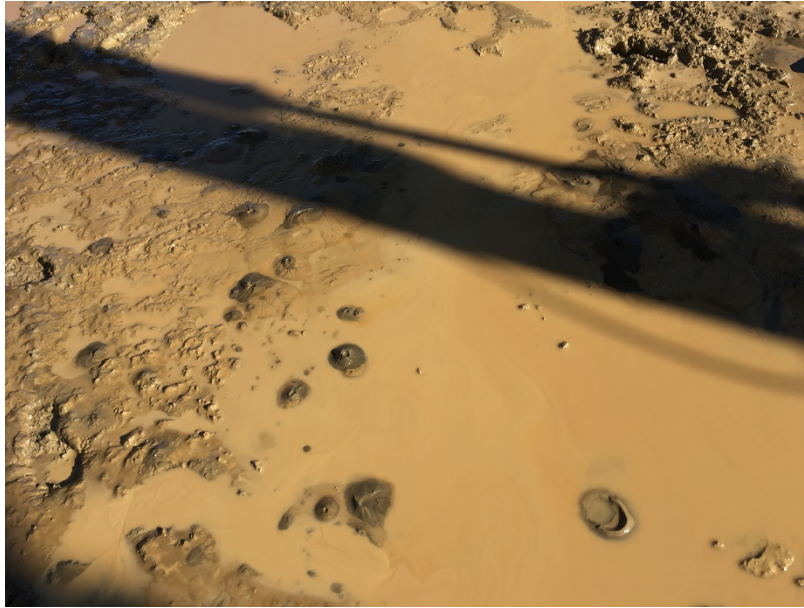
The water level presented another unexpected challenge. With groundwater at a depth of 0.5 m below the base of the subgrade surface, the motion from the heavy machinery tracking across the site caused challenges to the working platform that the subgrade surface provided. The subgrade experienced a temporary loss of strength that resulted in liquefaction of the subgrade and sand boil formation across approximately one quarter of the excavation (Figure 4).

**Figure 4: Sand boil formation at base of foundation excavation (August 2017).**

Within this area that liquefied, the bearing capacity of the soil was measured to be less than the target geotechnical Ultimate Bearing Capacity of 200 kPa and remediation was required to create a suitable surface for placement of the gravel raft. Again, discussion with the stakeholders was required around possible solutions. Three possible solutions were discussed: modification to the foundation design, additional excavation and replacement with ballast, or alternatively allowing time for the soils to dry out. Due to timing constraints, it was decided to undertake further excavation across this area and backfill to remove the loose saturated soils followed by back filling the over-excavated area with additional ballast.

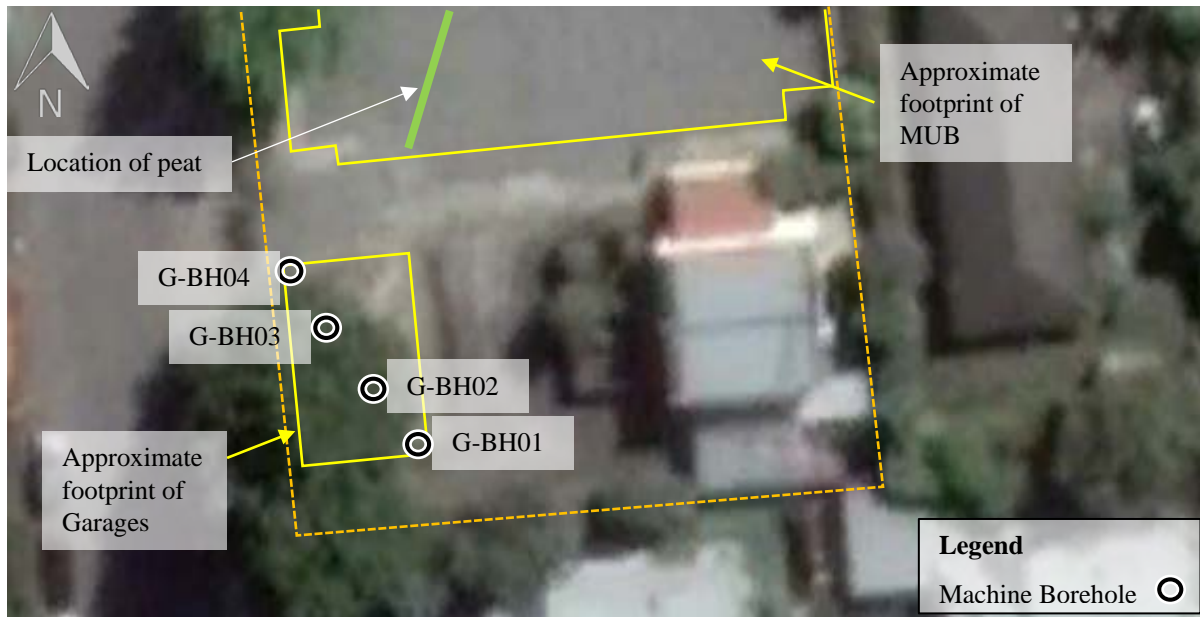
**Figure 5: Location of additional machine boreholes within the garage footprint (October 2017 aerial imagery sourced from Google Earth, not to scale).**

Peat was encountered within boreholes G-BH01 and G-BH04, on opposing corners of the garage, with no peat encountered within the central boreholes. Peat was encountered below 1.4 m depth with a maximum thickness of 0.7 m. This pattern did not support the hypothesis that the peat feature extended in a single linear feature in this direction, but suggested that there may be a more complex pattern of isolated pockets or branching peat channels within the garage location.
