Localised Failure of Cliff Top Waitemata Group Residual Soils, an Approach to Remediation

Andrew Gordon

WSP Opus, 100 Beaumont Street, Auckland, New Zealand

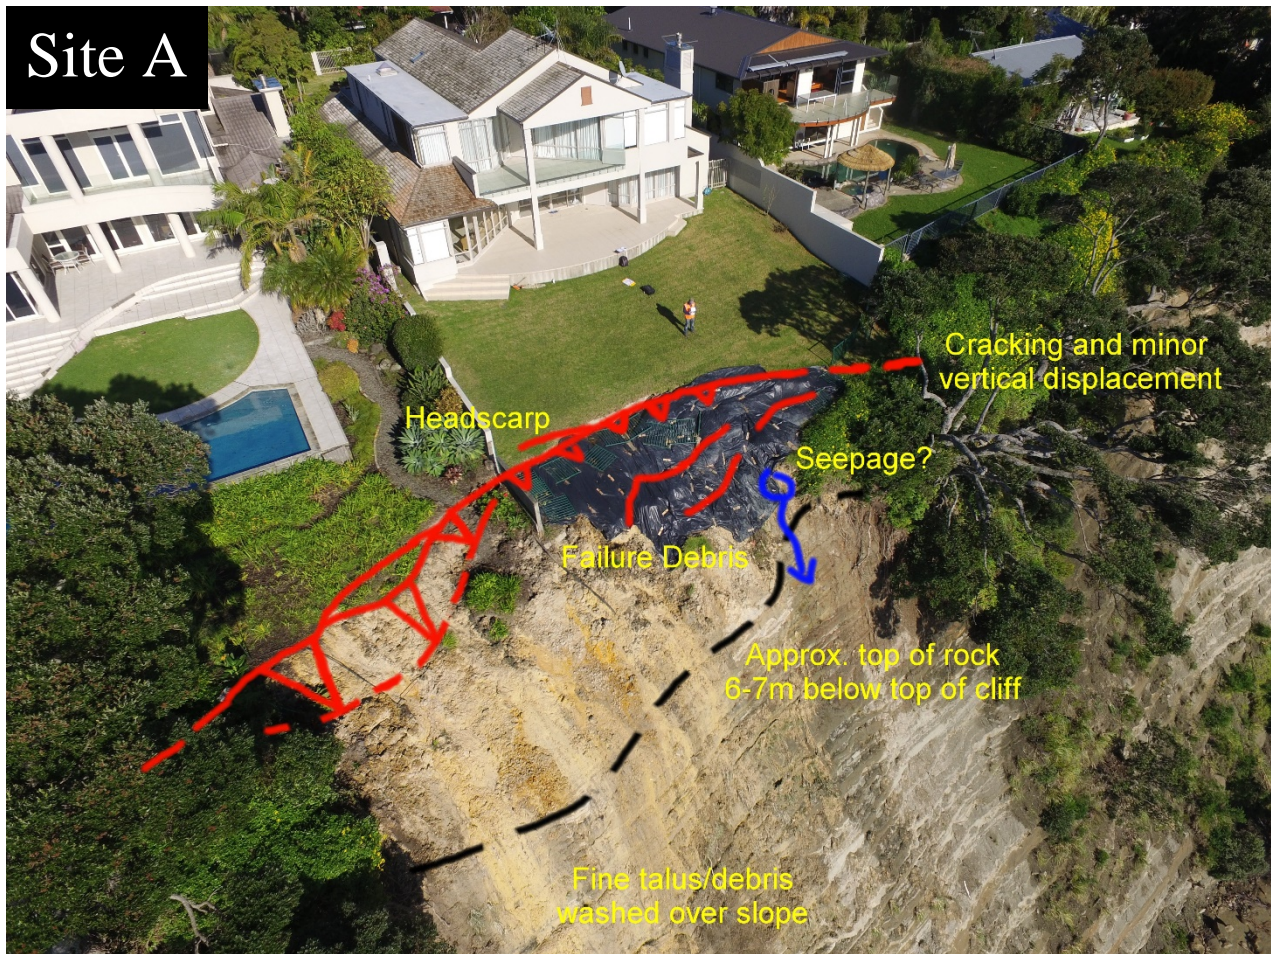
Site A

Figure 2: Examples of terrain evaluations produced from UAV photography. Site A) Typical soil failure observed along cliff tops in the Auckland Area. Site B) The variability of the East Coast Bays Formation geologic structure, the influence of the underlying geological structure of soil failures is important (Moon and Healy, 1994).

| Site ID | Failure mechanism | Preferred remedial option | Other options considered | Approximate Investigation and design cost | Approximate Construction cost | Whole of life cost |
|---|---|---|---|---|---|---|
| A | Residual soil circular failure across 2 properties, driven by high pore-water pressures during wet weather | 146 soil nails in six rows, from 2 to 9m long. Ten 9m long bored drains. | Do nothing. Extend existing in ground palisade wall across the property boundary. | \$20,000 | \$100,000 | \$150,000 |

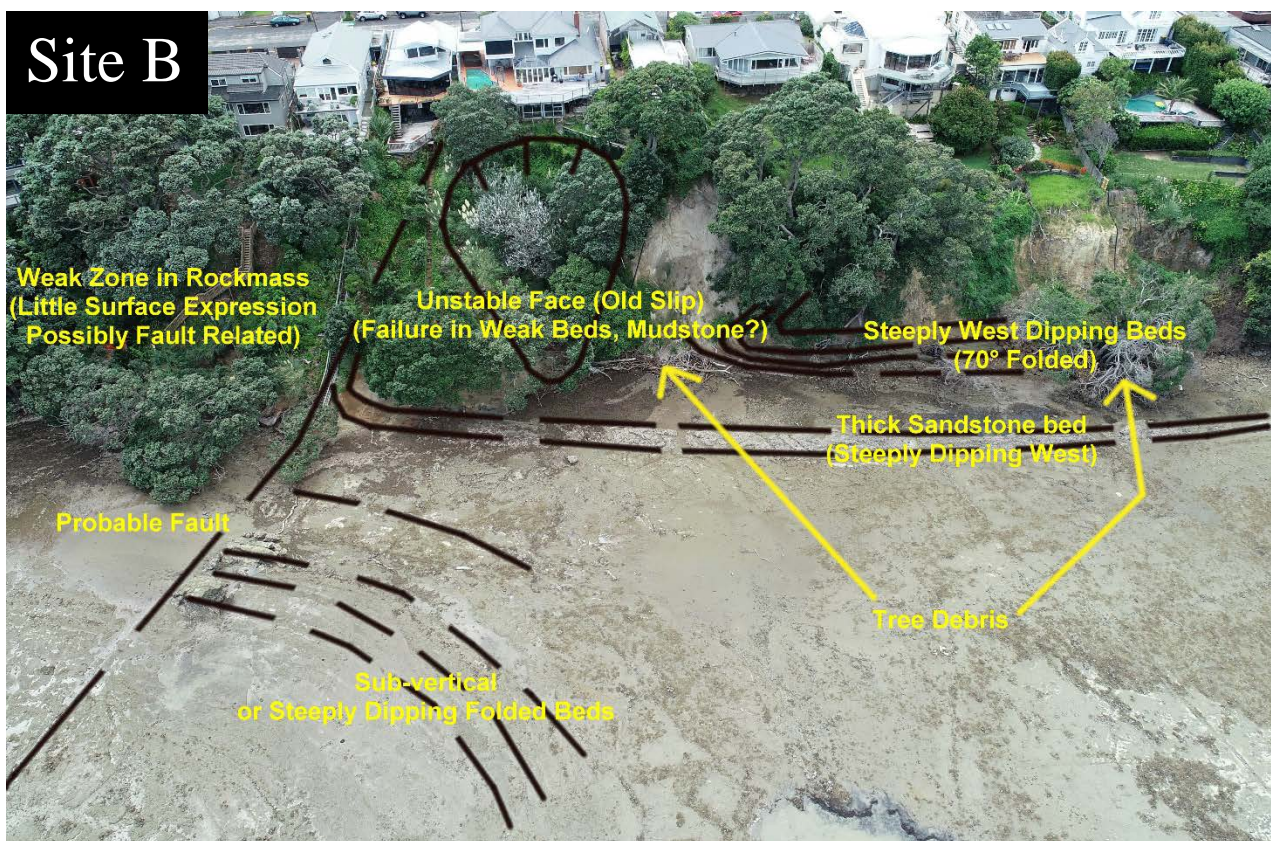
Site B

| Site ID | Failure mechanism | Preferred remedial option | Other options considered | Approximate Investigation and design cost | Approximate Construction cost | Whole of life cost |
|---|---|---|---|---|---|---|
| B | Failure of the soil mantle above a steeply dipping bedding present on the cliff face. | 54 composite rock bolts and soil nails in six rows, from 4.5 to 12.5 m long. Five 10 m long bored drains. | Do nothing: Due to severe access constraints, limited area was available behind the house and all materials and plant had to be bought through the existing house or craned in additional cost. | \$10,000 | \$50,000 | \$80,000 |

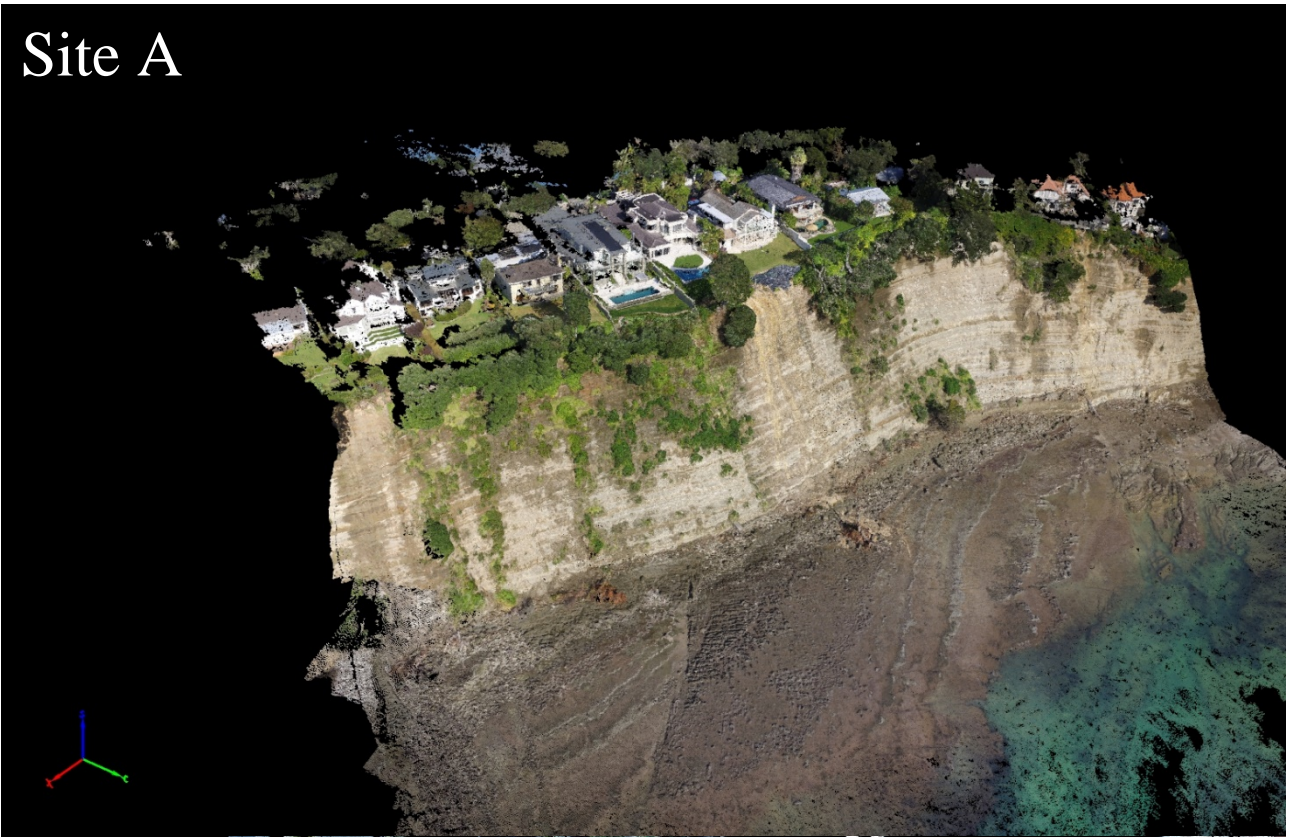
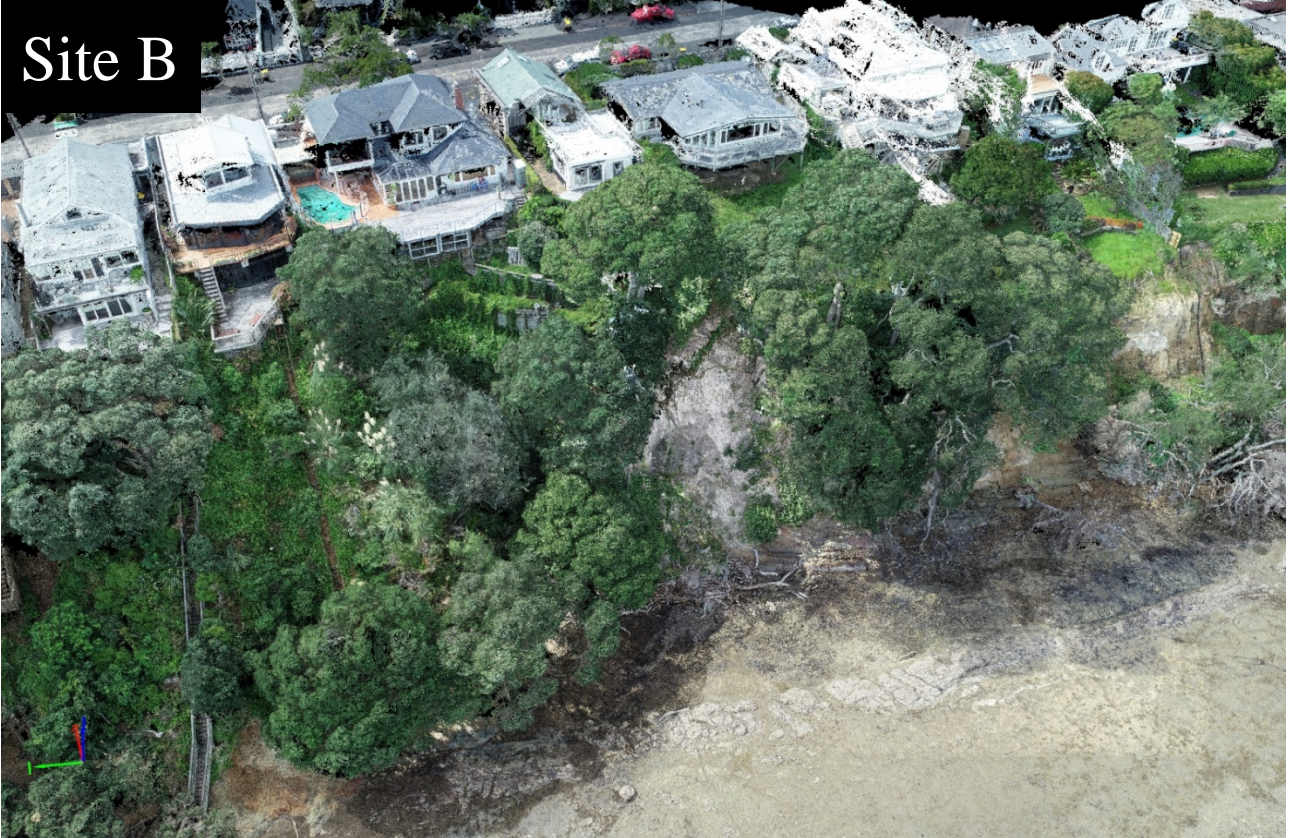
Figure 3: 3D models produced from the UAV aerial photography, from these models it is possible to gain a new perspective of the site and the underlying geological issues, in addition to allowing the creation of accurate cross-sections for stability analysis.

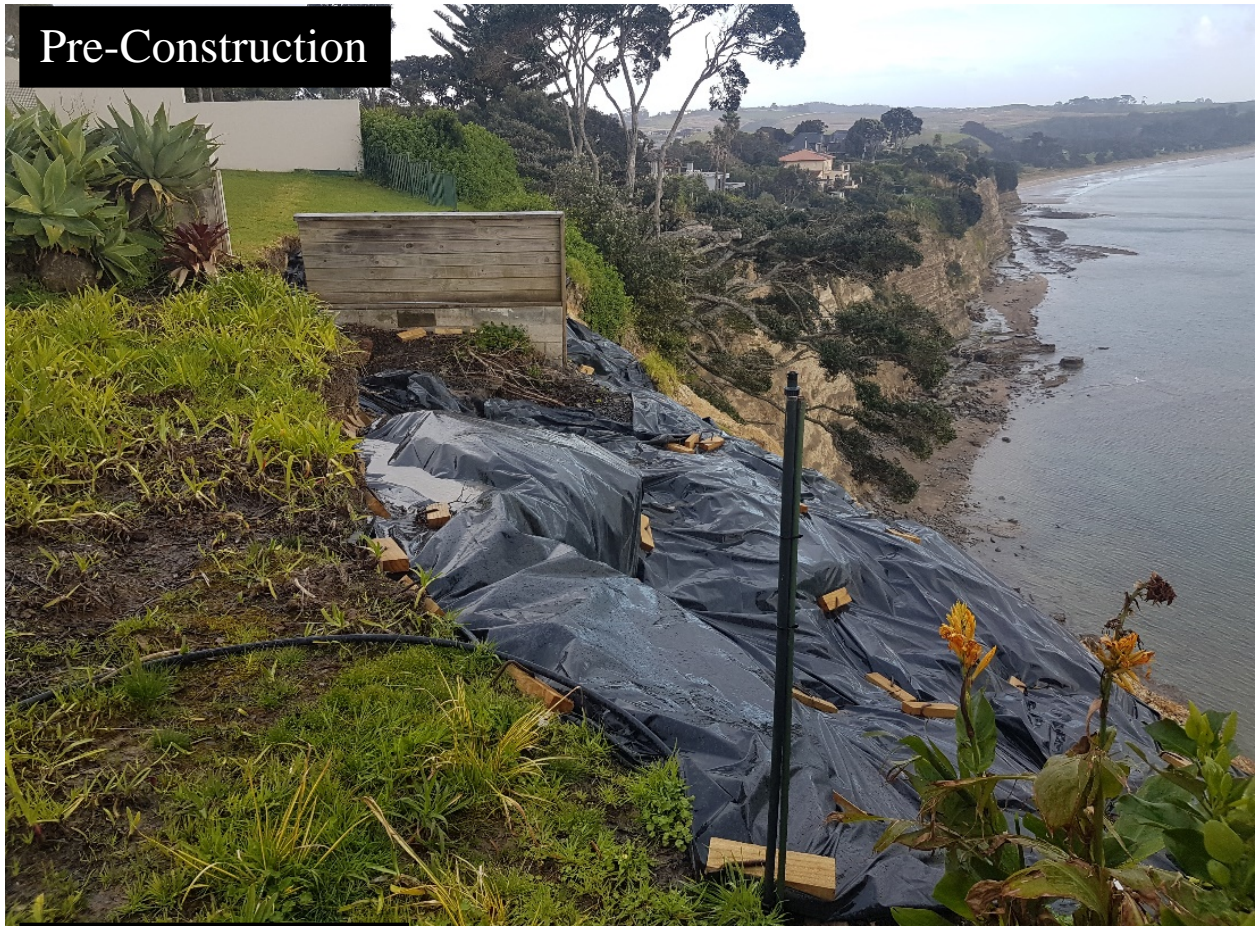
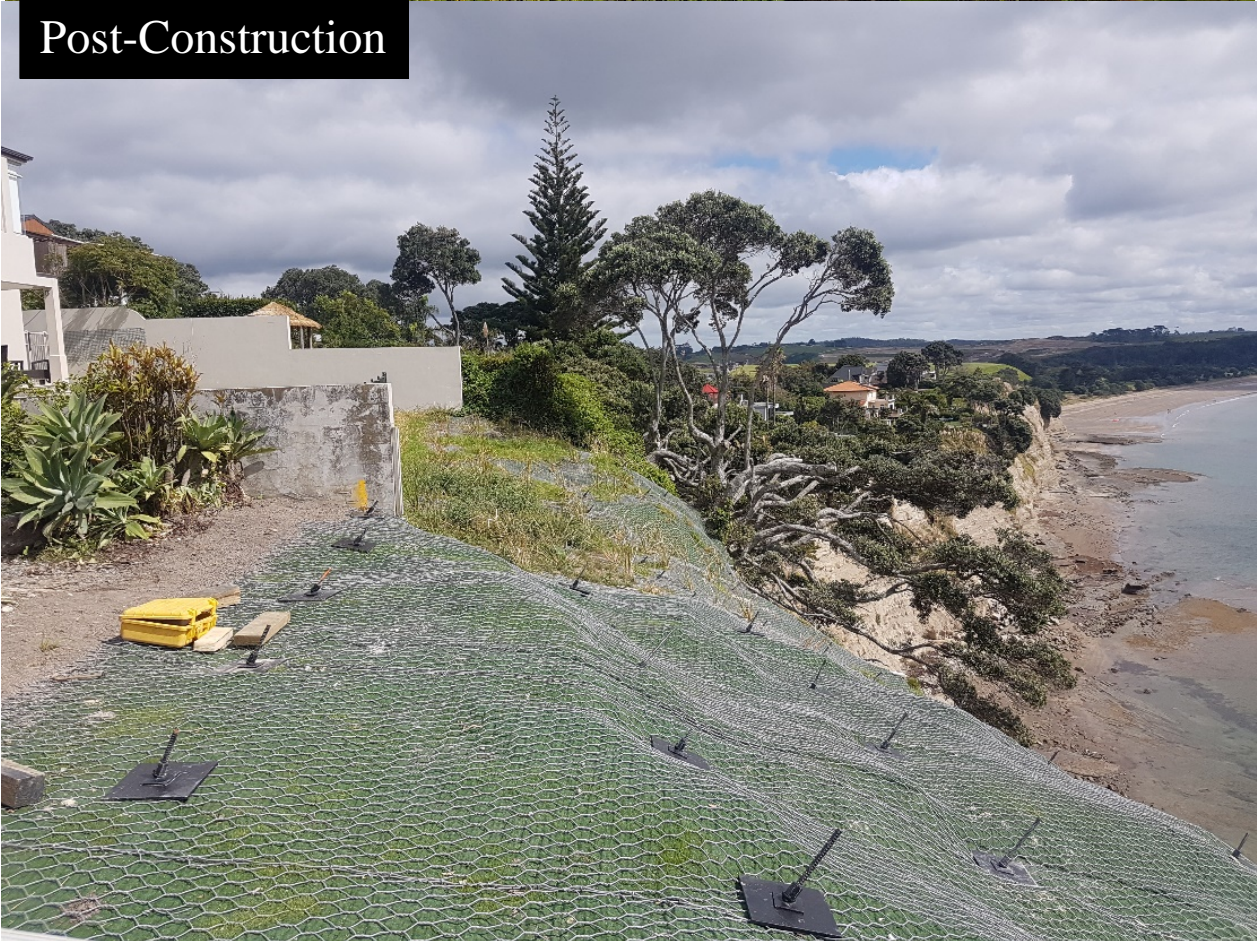
Figure 4: Pre-and post-construction photos of the Site A. Remediation was undertaken in two stages across the property boundary a few months apart, notice the rapid revegetation of the distal slope
