COMPARISON OF PREDICTED AND OBSERVED SEISMIC PERFORMANCE OF KEKERENGU AND TIROHANGA BRIDGES DURING KAIKOURA 2016 EARTHQUAKE

Jawad Arefi, Richard Young, Nik Stewart

Beca Ltd, Christchurch New Zealand

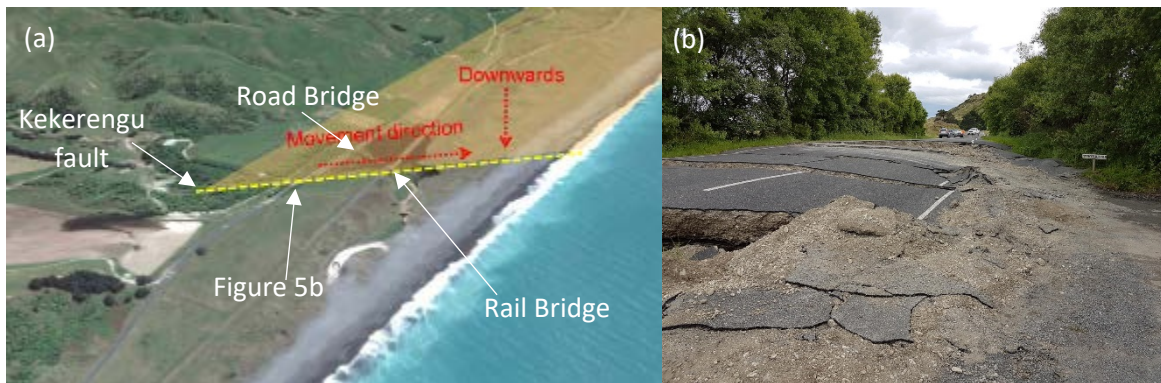
Most notably, around 180m south west of the bridge site, where the Kekerengu fault crosses SH1, severe road damage was observed. The fault rupture caused 2.5m of vertical and 5m of horizontal ground movement (Figure 6). The lowering of the ground level on the northern side of the fault allowed water to pond on the ground surface (Figure 7a, below). As such, flooding during future significant rainfall events was identified as presenting a major threat to the structure, which contributed to the proposal to construct a new bridge to replace the existing one.

Figure 6: a) Strike-slip fault causing, ~2.5m downwards and 5m horizontal eastwards b) Road damage 185m away from bridge site (Photos courtesy of NCTIR)

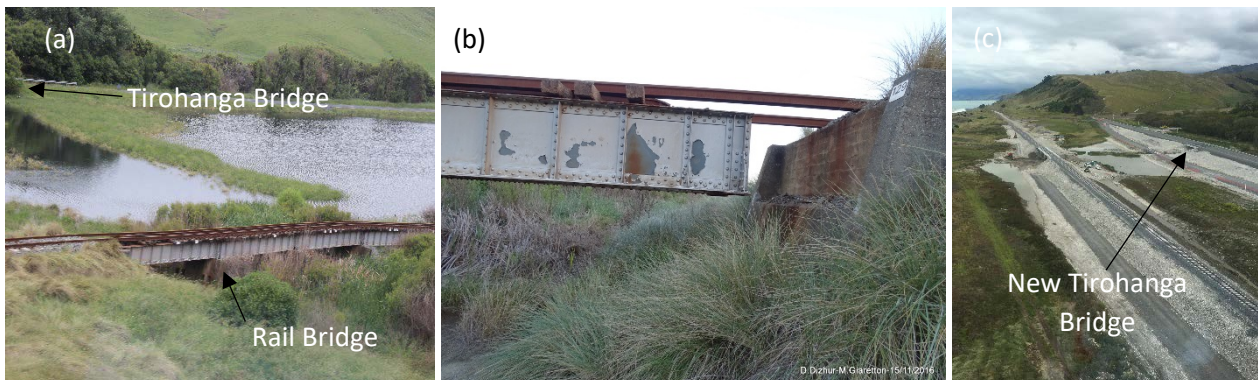
Another interesting observation on site was the performance of a KiwiRail Bridge located approximately 100m to the east of the road. Although no slumping or slope failures were observed on the elevated approach embankments, which are located on similar ground conditions to the road bridge, the rail bridge sustained severe damage to the extent that girders unseated from an abutment (Figure 7b). The damage to the rail bridge could be attributed to the proximity to Kekerengu fault trace and also high vertical accelerations.

Figure 7: a) Flooding of the bridge site after earthquake, b) Rail Bridge unseated girder, c) new Tirohanga road and Rail bridges (photos courtesy of NCTIR and GEER)

The new road bridge is shown in Figure 7c and is constructed approximately on the same alignment, but at a significantly higher elevation to reduce the potential for flooding. The higher elevation of the proposed alignment could result in consolidation of the clayey silt layer identified in the ground investigation.

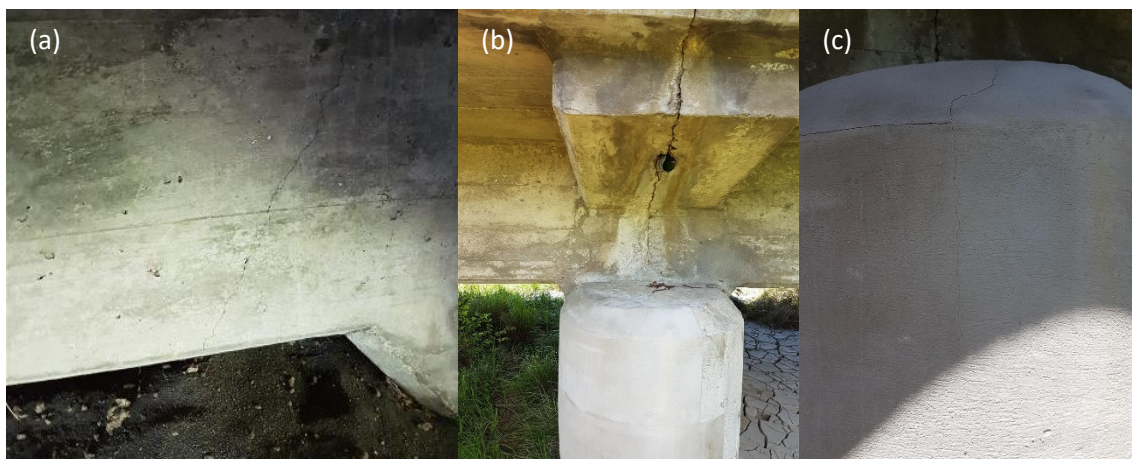
The bridge was inspected during the initial response by NCTIR (MacDonald 2018). According to the inspection report the bridge structure withstood the earthquakes well and demonstrated considerable robustness, although the bridge approaches were damaged due to minor settlement and horizontal movement. Minor subsidence in the approach embankment, surface undulations at abutments, and relatively minor approach and pavement damage in the form of longitudinal and transverse cracks was observed. The approaches were reconstructed through the placement of fill and resealing, which quickly made this road bridge usable again. Structurally, the post-earthquake inspection also concluded that there was only minor damage including some vertical and diagonal cracking to the pile cap and concrete beams at the southern abutment (Figure 8). The diagonal crack in the pile cap implies a vertical punching shear failure which had begun to manifest itself due to the earthquake shaking. No cracking was observed at the top of the northern abutment. The faces of the abutments and wing walls appeared to remain vertical. Hence, it was concluded that seismic vulnerabilities and severity of localised failures envisaged for the abutments and piers had not manifested themselves as suggested by the pre-earthquake assessment.

Figure 8: a) Minor cracking of capping beam at southern abutment, b) opening of pre-existing horizontal cracks of construction joints at the beam soffits at southern pier c) cracked concrete repairs at the top of pier (photos courtesy of NCTIR)
