EMERGENCY RESPONSE PROCESS FOR SLIP REMEDIATION ALONG THE STATE HIGHWAY 4, NEW ZEALAND

K.M. Johnson¹, N. Taghipouran²

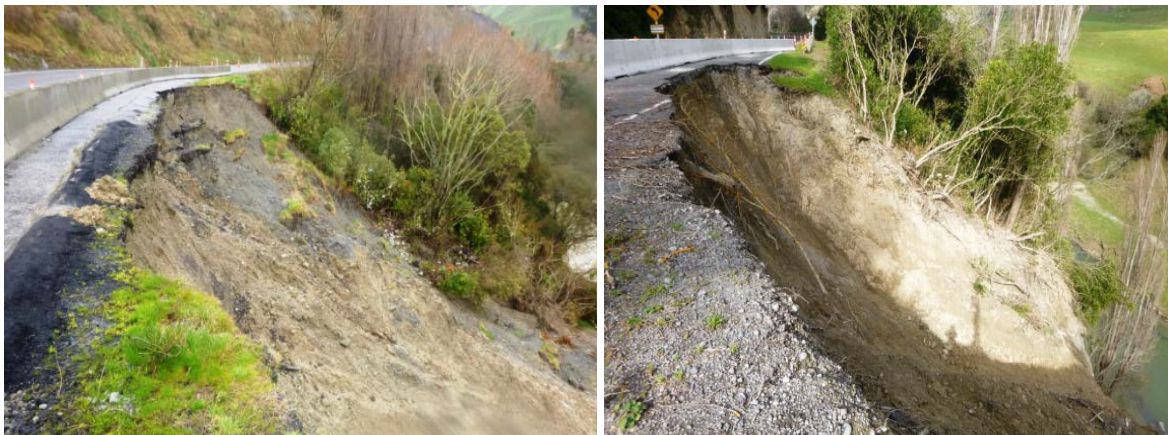
Figure 5: Observed damage at slip sites #14 (left) and #22 (right)

Site ID	Likely Failure Mechanism
Site 11	Rotational slide at the interface of the fill behind the existing crib wall and the <i>in-situ</i> landslide deposits.
Site 14	Shallow translational slide within the landslide deposits due to surface water run-off.
Site 16	Shallow translational slide of the fill over the mudstone due to erosion at the toe of the bank.
Site 17	Shallow translational slide of the near surface fill due to surface water run-off resulting in a failure of an existing retaining wall.
Site 21	Shallow translational slide of the near surface fill due to surface water run-off and bank erosion.
Site 22	Rotational slide within the colluvium and overlying fill due to the overland flow pathways created on the above carriageway and adjacent farm paddocks.
Site 22a	Rotational slide of the near-surface fill materials due to surface water run-off.
Site 24/25	Elevated river levels at the base of the existing retaining wall due to heavy rainfall, leading to erosion and undermining. Surface run-off also played a significant factor reducing the strength of the fill and landslide deposits behind the existing wall.

Site ID	Remedial Options	Reason for Selection of the Preferred Option
Site 14	1. Road re-alignment	<ul style="list-style-type: none"> • Lower construction cost • Re-alignment not considered feasible due to potential instability of upslope materials

2. Tied-back timber pole retaining wall	
	3. Tied back steel H-pile retaining wall	
Site 22	1. Timber pole retaining wall with or without anchors	<ul style="list-style-type: none"> • Lower construction cost • Gravity wall does not satisfy the design requirements

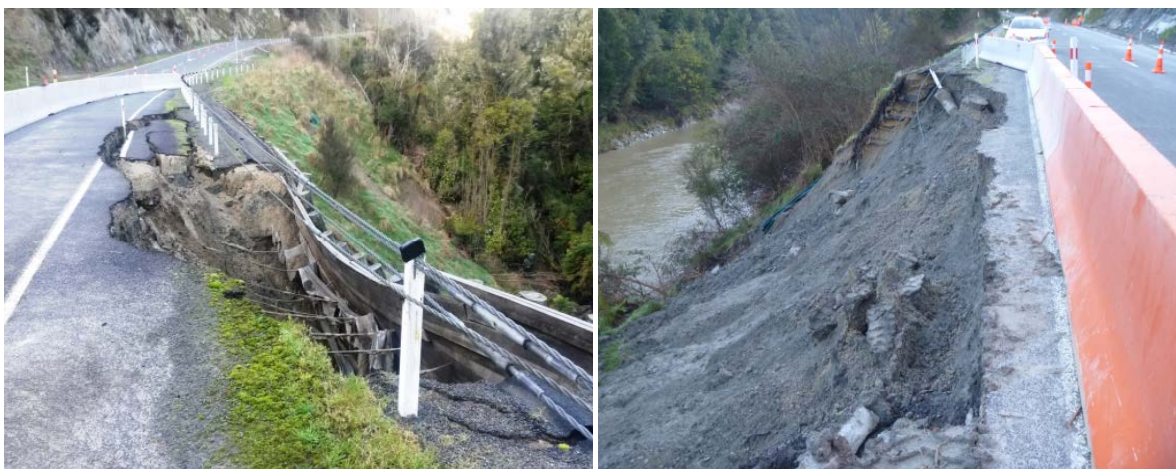
Figure 6: Observed damage at slip sites #24/25 (left) and #22a (right)

2. Steel H-pile retaining wall with or without anchors	
	3. Gravity retaining wall	
Site 22a	1. Tied-back timber pole retaining wall	<ul style="list-style-type: none"> • Lower construction cost • Gravity wall does not satisfy the design requirements

2. Gravity retaining wall	
Site 24/25	1. MSE 'Terramesh' wall	<ul style="list-style-type: none"> • Lower construction cost • High likelihood of continuing movement with the 'road alignment' option

Site 24/25	Tied back steel H-pile retaining wall (two rows of anchors)	250UC89 Section	2.0	13.0	Two row: 16 m long 32 mm dia. Bottom row: 16 m long 25 mm dia. Reid bars
Site 29	Detailed design of the preferred option has not been undertaken to date.				
Site 30	Detailed design undertaken by another consultant.

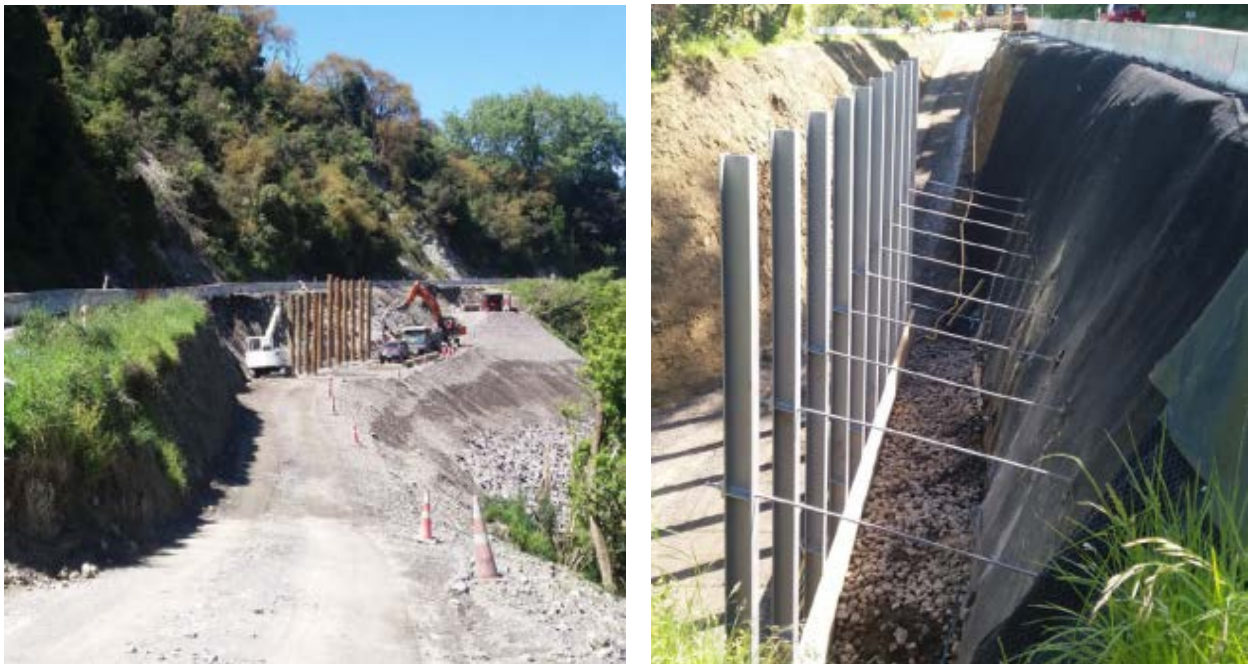
Figure 9: Photographs of Site #16 (left) and Site #22 (right) during construction

2. Tied-back timber pole retaining wall	
	3. Tied-back steel H-pile retaining wall	
Site 16	1. MSE 'Terramesh' wall	<ul style="list-style-type: none"> • Lower construction cost • Easier to construct compared to MSE Terramesh wall due to space requirements

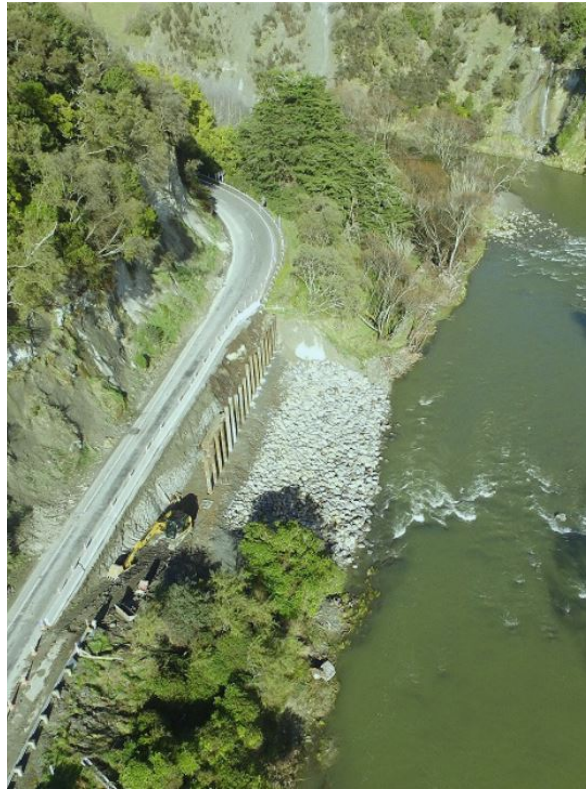
Slip ID	Slip Route Position* (RP)	Approx. width of head scarp (m)	Observed Damage
Site 21	176/4.58	30	<ul style="list-style-type: none"> • Loss of the north-bound shoulder. • Tension cracks. • Partial undermining of the north-bound lane.
Site 22	176/5.55	28 – 54	<ul style="list-style-type: none"> • Loss of the north-bound shoulder and approximately 1.5 m width of the north-bound lane.
Site 22a	176/11.35	20	<ul style="list-style-type: none"> • Loss of the north-bound shoulder. • Partial damage to existing MSE wall and barriers. • Tension cracking and partial undermining of the north-bound lane.
Site 24/25	188/5.95	30	<ul style="list-style-type: none"> • Failure of existing tied-back timber pole retaining wall. • Loss of the north-bound shoulder and approx. 0.5 m width of the north bound lane.
Site 29	206/6.39	15	<ul style="list-style-type: none"> • Damage to the existing retaining wall. • Loss of the north-bound shoulder.

Figure 10: Aerial Photograph of Site #21 during construction

2. Tied-back timber pole retaining wall	
	3. Cantilevered steel H-pile retaining wall	
Site 21	1. Do nothing – continue to monitor	<ul style="list-style-type: none"> • Lower construction cost • High risk of continuing movement with the 'do nothing' option

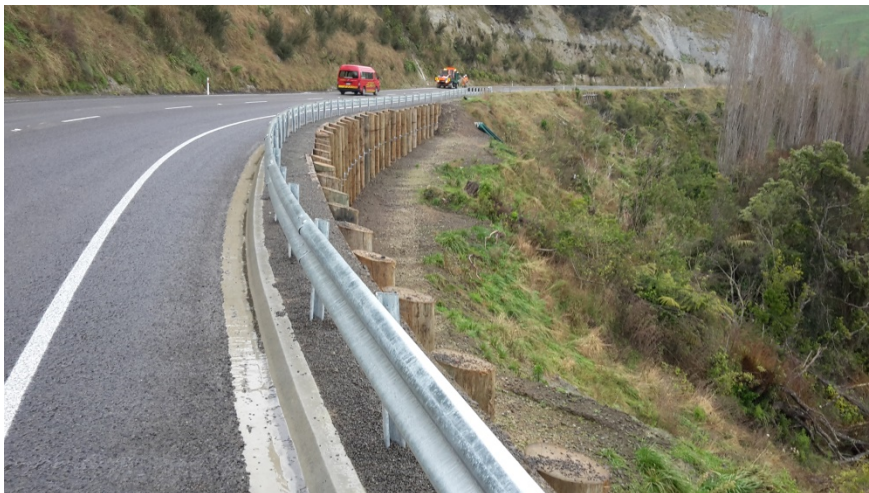
Figure 11: Photograph of completed remedial works at Site #14

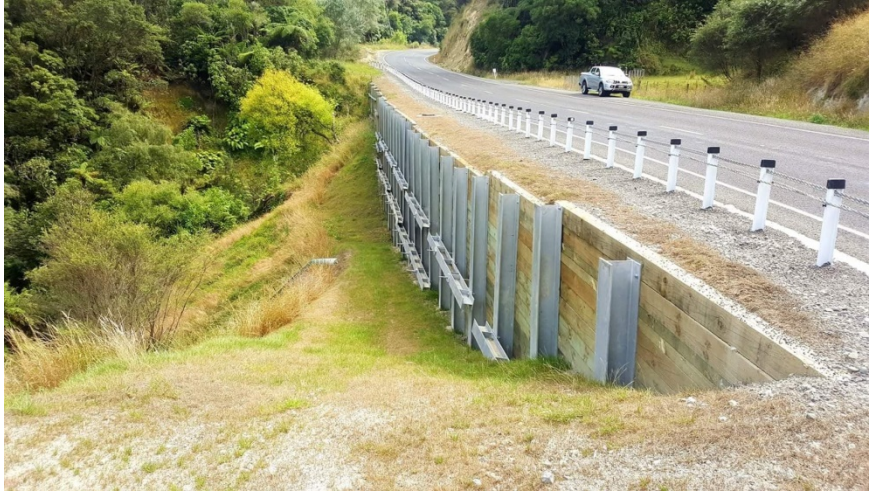
Figure 12: Photograph of completed remedial works at Site #24/25
