ROCKFALL HAZARD ASSESSMENTS AND REMEDIATION FOR THE MAJOR CLIFF PRECINCTS OF BRISBANE

Tharindu Abeykoon, Matthew Cochrane, Andy Law & Bruce Cheesman
SMEC, Level 6, 480 St Pauls Terrace, Fortitude Valley, QLD 4006, Australia

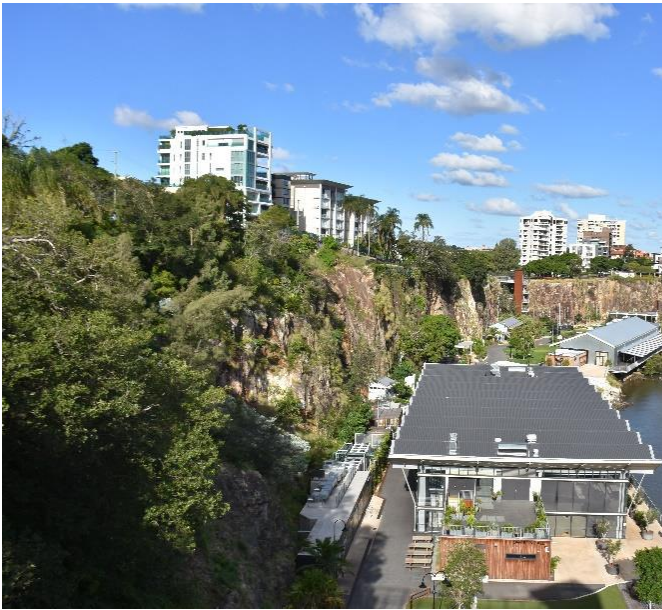
The geometry of the quarried cliff faces, which slope at between 65 and steeper than 90 degrees, are up to 32 m in height and 550 m in length. The geometry of the site, together with localised adverse rock mass properties and other factors such as damage to the rock from blasting during their construction, has led to a number of rockfalls occurring in the past. Some historic scaling and installation of rock bolting, buttressing, shotcreting and secured meshing had been completed. Although these remediation measures helped to reduce the likelihood and size of potential hazards, they did not remove

all hazards. Based on the site inspections, it was considered that rockfalls would continue as the geological conditions are such that the slopes would deteriorate due to both natural and human-induced processes. Hence to reduce rockfall risks, further remediation would be required.

Figure 1: Overview of HSW cliffs

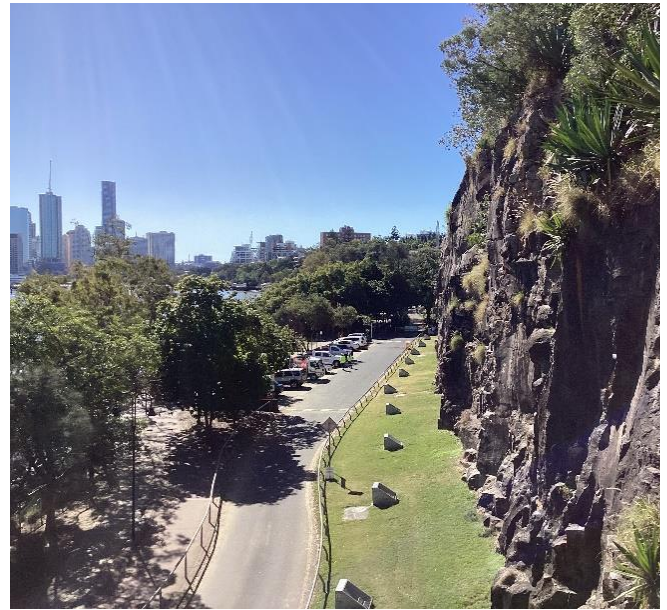
KP cliffs are heritage-listed and were quarried for almost 150 years (quarrying works ceased at the site in 1974) to form the current near-vertical profile between 15 m to 26 m in height. The cliffs are approximately 825 m in length, and the study area extended from the Riverlife Centre south to Cox's Bluff and included the smaller cliffs known as the 'Nursery Slopes'. The Nursery Slopes are approximately 70 m in length and 6 m to 8 m in height. The popular climbing area between the cliff's café (Joey's Café) and Cox's Bluff (refer to Figure 2) has had a number of remediation stages in the last 30 years. Remediation has primarily been in the form of recessed dowels and limited coloured shotcrete support.

Figure 2: General view of KP cliffs

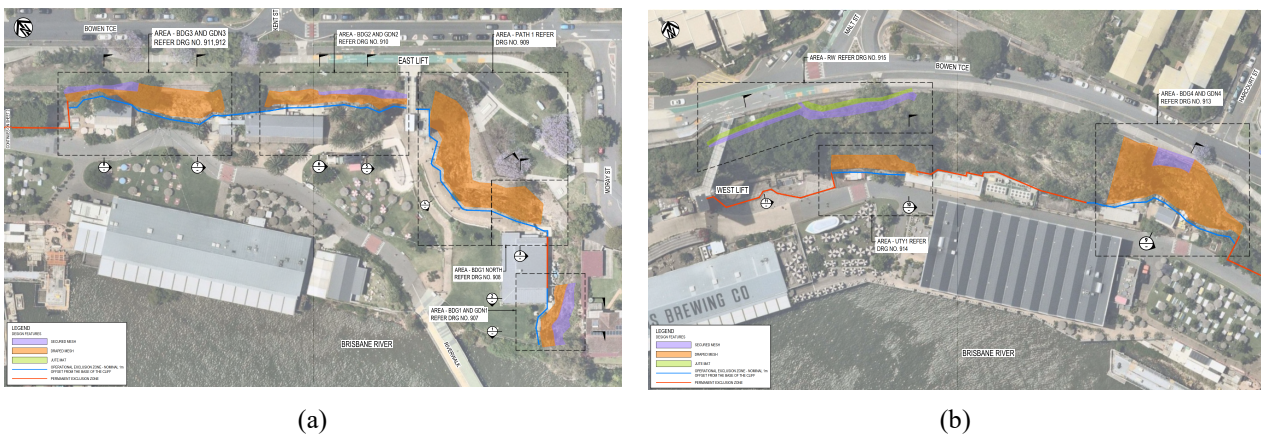
Figure 4: HSW site layout with remedial solutions across the site

A high-tensile steel wire mesh secured to the cliff face with reinforcement bars (dowels) is installed with evenly spaced dowels over the entire mesh surface at a typical spacing between 1.5 m and 2.0 m. The secured mesh system effectively 'holds' the loose material into the rock face and prevents the rocks from falling.

The draped mesh system was implemented in areas with multiple hazardous blocks, anchored at the top and extending down the slope to effectively contain falling debris and direct it safely to the toe (Geobruigg, 2014). The design followed the principles outlined in the Design Guidelines for Wire Mesh/Cable Net Slope Protection (Muhunthan et al., 2005).

Figures 4a and 4b illustrate the layout of remedial measures across the site, and Figure 5 presents a representative elevation and cross-sectional view of a typical treatment zone.

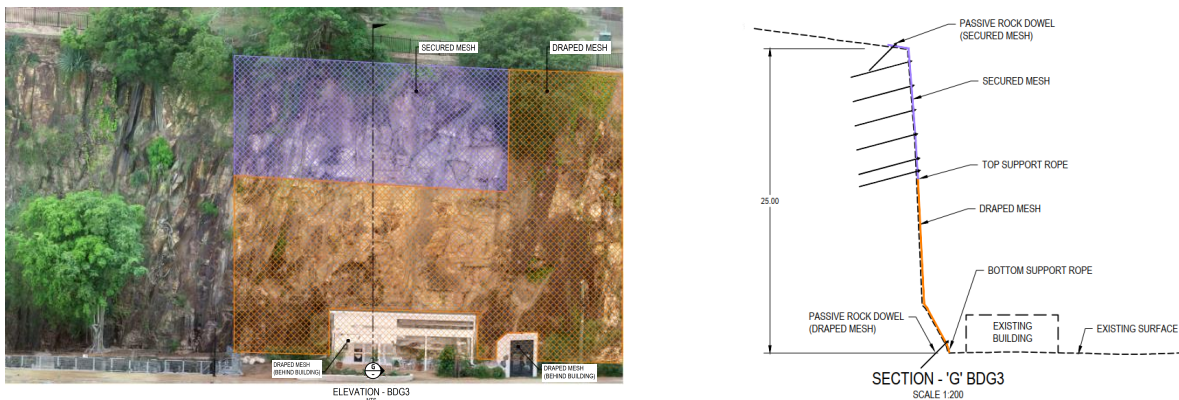
Figure 5: Representative elevation and cross-sectional view of a typical treatment zone

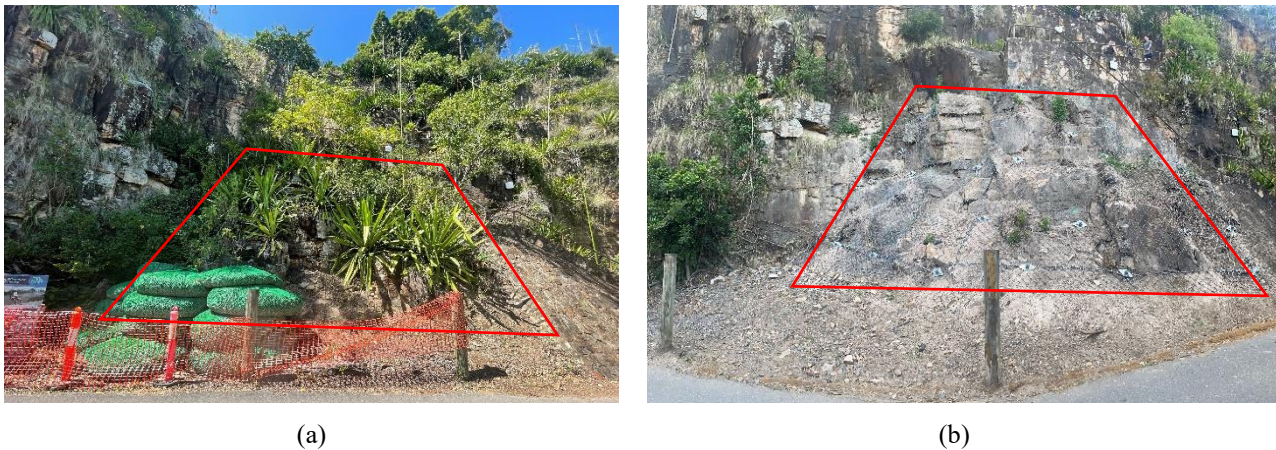
This system was implemented in areas of highly fractured rock, particularly beneath pedestrian stairwells where foot traffic and exposure levels warranted a higher level of protection.

Figure 6: High-capacity wire rope mesh remediation (a) prior to remediation, (b) post remediation

Figures 6a and 6b illustrate the treatment area before and after installation of the high-capacity wire rope mesh below the cliff stairs.

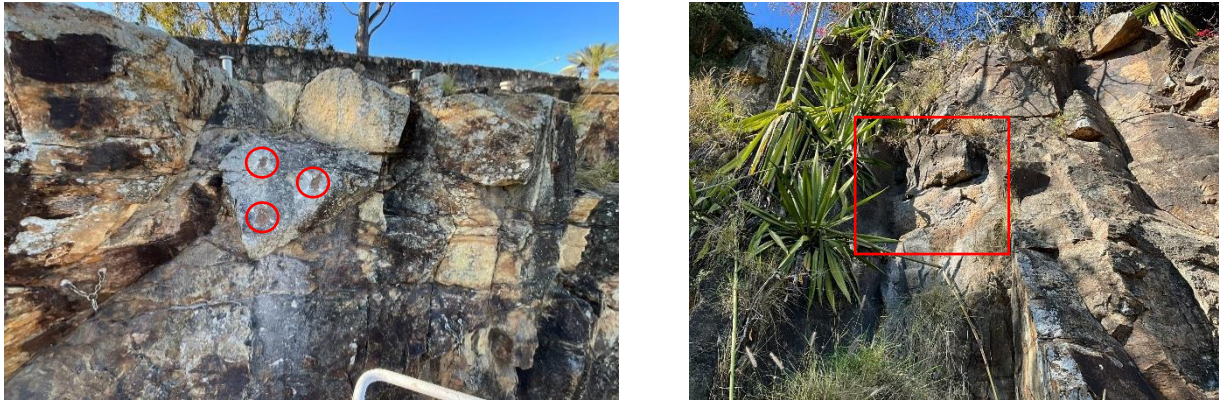
Figure 7: Remediated hazard areas at KP (a) recessed dowels (b) sculpted shotcrete

Shotcrete was selectively applied in locations where the rock mass was highly fractured and other support measures were not feasible. The shotcrete surface was sculpted and coloured to blend with the natural rock, minimising visual impact while providing mechanical interlock with the embedded dowels. This treatment also served to consolidate surface layers and reduce progressive weathering.

To minimise the impact of remediation on climbing activities, GRP and stainless-steel bars were selected to support identified hazards. These bars met the corrosion protection requirements for permanent dowels while allowing installation with relatively smaller diameter holes. Additionally, to reduce the visual impact on the exposed rock face, the dowels were recessed into the rock and filled with mortar, colour-matched to blend with the surrounding area.

Figure 7 illustrates the final treatment of hazard locations using recessed dowels and shotcrete.
