# ENGINEERING GEOLOGICAL MODELS IN REMOTE AND DIFFICULT ACCESS TERRAIN: A CASE STUDY FROM BOGONG HIGH PLAINS ROAD

**Davide Casagrande<sup>1</sup>, Dane Pope<sup>2</sup>, Katerina Irwin<sup>3</sup>**

## ABSTRACT

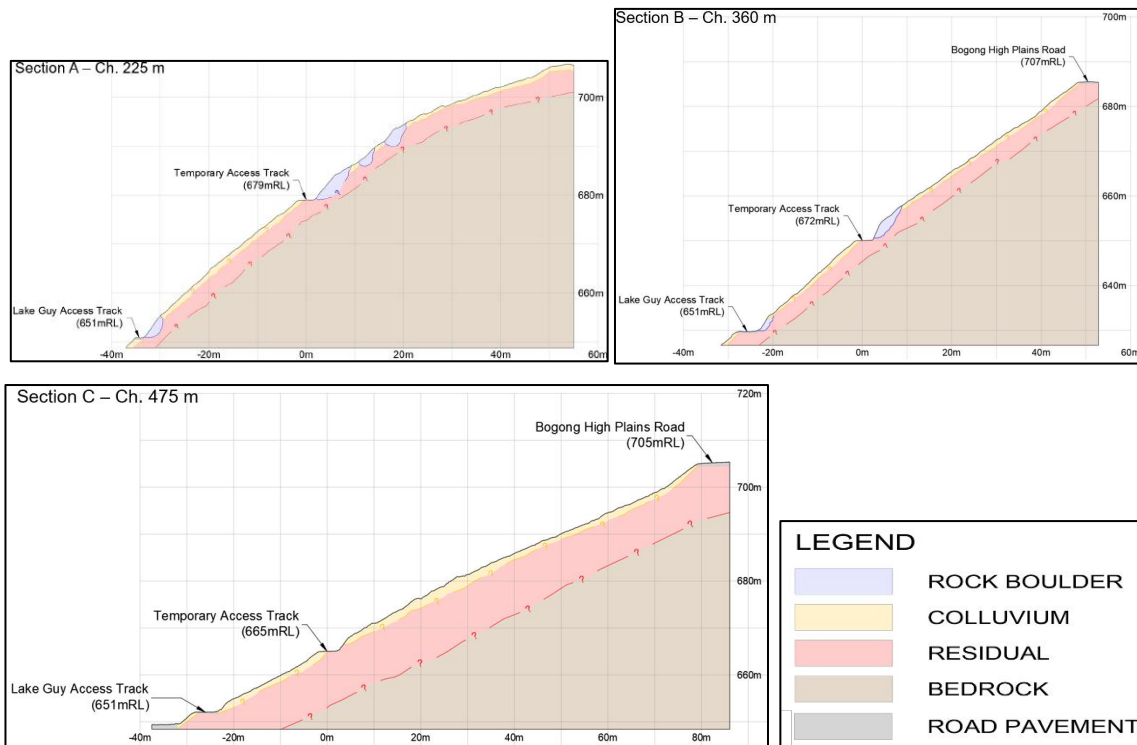
The geological units identified during the fieldwork are summarised in Table 2. The depth below surface of the geotechnical units is difficult to differentiate, and three representative cross-sections are presented in Figure 4.

Figure 4: Representative cross-sections

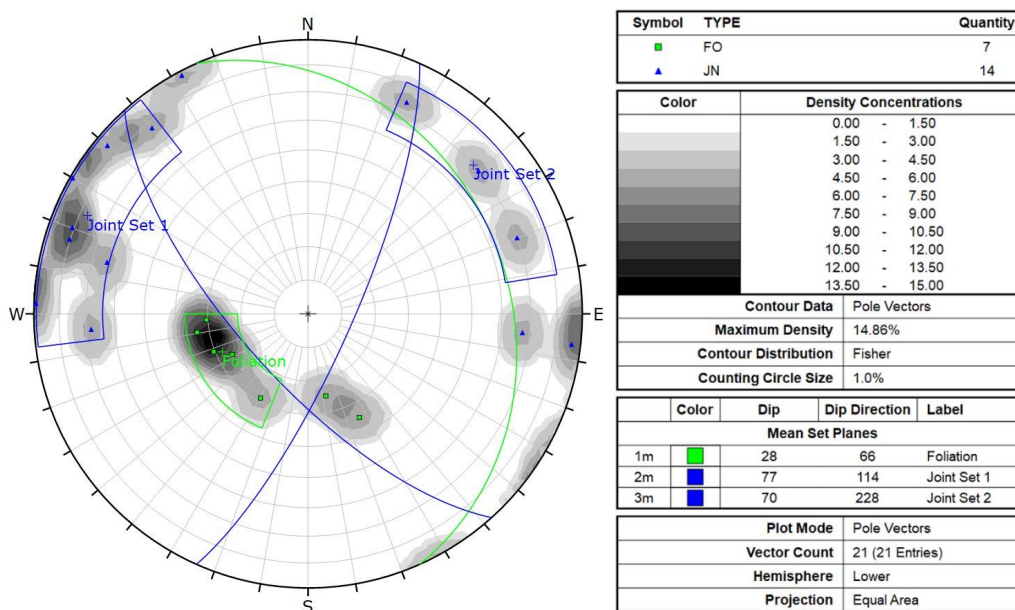
Bedrock exposures of BEDROCK1 and BEDROCK2 units along Bogong High Plains Road present as a moderately to extremely weathered foliated and massive rock mass respectively. Geotechnical face mapping from available exposures is presented on a stereonet in Figure 5.

Figure 5: Stereographic projection of BEDROCK1 and BEDROCK2 defects.

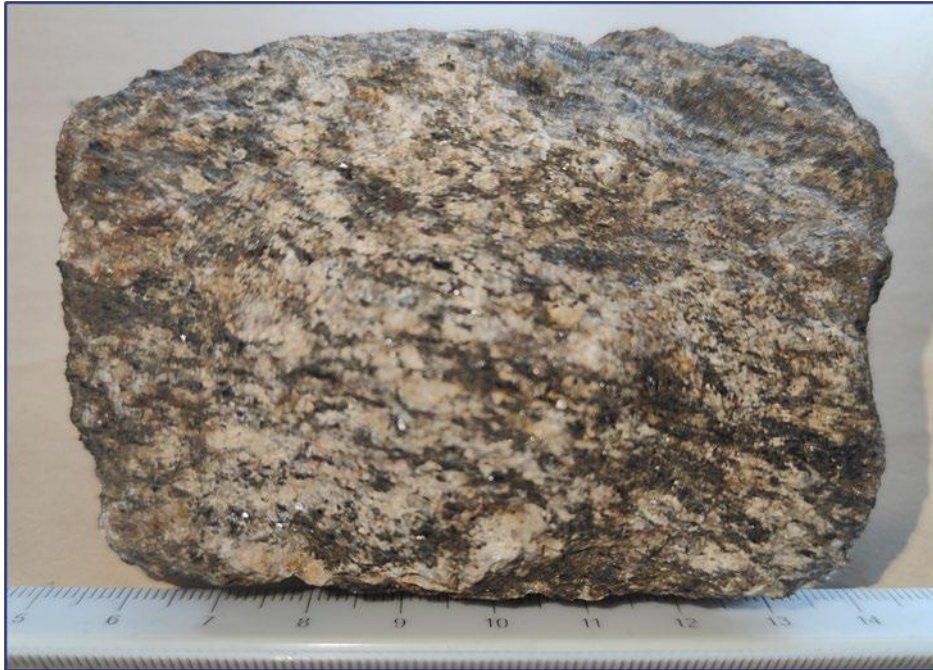
**Figure 6: Sample taken from road cut in BEDROCK1 on Bogong High Plains Road, showing an example of mineral lineation and crenulation folds following the black minerals**

The observed foliation had a dip of  $25^{\circ}$  to  $35^{\circ}$  towards  $030^{\circ}$  to  $090^{\circ}$ . PSM notes that there is uncertainty about the validity of defect measurements due the potential for disturbance and rotation from landslide activity. Nonetheless, it was anticipated that foliation could have unfavourable orientations at the Site where BEDROCK1 was exposed in cuttings and slope aspect was towards the east/northeast (e.g. CH. 100 m to 200 m, Figure 1). Between these Chainages, cuttings were dominated by colluvium and residual soils without relict foliation observed.

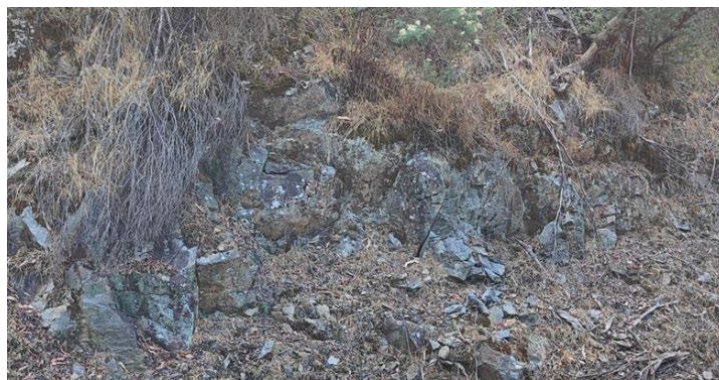
The joints are mostly relict joints in BEDROCK2 or overturned joints in BEDROCK1, Figure 7. The joints in BEDROCK1 may have formed from lineation or foliation overturned by folds documented in the area. Two joint sets were mapped within the temporary access track:

Note that stress relief joints were not observed however, evidence of planar slide was documented in areas of BEDROCK2. Basal landslide angles ranged from  $25^{\circ}$  to  $40^{\circ}$ .

**Figure 7: View of a jointed BEDROCK1 on Bogong High Plains Road Ch. 13.88 km.**

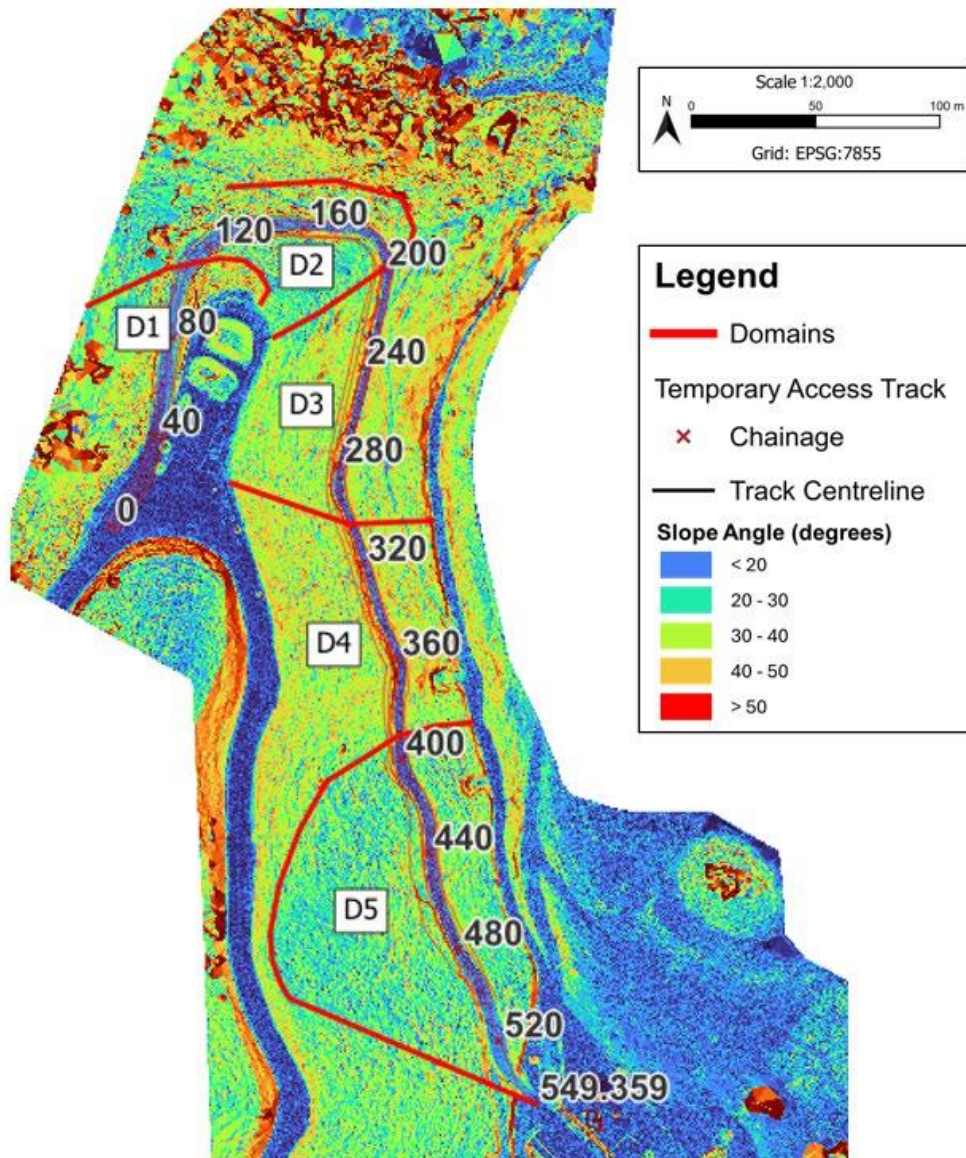
Figure 10: Slope map with two inferred planar slides marked by black ovals

Domain	Chainage	Rock mass and soil characterisation	Slope observation	Slope performance
D1	Ch. 0 m to 110 m	COL1 and RES	Downslope 40° Upslope 25° - 35°	No sign of instability observed
D2	Ch. 110 m to 200 m	COL1 and RES Scattered boulders	Downslope 40° Upslope 25° - 35°	Minor slip in COL1 recorded. The upslope angle controls stability of the area
D3	Ch. 200 m to 305 m	COL1, RES and BEDROCK1	Downslope 45° Upslope 40° - 45°	Minor slips observed in COL1, and RES caused by recent construction.
D4	Ch. 305 m to 390 m	COL1, COL2, RES and BEDROCK2	Downslope 40° Upslope ~ 45° From Ch. 385 m ~ 35°	One inferred planar slide observed in COL2, RES and BEDROCK2, and one minor slip in COL1, COL2 and RES along Lake Guy Access track
D5	Ch. 390 m to 550 m	COL2 and RES Scattered boulders of BEDROCK2	Downslope 25° - 35° Upslope 30°	One inferred planar failure in COL2 and BEDROCK2 observed along Lake Guy Access track

Domain	Chainage	Hazard	Consequence	Conceptual Remediation
D1	Ch. 0 m to 110 m	<ul style="list-style-type: none"> <li>Metastable cut slopes</li> <li>Debris flows.</li> </ul>	<ul style="list-style-type: none"> <li>Temporary closure of road</li> <li>High maintenance.</li> </ul>	<ul style="list-style-type: none"> <li>Appropriate permanent batter angle.</li> </ul>
D2	Ch. 110 m to 200 m	<ul style="list-style-type: none"> <li>Metastable cut slope</li> <li>Small changes in stress could result in slumping soil.</li> <li>Debris flows and rock fall: 300 to 600 mm boulders in sand matrix.</li> </ul>	<ul style="list-style-type: none"> <li>As per D1 and,</li> <li>Over excavation</li> <li>Need for strengthening.</li> <li>Impact vehicles at low speed.</li> </ul>	<ul style="list-style-type: none"> <li>Soil nailing</li> <li>Appropriate permanent batter angle.</li> </ul>
D3	Ch. 200 m to 305 m	<ul style="list-style-type: none"> <li>Very high strength boulders with undefined dimension – mobilised by earthworks</li> <li>Rockfall</li> <li>Slips between boulders.</li> </ul>	<ul style="list-style-type: none"> <li>As per D2 and</li> <li>Over and under excavation.</li> </ul>	<ul style="list-style-type: none"> <li>Soil nailing</li> <li>Rock meshing.</li> <li>Loose boulders removal.</li> </ul>

D4	Ch. 305 m to 390 m	<ul style="list-style-type: none"> <li>• Very steep upslope but dense soil and less boulders, more cobbles</li> <li>• Wet area with gullies</li> <li>• Debris flows.</li> </ul>	<ul style="list-style-type: none"> <li>• As per D2.</li> </ul>	<ul style="list-style-type: none"> <li>• Combination of surface and sub-surface drainage</li> <li>• Appropriate permanent batter angle</li> <li>• Soil nailing.</li> </ul>
D5	Ch. 390 m to 550 m	<ul style="list-style-type: none"> <li>• No or scattered boulders, loose soil. But slope flatten</li> <li>• Metastable cut slopes</li> <li>• Debris flows.</li> </ul>	<ul style="list-style-type: none"> <li>• As per D2.</li> </ul>	<ul style="list-style-type: none"> <li>• Appropriate permanent batter angle.</li> </ul>
