# **SLOPE HAZARD MANAGEMENT ON THE TOOWOOMBA RANGE RAIL CORRIDOR, QUEENSLAND.**

**Bruce Cheesman, David Cooper, Andy Law & Matthew Cochrane**  
*SMEC, Level 6, 480 St Pauls Terrace, Fortitude Valley, QLD 4006, Australia*

## **ABSTRACT**

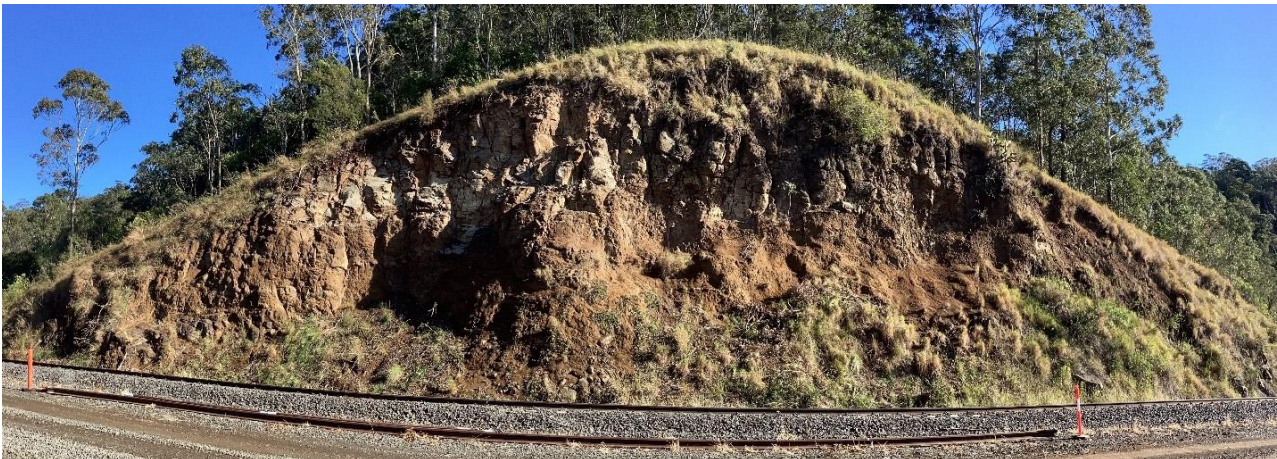
The Main Range Volcanics comprise a series of basaltic flows, most just a few metres thick, with discontinuous beds of tuff and agglomerate in some areas. These volcanics occur between Murphy's Creek Road and Harlaxton, with occasional outcrops south of Spring Bluff Station, predominantly along spur ridge lines. Typically, the terrain in this geological unit is steep, with exposed rock outcrops and boulders visible on cleared slopes. Common failure modes include rockfalls, boulder roll, debris slides, and occasional large landslides. Some basaltic flows have an altered upper horizon that has preferentially weathered. In some locations, this has led to undercutting of more competent basalt blocks, increasing their potential for instability. This appears to be a primary failure mechanism in basaltic cuttings, as shown in Figure 3.

**Figure 3: Rail cutting showing competent basaltic blocks progressively undercut**

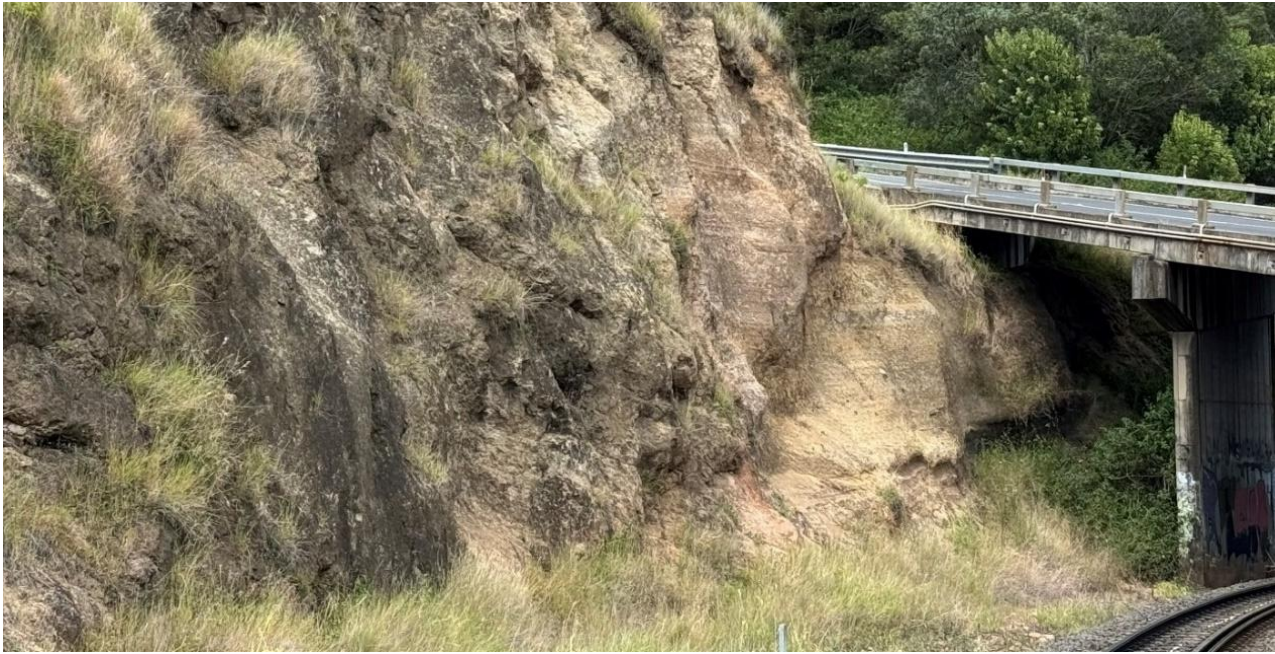
Volcanic tuff is observed near the rail intersection with Murphy's Creek Road (previously Ballard railway station) where they are seen in layers of 10-15 m in thickness (see Figure 4).

**Figure 4: Typical rail cutting in Tuff**

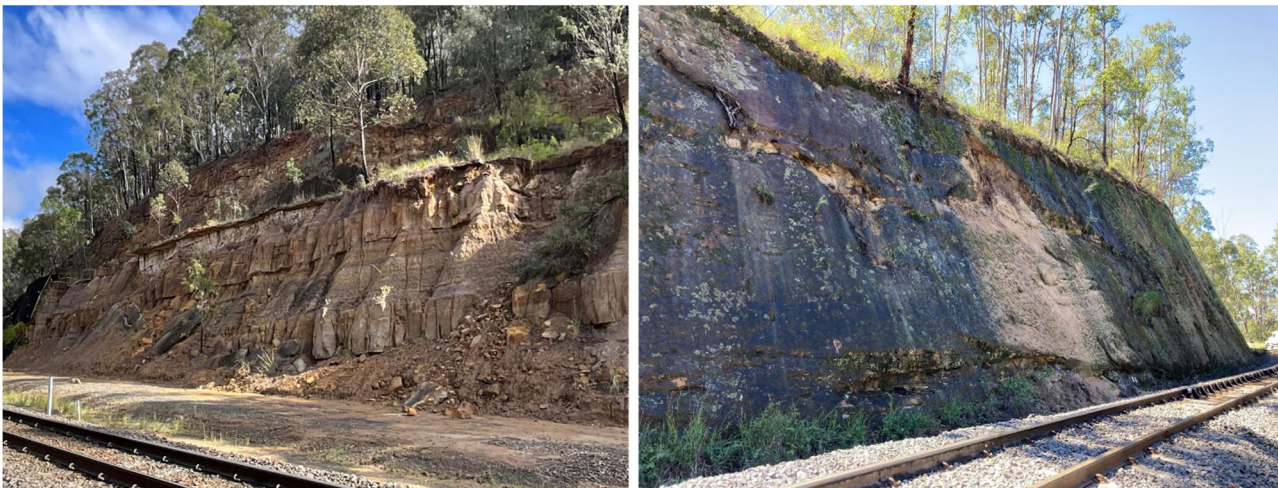
The Koukandowie Formation and Gatton Sandstone form two of the major components of the Marburg subgroup (see Figure 5). This group is typically described as “Fine to coarse-grained, thin- to very thick- bedded, crossbedded, quartzose to lithofeldspathic sandstone, interbedded with polymictic pebble and minor cobble conglomerate, siltstone and claystone; minor coal and basalt, fossil wood ferruginous oolite” (GSQ, 2018). These units are typically found east of Murphy’s Creek Road. The Gatton Sandstone typically comprises much thicker beds of sandstone. Areas of instability and/or existing failures are often observed where flat-lying relatively competent sandstone has been undercut by less resistant shales and siltstones. This appears to be a primary mechanism for failure within these cuttings.

**Figure 5: Typical rail cuttings in the Koukandowie Formation (left) and Gatton Sandstone (right)**

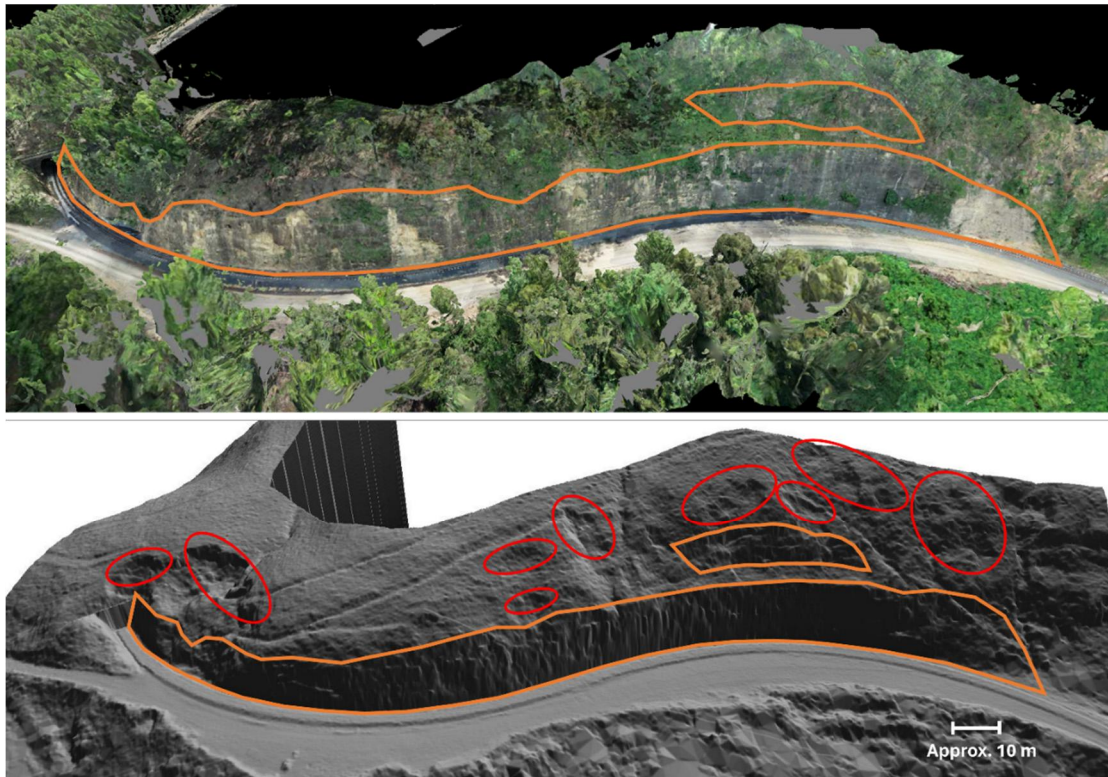
Figure 8 illustrates how the combined photogrammetry and hillshade visualisations can be used to highlight visible instabilities in the rock slope and to identify additional zones of concern that may exist within the natural terrain beyond the cut slope crest.

**Figure 8: (Top) photogrammetry with rock slope details and extents indicated (orange). (Bottom) 3D hillshade showing additional zones to be assessed located within the vegetated natural terrain above the cutting (red).**

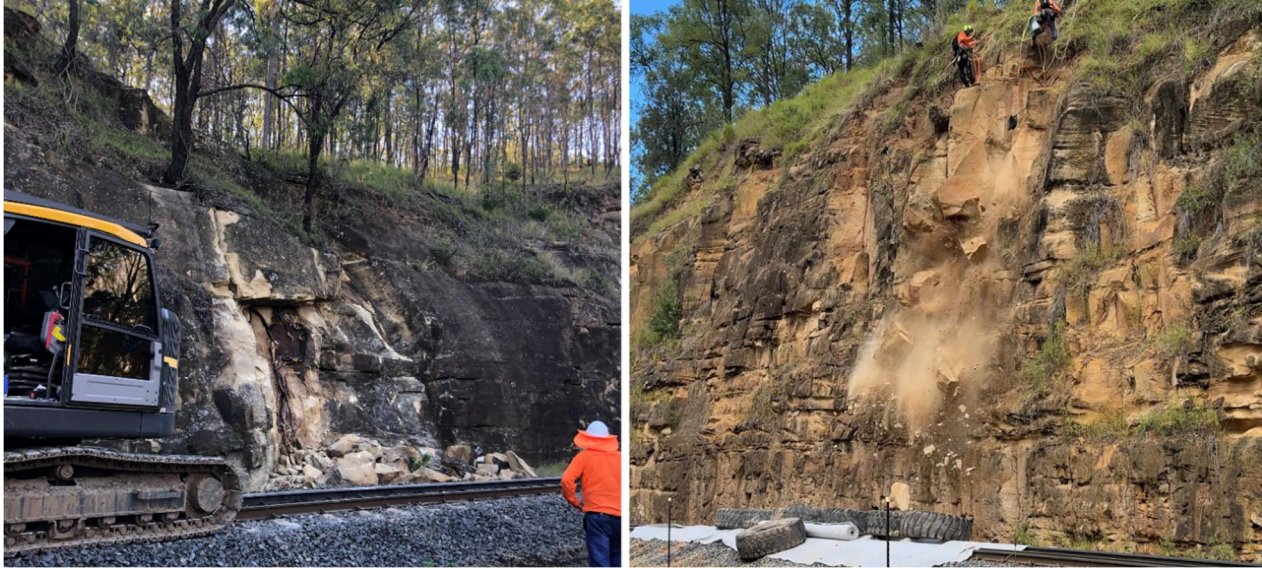
**Figure 9: (Left) Rockfalls induced by root jacking, trimming and poisoning of critical vegetation is often utilised. (Right) Roped access assessment and the use of air bags to remove large localised blocks from the slope face.**

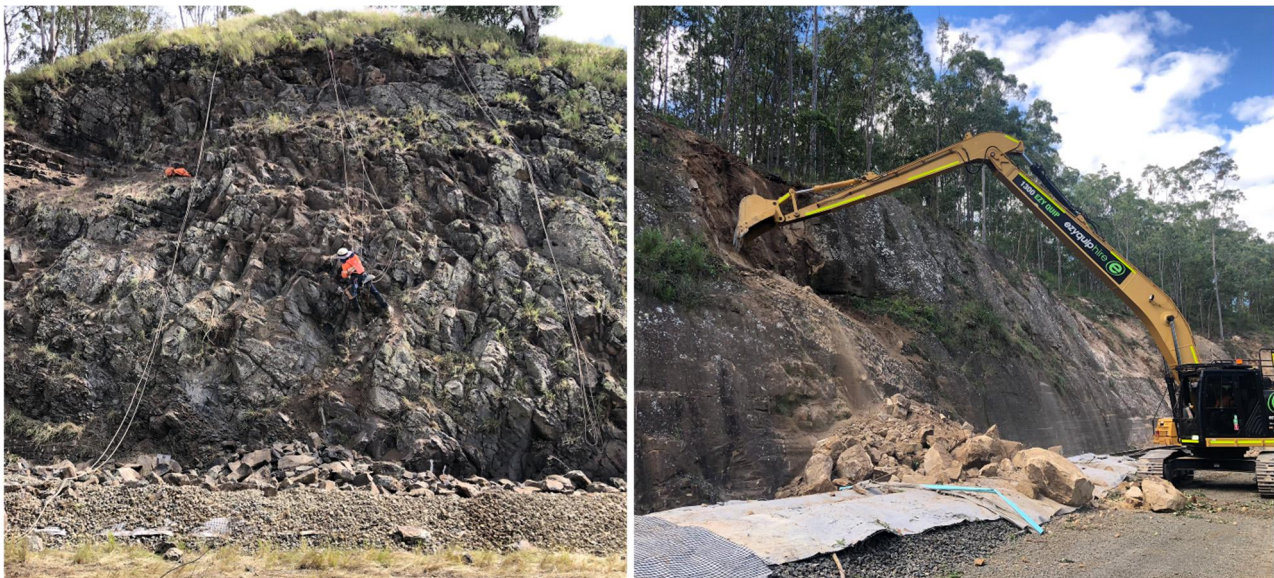
**Figure 10: (Left) Extensive scaling via roped access and the use of hand tools. (Right) Mechanical scaling of larger zones of problematic rock mass via long reach excavator.**

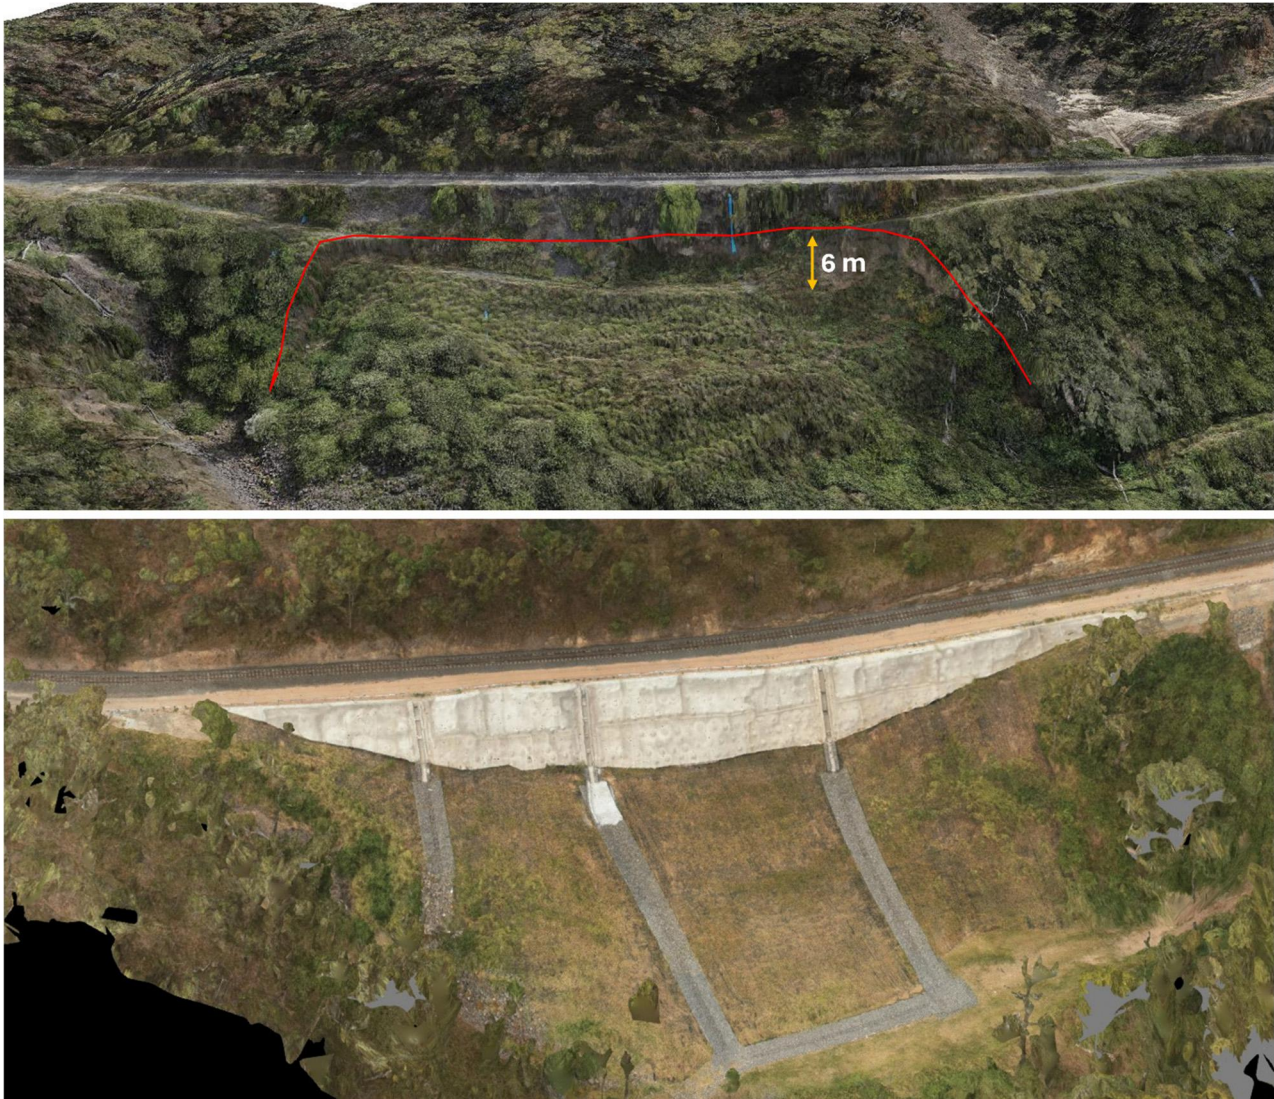
The embankment below the rail line is positioned on a historical landslide area, which was reported to have occurred following a rainfall triggering event in 2012. The landslide was reactivated following extreme rainfall event in February 2022 where approximately 450 mm was recorded over a four-day period. A landslide scarp of approximately 80 m long developed with up to 6 m of downwards displacement. The landslide continued slow displacement predominately associated with each rainfall event. A detailed design was undertaken to support the upper access track and mitigate the slope instability.

**Figure 11: (Top) Reactivation of an existing failure at CH. 141.1 km resulted in the mid-slope access road experiencing 6 m downwards displacement. (Bottom) Post construction condition of the slope following remedial works undertaken in 2023.**

Remediation works were undertaken between July 2023 and October 2023 comprising:

- Soil nails and shotcrete to upper access track: to aid long-term stability of the slope by mitigating potential erosion issues, assisting drainage control and decreasing the risk of global slope instability.
- Site-wide drainage: to mitigate potential scour/erosion from the site and to mitigate water infiltration into the slope. The drainage system aimed to slow the flow velocity at the pipe exits of existing culverts (using a pit), down the chute (by added bevels/steps), and along the slope (using a rock mattress/gabion) and to collecting the water and convey it away from the slope.
- Regrading the slope: to flatten the slope steepness, which results in a reduction of shear stress acting on the soil, hence creating more stable slope conditions.
- Vegetation: was added to the slope surface. The roots of the vegetation hold the soil in place and reduce the effects of erosion.
