RISK MANAGEMENT OF COASTAL CLIFF HAZARDS – A CASE STUDY FROM THE SURF COAST, SOUTHWEST VICTORIA

Kris Jelly-Butterworth
Senior Engineering Geologist, GHD

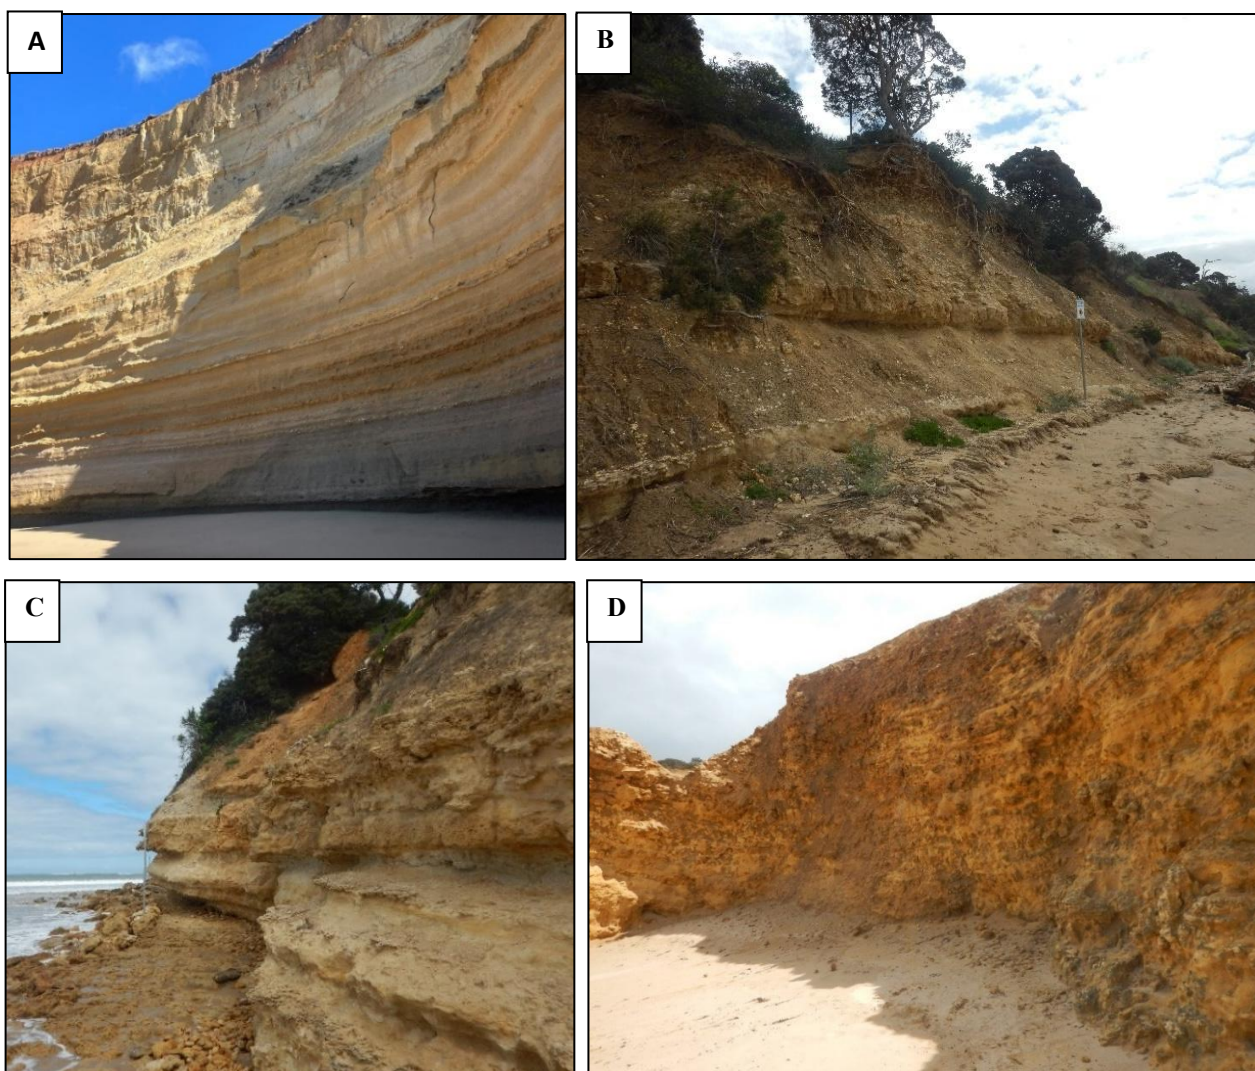
The Jan Juc Formation generally comprises silty glauconitic marl and clayey sandy calcarenite, noted to be highly friable. The calcarenite layers are more strongly cemented, more ferruginous and more resistant than the marl beds (Abele 1979), leading to an irregular weathering pattern on cliff faces, as shown in Figure 3A. The Jan Juc Formation is exposed in the lower part of the cliffs from Bird Rock to Fisherman’s Steps beach.

Danger and just south of Yellow Bluff. The unit comprises grey, orange to pale orange sandy bryozoal calcarenite. The calcarenite has a rubbly texture due to the differentially cemented nature of the rock. This texture is well illustrated in a cliff section at Rocky Point, Jan Juc (Figure 3D).

Figure 3: Typical outcrops of the Jan Juc Formation (A – Near Bird Rock GHD 2023), Puebla Formation (B and C, near Yellow Bluff GHD 2020) and Zeally Limestone Member (D, Rocky Point, Jan Juc GHD 2020).

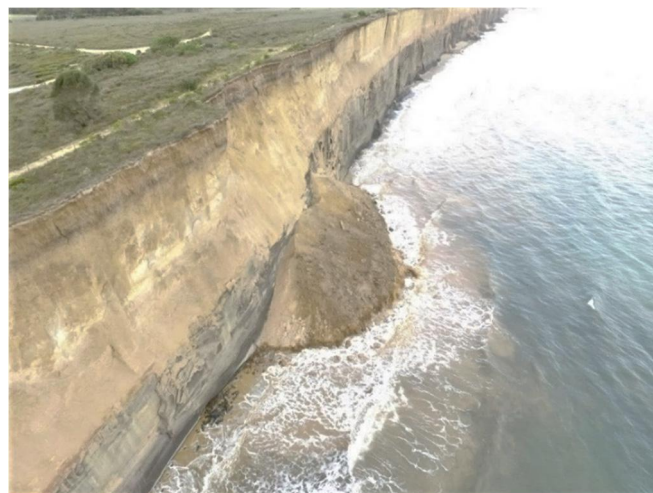
Figure 5: Drone capture showing typical outcrop of the Anglesea Member, in the Demons Bluff cliffs, Anglesea (Provided by GORCAPA)

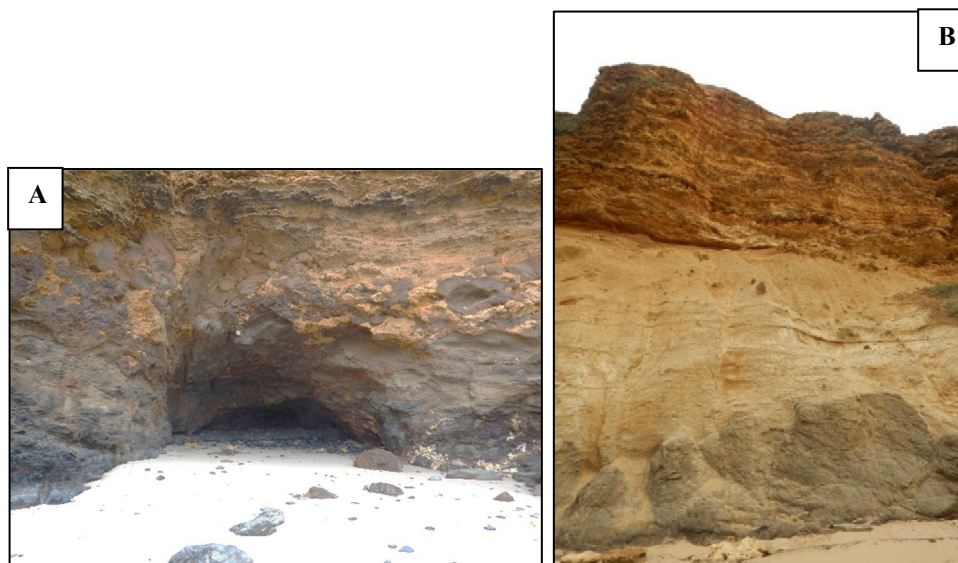
Figure 6: Typical exposures of the Angahook Member at Aireys Inlet, showing lithological diversity from basalt/basaltic sediments (A) to tuffaceous sediments and pyroclastic sediments (B). Photo B shows the contact of the Point Addis Limestone Member and the Angahook Member (GHD 2020)

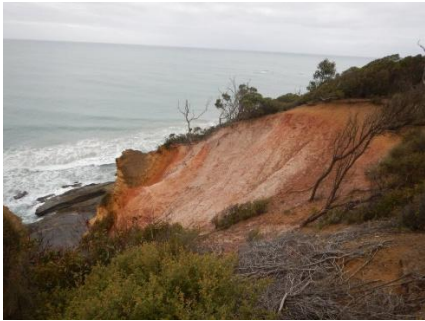
Classification	Danger Type	Description	Example From Site
A	Small rotational and translational slides	Less than 1000 m ³ displaced material. Initial failure is likely to be rapid. Example: Failure of infilled sinkhole, Aireys Inlet

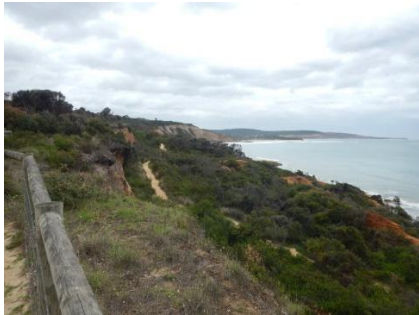
B	Large rotational and translational slides	Larger, generally deeper, slides than those in 'A' above, involving greater than 1000 m ³ displaced material. Example: Soapy Rocks Landslide, Anglesea

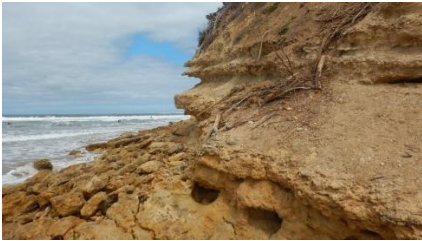
C	Minor falls/topples	Failure of less than 1 m ³ of material from cliff face. Failure likely to be extremely rapid. Example: Rock fall, Yellow Bluff, Torquay

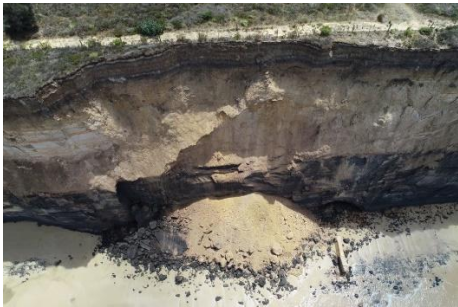
D	Major falls/topples	As in 'C' above, with greater than 1 m ³ of failed material. Example: Cliff failure, Demons Bluff, Anglesea

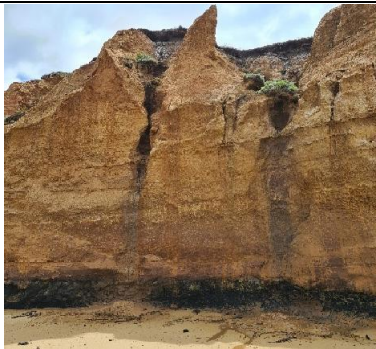
E	Rill and gully erosion	These are often ephemeral features and are formed by erosion of the land surface by flowing water. Example – Rills/Gullies adjacent to Anglesea SLSC

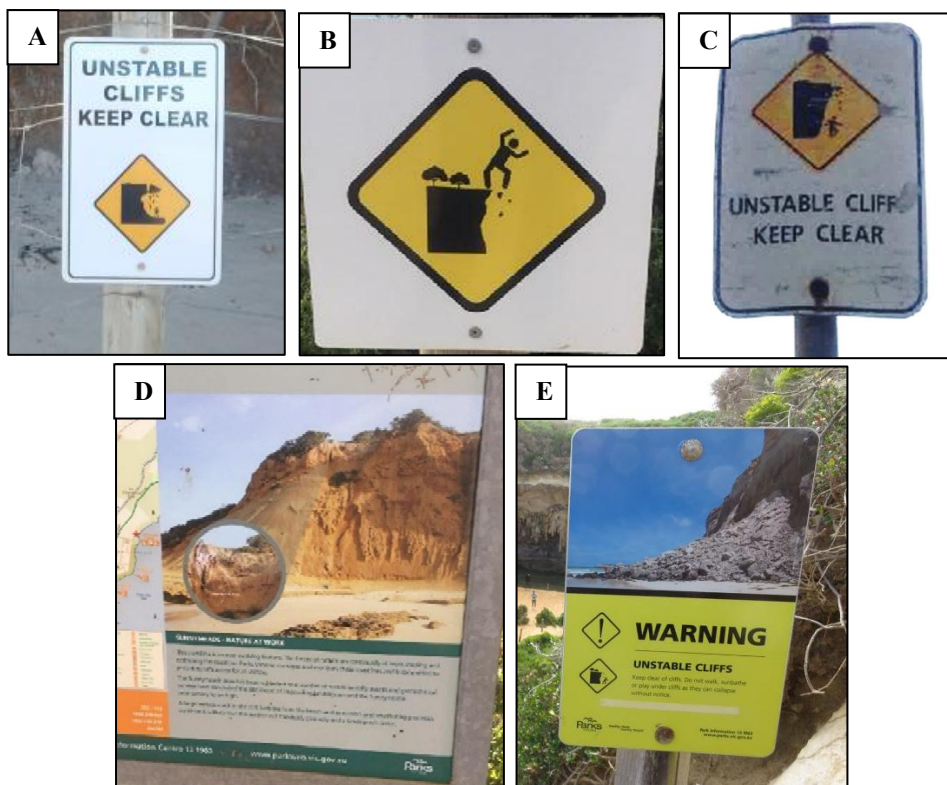
The signage audit found five different styles of warning sign (three types shown in Figure 7A, 7B, 7C) depicting the same hazard – unstable cliffs. Some had accompanying text in English, others had only the pictogram with no words. Spatial distribution was generally quite random, with some areas having more signs than others for no obvious reason. With so many varieties of the same sign, communication of the hazard could become confused/unclear.

Figure 7: Cliff hazard signage examples from the signage audit. A, B and C – sign examples as observed by GHD in 2020 in the GORCAPA managed areas, three different varieties of sign all communicating the same hazard. D, E – Signs from Parks Victoria managed areas, communicating the hazard posed using words, pictograms, colour and photographs of the actual hazard to clearly communicate the hazard and risks, including contact details/places to obtain further information as required.

Example signage from other land management agencies, such as Parks Victoria, were used to compare against those found in the GORCAPA managed land area and showed what could be achieved. For example, at popular sites along the Great Ocean Road, Parks Victoria had combined Warning signage compliant with the Australian standards with a photograph of similar hazard/failure, in order to visually communicate the risk. Signs observed are shown in Figure 7.

Following the recommendations of the signage audit completed in 2020, GORCAPA committed to upgrading and improving hazard signage. Cliff hazard signs were replaced/upgraded with standardised symbology and wording along the coastline (Figure 9). In addition, GORCAPA also implemented different signage to communicate the hazards at beach and coastal path entrances, taking cues from the Parks Victoria examples in incorporating photographs of the hazard, as well as additional information available in other languages access via the website/QR codes on the sign (Figure 9).

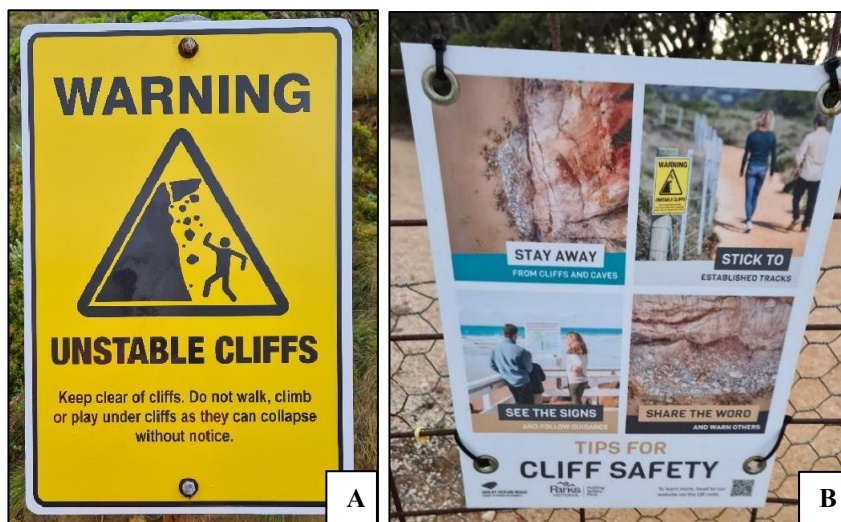
Figure 9: Updated signage examples found at Jan Juc and Anglesea. A: Unstable cliff warning sign, showing a clear pictogram of the hazard and advice on what to do to avoid the hazard. B: Photographic sign depicting typical failures, as well as showing the correct usage of paths. A QR code also links viewers to the GORCAPA website for further information which is also in other languages.
