ROCKFALL RISK ASSESSMENT AT NORTH HEAD, SYDNEY HARBOUR NATIONAL PARK, NSW

Michael Egan¹ and Paul Roberts²
JK Geotechnics, Sydney, NSW, Australia¹
JK Geotechnics, Sunshine Coast, QLD, Australia²

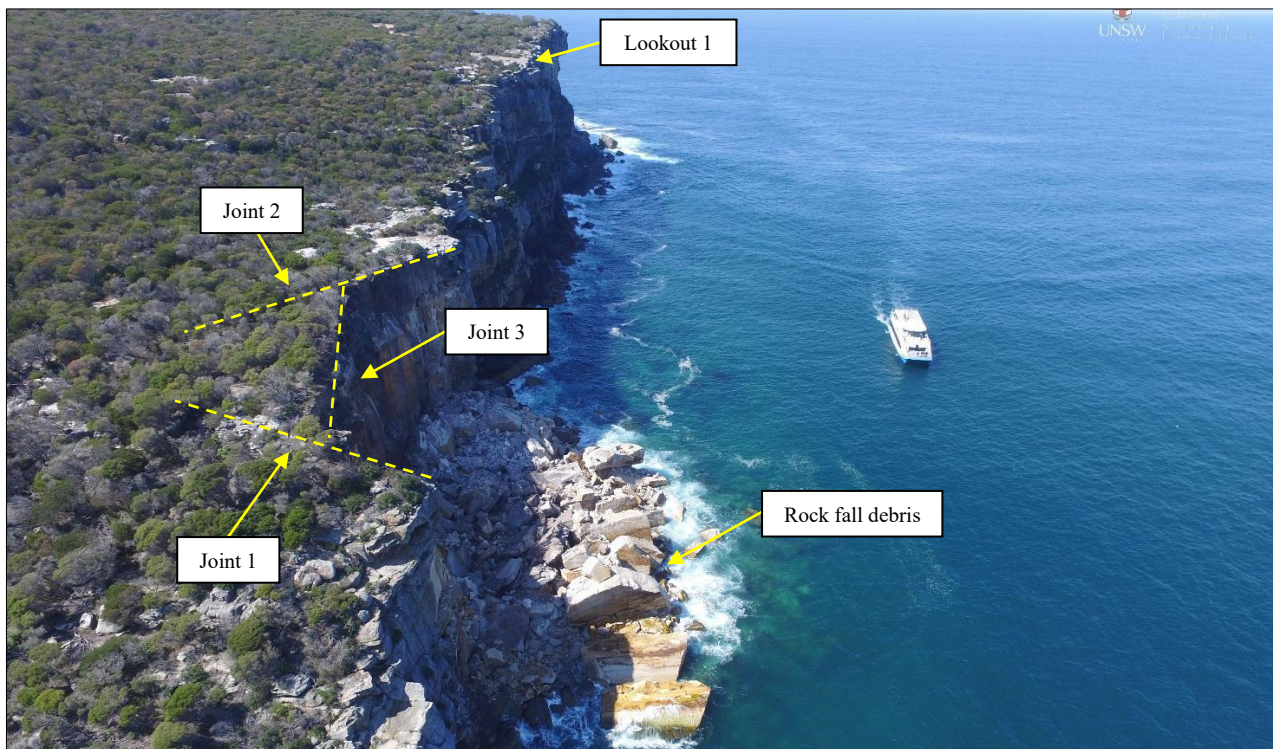
The previous rock fall impacted an approximately 85 m long section of the cliff face located about 300 m to the west of Lookout One. At this location, the cliff face was a maximum height of about 20 m and the majority of the rock fall debris comprised large sandstone blocks (defined by the orthogonal joint sets described above) and extended seaward at least 20 m; see Figure 2.

From a review of the JKG site observations and previous photographs prior to the collapse, the likely cause of the rock fall was considered to be ongoing erosion of the undercut section at the base of the cliff. This process had ultimately resulted in the undermining of the jointed rock mass, leading to an overturning moment of sufficient magnitude to induce toppling failure of the upper jointed rocks. Ephemeral hydrostatic pressures associated with temporary collection of water in open joints was also considered to be an additional potential trigger mechanism. The identified release surfaces of the rock fall are outlined below and indicated on Figure 2:

- Over the eastern section of the cliff, an approximately 030° trending sub-vertical joint (Joint 1);
- Over the western end, an approximately 140° trending sub-vertical joint (Joint 2); and
- Over the central section, a localised sub-vertical joint (Joint 3) trending approximately 100°, extending east from Joint 1 and intersecting Joint 2.

Figure 2: Oblique view of the cliff face and Lookout One following the rock fall (image supplied by NPWS, 2016)

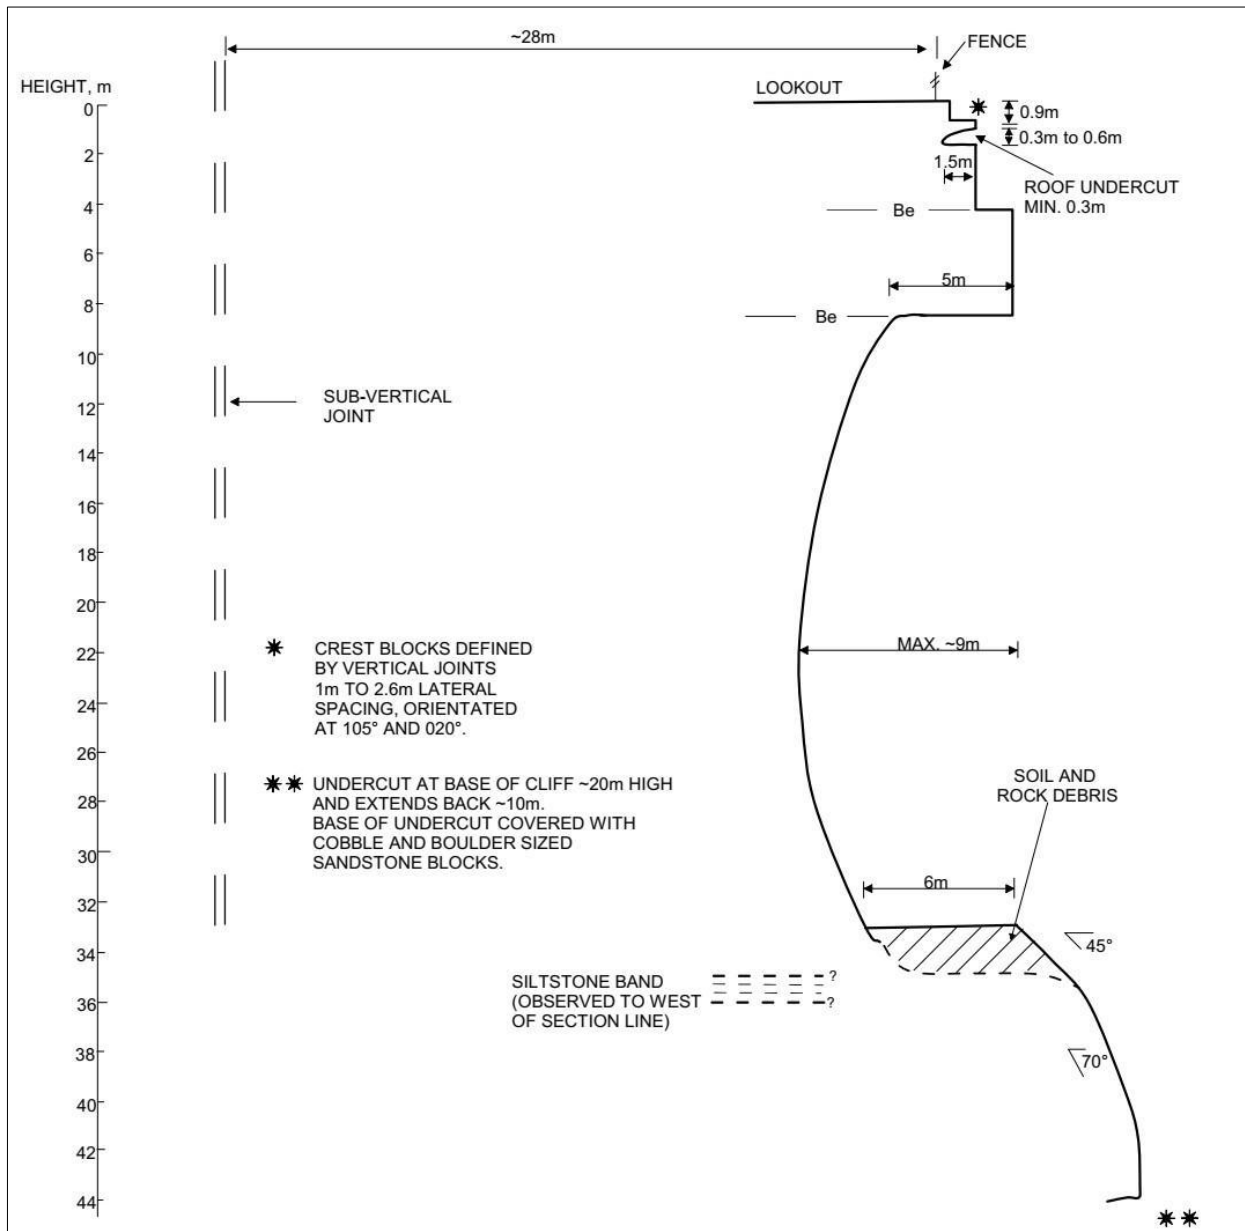
The original Lookout One was located at a minimum set back distance of approximately 0.3 m from the edge of the cliff. An open, sub-vertical joint (Joint 4) trending at approximately 130° was intermittently exposed in the sandstone bedrock between approximately 20 m and 29 m landward (i.e. to the north) of the cliff edge. Figure 3 presents a cross-sectional sketch of the cliff face at Lookout One.

Several overhangs (maximum horizontal 'depth' of approximately 3 m) were present within the upper sections of the cliff. Below these overhangs, a second more extensive overhang feature extended over a horizontal distance (east-west) of about 40 m. The overhang was present below the full length (east-west) of the lookout, extended down the cliff face a

maximum vertical height of about 26 m, and had a maximum horizontal ‘depth’ of about 9 m. The base of the overhang was covered with soil and sandstone debris (gravel and cobble sized) which was typically overgrown.

Figure 3: Cross-sectional sketch of the cliff face and cliff top area at Lookout One (looking east)

- To reduce the likelihood of cliff face instability impacting the lookout, either from collapse of the upper portion of the overhangs or the entire lower overhang, the footings supporting the new lookout must be located a minimum set back distance of 8 m and 4 m of the existing fence lines at Lookout One and Lookout Three, respectively;
- Any portions of the lookout seaward of these set back distances must be designed as cantilevered and supported by foundations located landward of these set back distances; and
- The proposed areas of the new lookout foundations would need to be cleared of vegetation and inspected by a geotechnical engineer to check for the presence of any traces of open sub-vertical joint planes and to confirm the above mentioned set back distances.

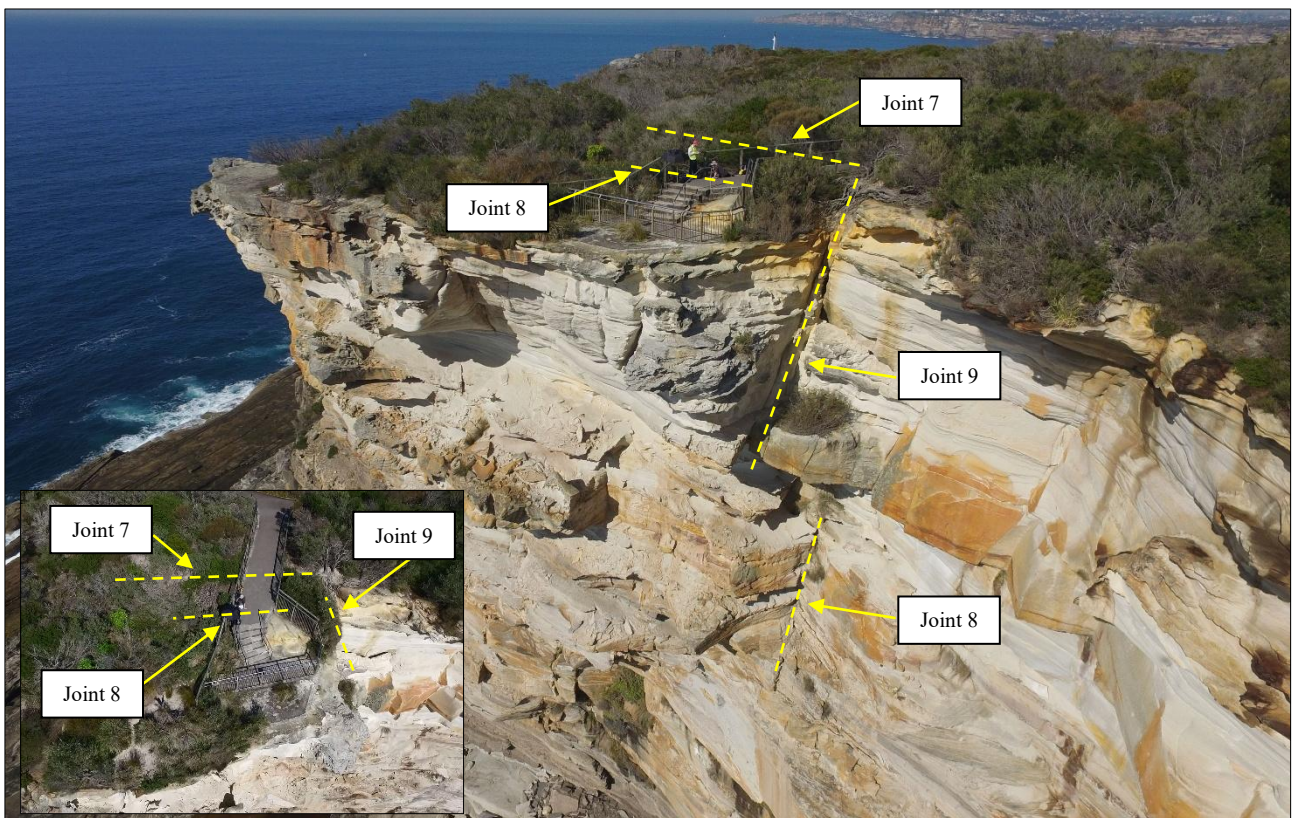
The original Lookout Three was located at a set back distance of between approximately 1 m and 3.2 m from the edge of the cliff, and approximately 17 m seaward (i.e. to the north-east) of the walking track. Figure 4 presents an oblique view of the lookout during the 2016 assessment.

From the Fairfax walking track, access to the lookout was along a sand/gravel surfaced walking path and a number of voids and depressions were observed which impacted both the access path and adjacent cliff top area to the south-east. The voids and depressions appeared to be associated with soil loss through a persistent open joint (Joint 7) orientated at approximately 120° within the underlying bedrock. Joint 7 steeply dipped down to the north-east at between approximately 70° and 90° and had a sub-parallel alignment to Joint 8 observed in the cliff face below the north-western side of Lookout Three. Joint 7 and Joint 8 were set back approximately 8 m and 13 m from the cliff edge, respectively. The north-western side of the cliff face adjacent to the former lookout also exposed a sub-vertical planar joint (Joint 9) orientated at approximately 012° (i.e. trending back into the cliff face).

Figure 4: Oblique views of Lookout Three (images courtesy of NPWS, 2016)

The upper approximately 6 m of the cliff immediately below the lookout was characterised by a number of overhang features ranging between about 2 m and 4 m height and ‘depths’ of between about 0.4 m and 6 m. Several additional overhangs (maximum horizontal ‘depth’ of approximately 4.5 m) were observed down the cliff face. The persistent undercut feature had a maximum height of about 25 m, with a maximum horizontal ‘depth’ of about 5 m, and extended down to the wave cut platform below.

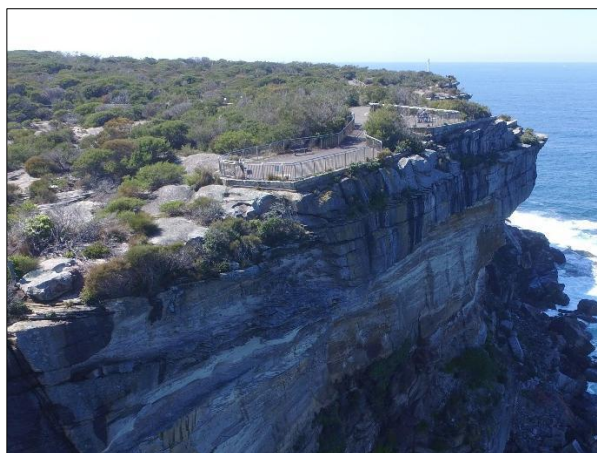
Figure 6a Lookout One pre construction (looking east, image courtesy of NPWS, 2016)

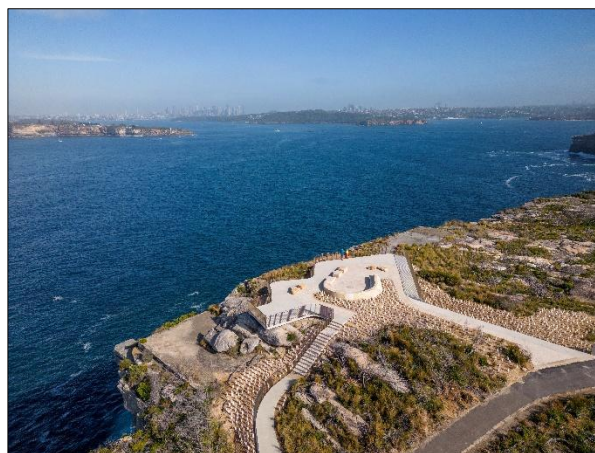
During the inspections, several of the persistent joints identified during the earlier assessments were locally exposed in footing excavations and were subsequently ‘bridged over’ with sacrificial formwork and additional reinforcement, or a Bondek slab, in accordance with advice from SDA Structures. It was noteworthy that a strong breeze could be felt in

one localised section of an open joint (Joint 4) exposed at Lookout One, with the air most likely being blown through the open joint exposed within the cliff face approximately 20 m to the south-east.

Figure 6b: Lookout One following construction (looking south-west, image courtesy of NPWS, 2023)
