ANALYSIS OF THE MECHANISM OF LANDSLIDING, GARIE ROAD, ROYAL NATIONAL PARK, NSW

Tim Donovan¹ and Luke Johnstone²

¹Associate Engineering Geologist, Aurecon ²Engineering Geologist, AtkinsRéalis

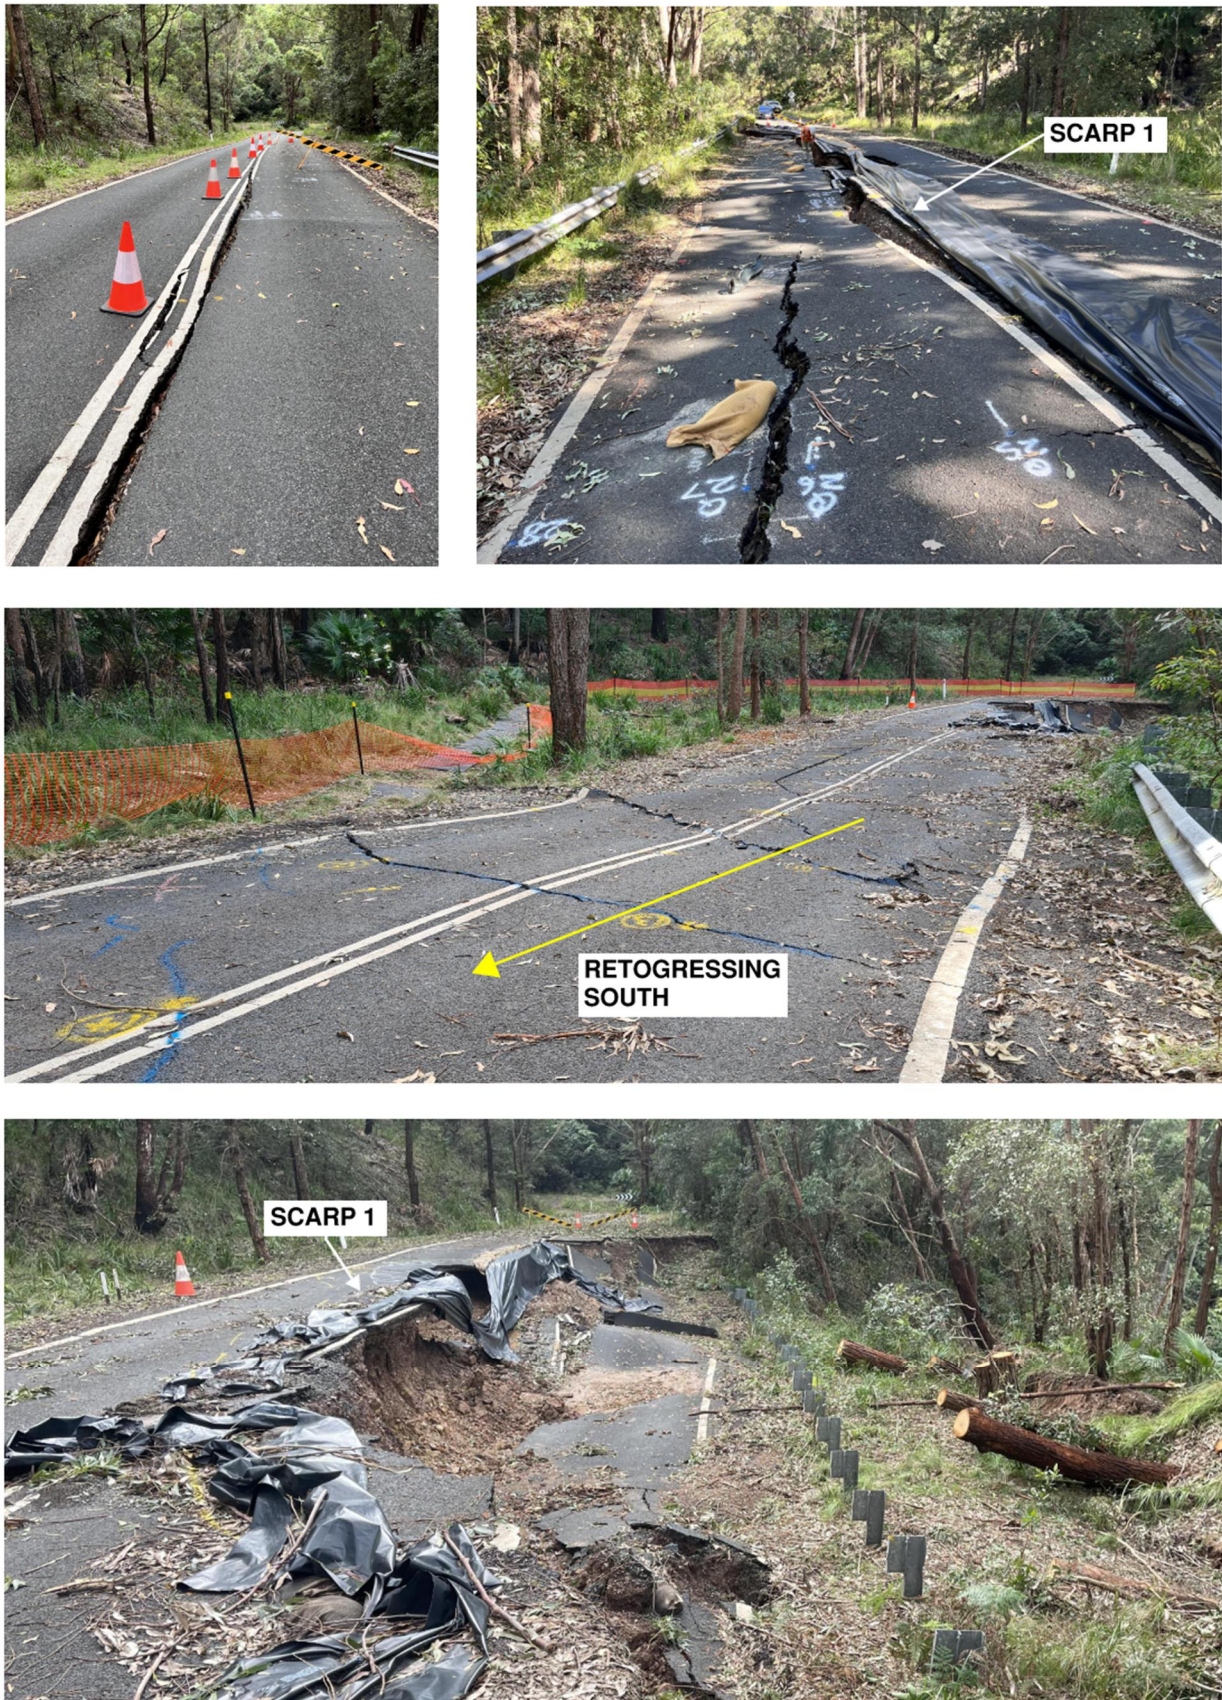
In early March 2022, a large landslide developed on Garie Road with the movement direction downslope and to the east. With additional heavy rain events, the landslide grew, retrogressing across the road to the west and some distance to the south between March 2022 and October 2022 (Figure 4). The landslide eventually encompassed the entire road, rendering it impassable by any vehicle.

Figure 4: Photos showing the development of the Garie Road landslide. Top left - vertical and horizontal displacement along road centreline (30 March 2022). Top right - significant progression of the deformation (4 April 2022). Middle - landslide retrogressed south (early July 2022). Bottom - Scarp 1 condition (July 2022).

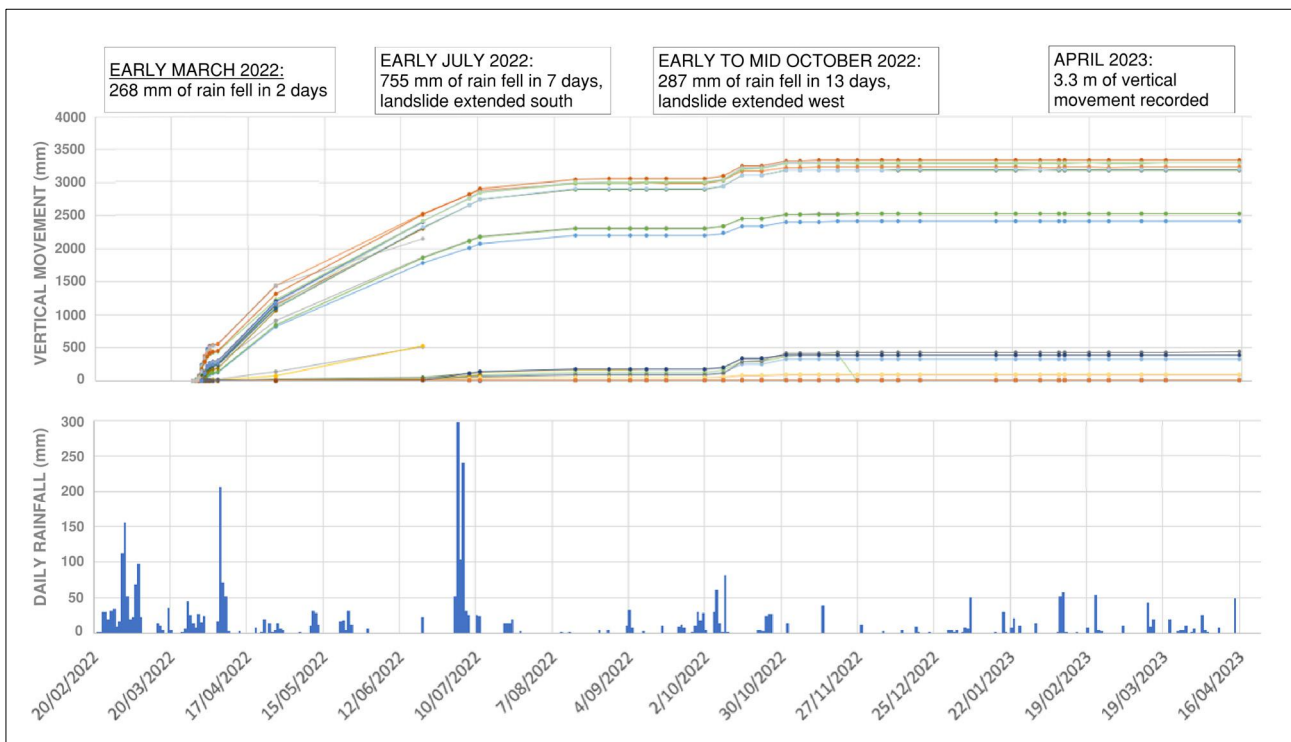
Figure 5: Landslide vertical movement plotted from key survey monitoring points (coloured lines) installed below Scarp 1 and rainfall plot from March 2022 to April 2023. The rainfall data is taken from the BOM database for the Darkes Forest, Kintyre rain gauge.

- The landslide is a pore pressure driven; slow moving ‘stick-slip’ landslide as demonstrated by the rainfall vs ground monitoring data (Figure 5). Ground movements accelerated subsequent to intense rain events with retrogression of the landslide and slowed or ceased during periods of dry weather.

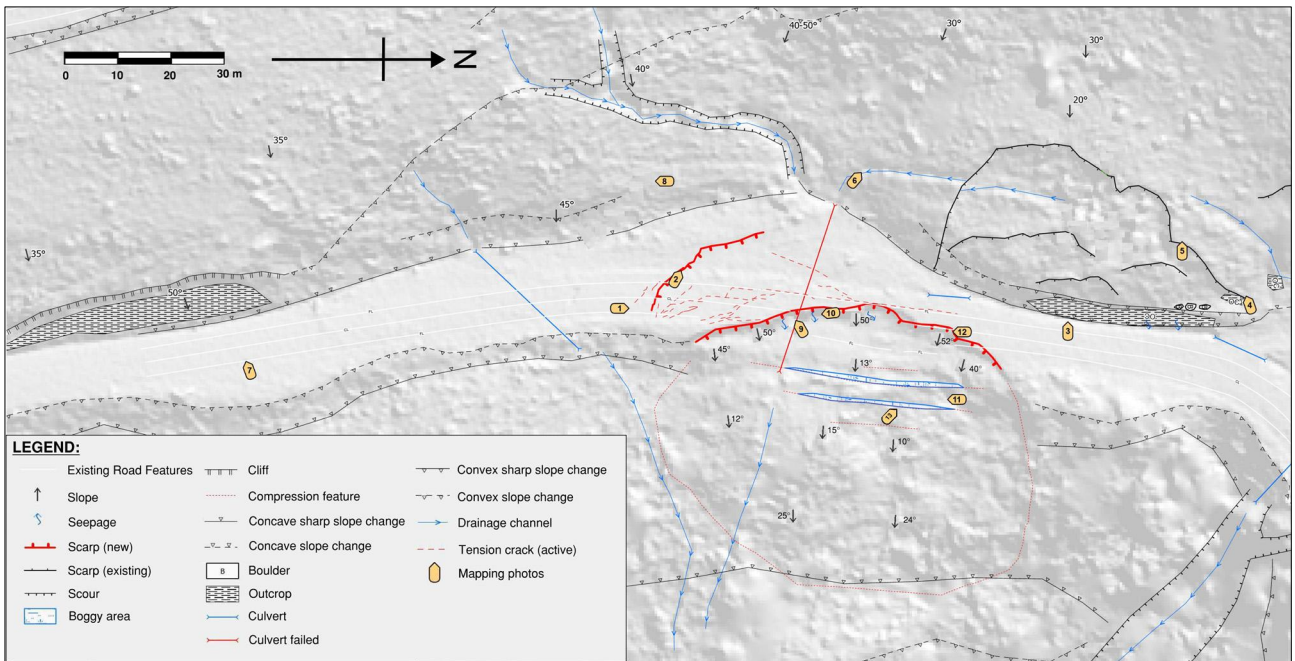
Figure 6: Engineering geological map of the landslide and surrounding area. Source of DTM is MES (2022).

- The landslide was relatively large; the dimensions were assessed to be approximately 80 m in width and 60 m in length from landslide backscarp to toe. The landslide toe extended significantly beyond the road reserve into the National Park to the east.

- The landslide backscarps in the road and road reserve were inclined relatively steep, dipping $\sim 65^\circ$ to the east.
- A historic scarp was mapped on the immediate downslope to the main landslide with approximately ~ 2 m of vertical displacement. This historic scarp was less obvious due to compression features resulting from the recent instability.

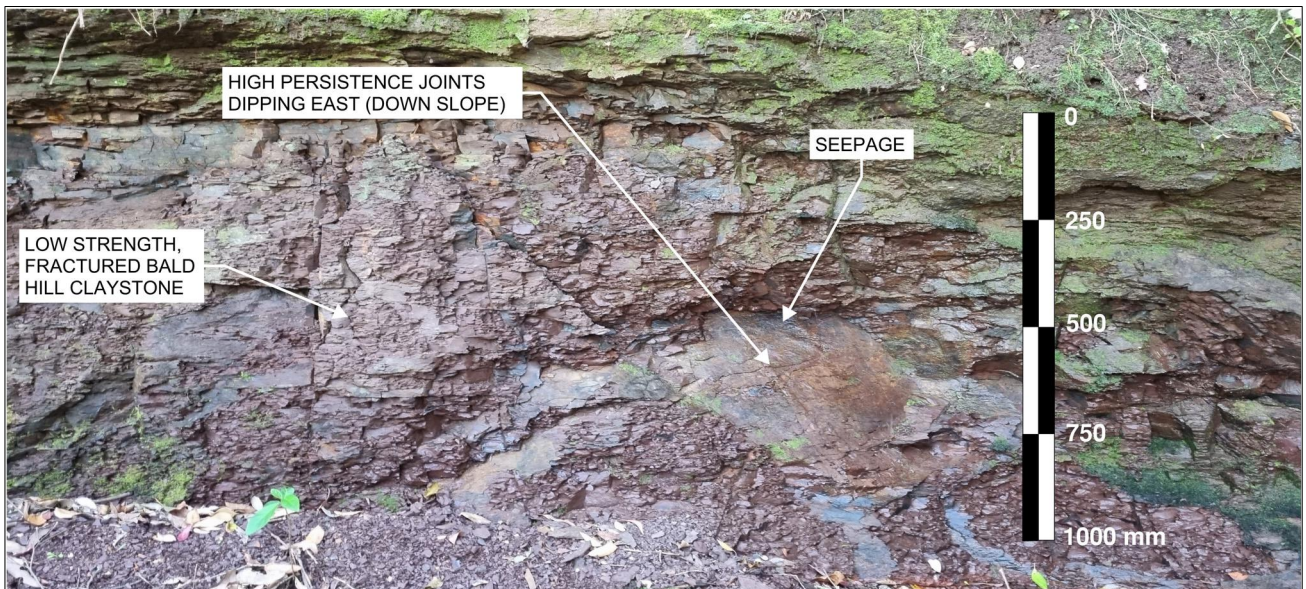
Figure 7: Typical Bald Hill Claystone rock cutting present on the upslope of Garie Road immediately to the north of the landslide

- The Bald Hill Claystone outcrops are typically highly fractured with their surface being comprised of angular interlocking gravel and cobble sized claystone fragments, separated by clay infilled defects.

- A key outcrop observation was a number of higher persistence smooth joints with groundwater seepage, dipping approximately 60° east (general slope failure direction).

- The steep joints with high persistence dipping approximately 60° to the east (general slope failure direction) mapped within the Bald Hill Claystone road cuttings are assessed to provide a preferential weak surface for the formation of backscarps during high intensity rainfall events.

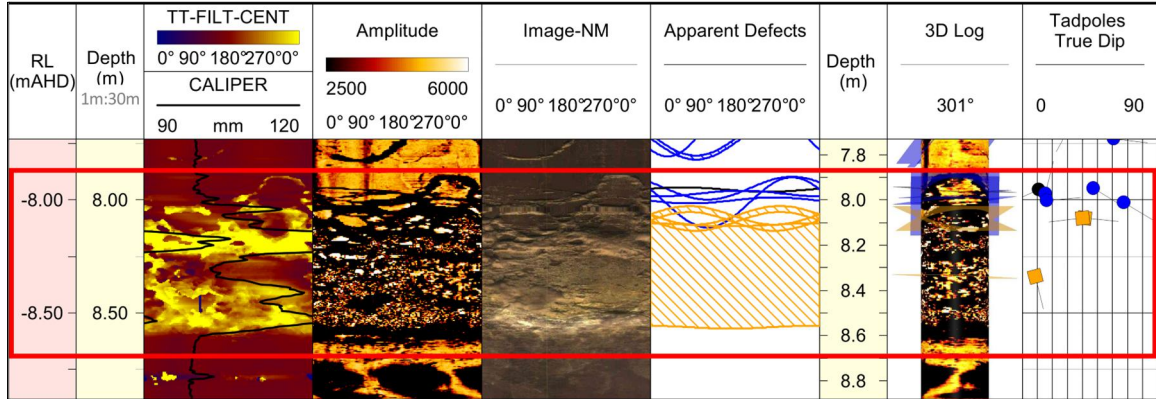
- A pale weathered zone of reduced strength (named ‘weak zone’ from here in) was encountered in boreholes BH06, BH08, BH10 and BH12 within the Bald Hill Claystone in close proximity (within ~ 1 to 2 m) to the underlying interface of the Bulgo Sandstone (Figure 9). This weak zone was logged varying from 350 mm to 800 mm thick where the material had been recovered.

Figure 9: Weak zone clearly identified in the downhole OTV and ATV logs between 8.05 m to 8.5 m depth in BH12

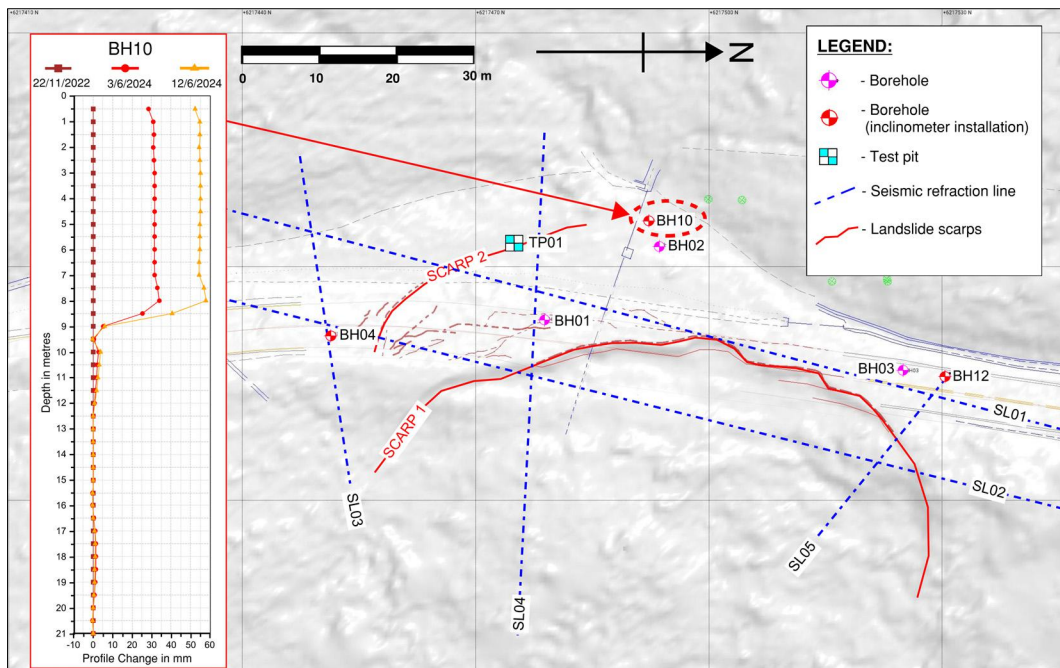
Figure 10: Ground movement at ~9 m depth recorded in BH10 inclinometer in June 2024.

- The ground movement recorded in the BH10 inclinometer at ~ 9 m depth in June 2024 is assessed to be a retrogression of a new backscarp trending up at a similar geometry to the existing Scarp 1 and 2 from the ‘weak zone’ basal slide plane. This inclinometer movement further validated the landslide movement is within the identified ‘weak zone’.

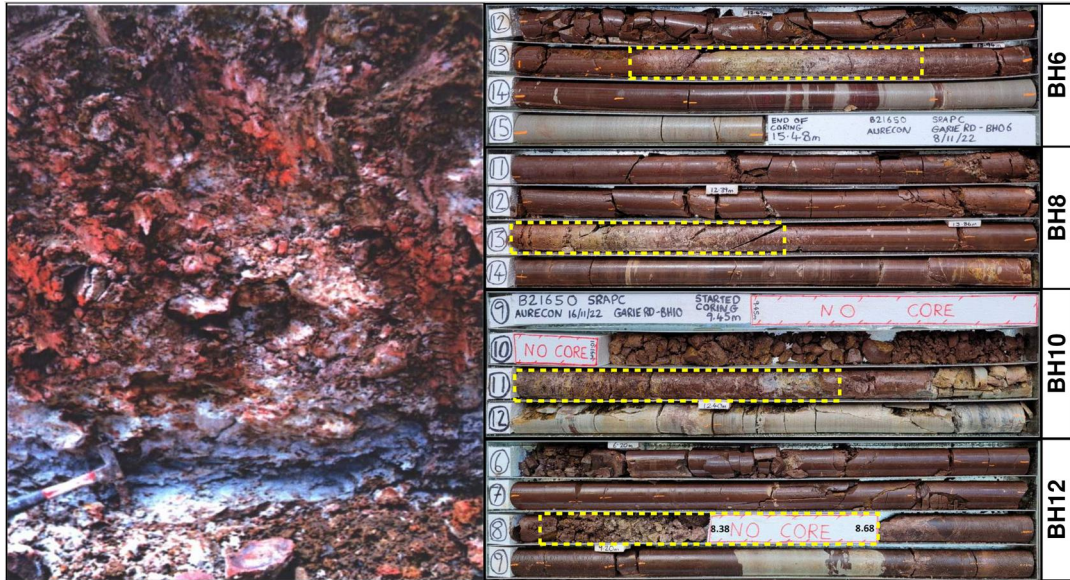
Figure 12: Left image - pale white clay ‘gouge’ associated with a zone of sliding in the Bald Hill Claystone at Site 43 (Stone, 2012). Right images - BH06, BH08, BH10 and BH12 core displaying a similar pale white weathered clay zone (yellow dashed boxes) within the Bald Hill Claystone, 1 to 2 m above the interface with the underlying Bulgo Sandstone.

- The Garie Road landslide has a number of close similarities to the Site 43 South Coast Railway landslide site, namely the same zone of sliding within the white clay gouge ‘weak zone’ is common to both landslides (Figure 12). In addition, both landslides have similar backscarp and basal slide plane geometry, the presence of superficial instabilities on the upslope and progressive movement was experienced until the onset of dry weather (Flentje & Leventhal, 2012; Stone, 2012).

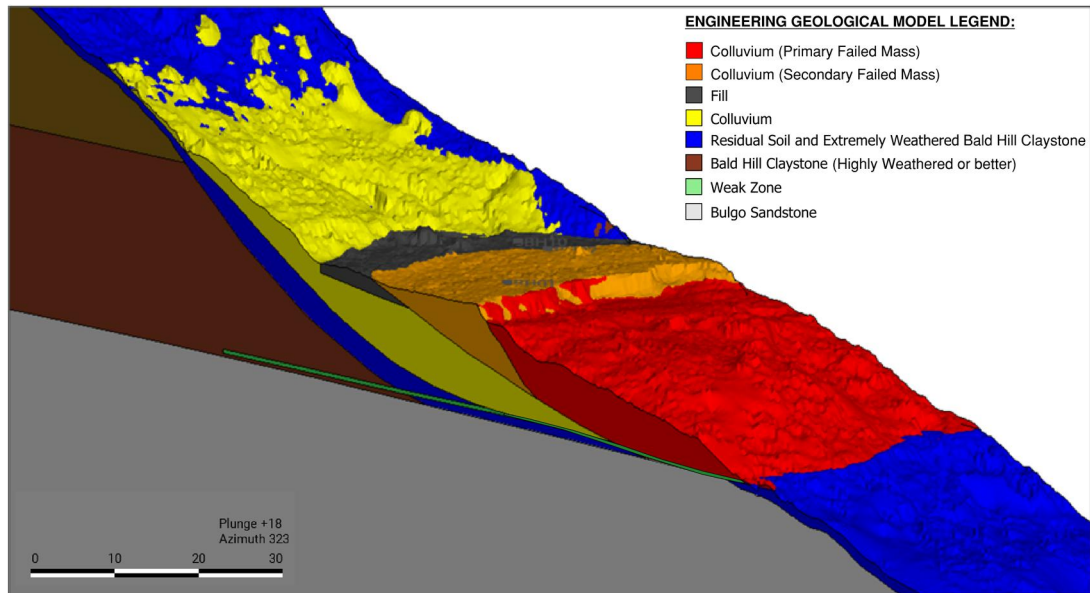
Figure 13: Cross section through the Leapfrog developed EGM. Source of DTM (MES, 2022).

In the EGM, the landslide was interpreted to have a backscarp in the order of $\sim 65^\circ$ dip and an assessed planar basal sliding plane ~ 13 m below ground level at the Scarp 1 location. The geometry of the landslide was defined based on the engineering geological mapping, intrusive investigation results and comparison with the published literature (Flentje & Leventhal, 2012; Stone, 2012).

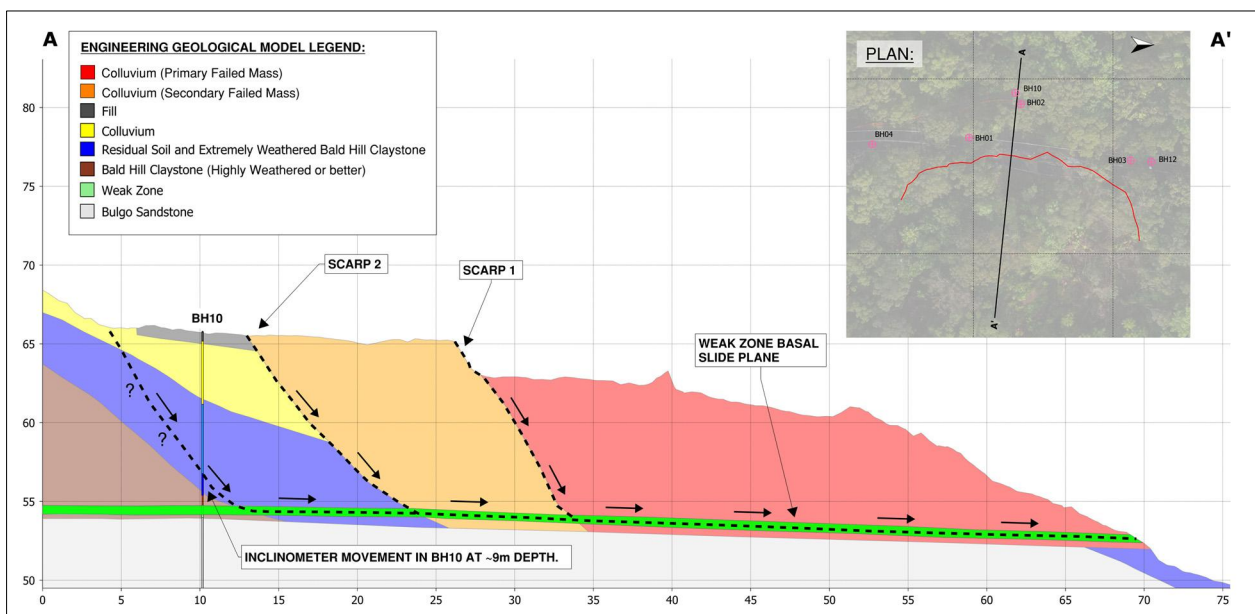
- The mechanism of mass movement is a large slide with both a rotational and translational component. The backscarp to the landslide is assessed to be semi-rotational measured dipping at $\sim 65^\circ$ to the east at the ground surface. The basal slide plane is the translational component of the landslide mechanism sliding on the weak zone within the Bald Hill Claystone close to the interface of the underlying Bulgo Sandstone. The assessed dip of the basal slide plane is just $\sim 5^\circ$ to the east, approximately parallel to the sub-horizontal top of the Bulgo Sandstone.

The components of the mechanism of landsliding comprising a semi-rotational backscarp and a sub-horizontal basal slip plane formed at the location of the ‘weak zone’ is presented in Figure 14.

Figure 14: Cross section A-A' through the EGM displaying the assessed mechanism of landsliding at Garie Road.
