THE BOGONG LANDSLIDE, A CASE STUDY INTO AN AUSTRALIAN LANDSLIDE IN UNSATURATED SOILS

Darren Paul, Simon Harbig, Emma O'Brien, Alana Dubowik
WSP, Melbourne, Victoria

ABSTRACT

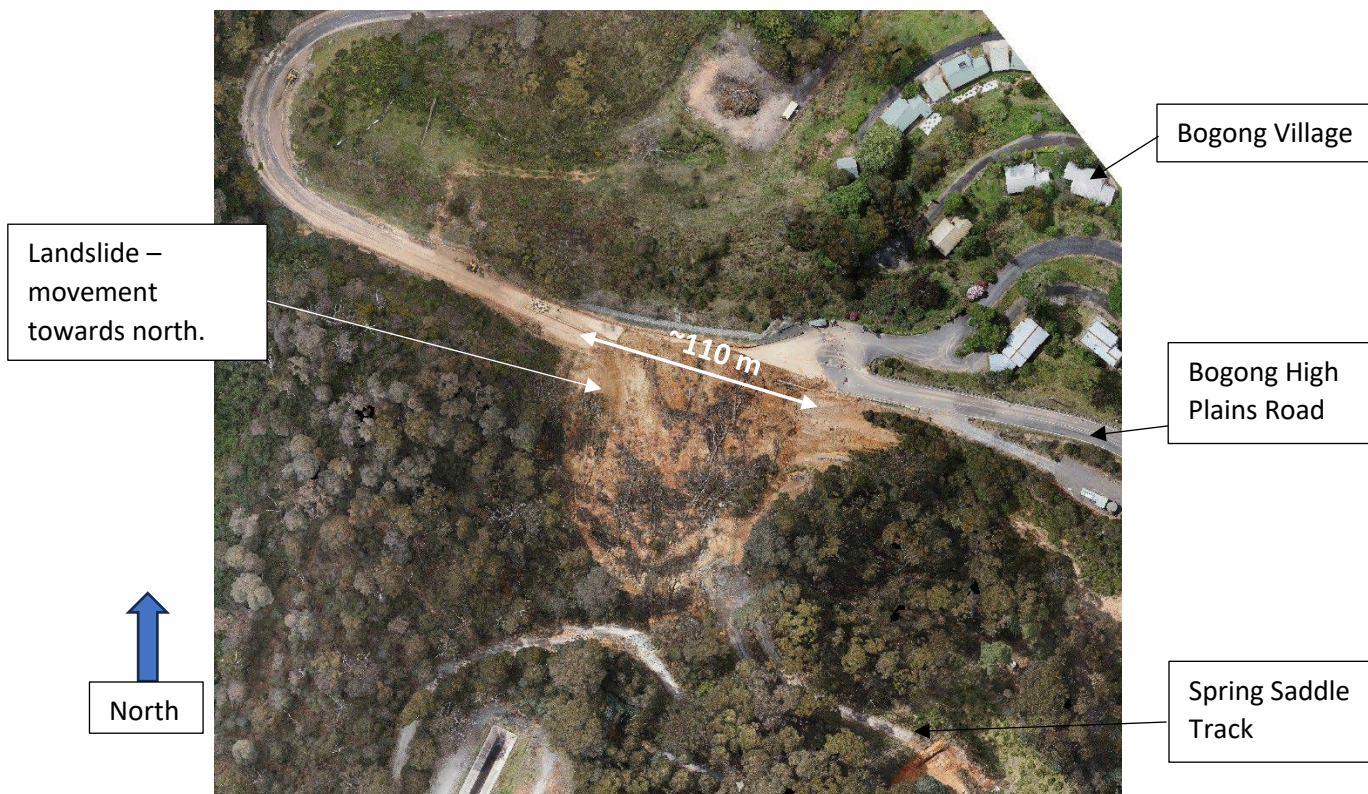
The Bogong landslide occurred upslope of Bogong High Plains Road and Bogong Village as indicated in Figure 1.

Figure 1: Aerial photograph of the Bogong landslide taken 11 November 2022

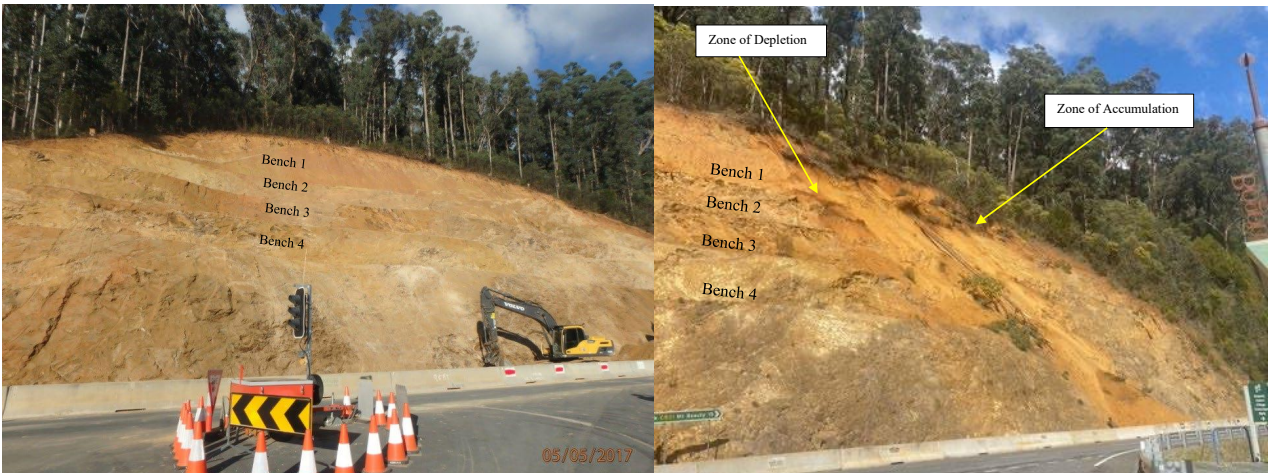
The cut road batter at the site of the landslide had exhibited signs of instability in the past, including in 2017 at which time the road batter was cut back and benched, with an overall slope angle of about 60° and height of about 15 m (Figure 2). The Bogong landslide of October 2022 was preceded by three years of above average rainfall induced by La Niña climate conditions. Approximately two weeks before the landslide, tension cracks were observed on a track about 90 m back from the roadway (Figure 3). Ongoing movement was observed before the landslide, which ultimately displaced approximately 30,000 m³ of soil. Spoil and vegetation were deposited across both lanes of the road, completely blocking access between the major towns of Mount Beauty and Falls Creek and threatening Bogong Village downslope of the landslide (Figure 1). Falls Creek is an alpine resort reliant on income from tourism, particularly in winter, making the financial consequences of not opening the road before the 2023 ski season significant and demanding a rapid response.

Figure 2: Left: Road Batter in May 2017 at completion of excavation. Right: Road Batter on 8 October 2022 following landslide initiation

Video and photographs taken in October 2022 on the day material reached the road indicate that material detached from the natural 40° slope upslope of benches 1 and 2. The debris travelled as a non-saturated soil (poured over like sand rather than flowed as a liquid) over the lower two benches. Based on the video and photos, slope materials did not detach from the lower two benches. However, materials may have been stripped from the benches as debris flowed over them. Seepage was not observed from the face, nor did it appear to be associated with the material detachment. Over the subsequent week further material detached from above Bench 2, causing debris to bury the lower benches and the buildup of a colluvial fan at the toe of the slope as indicated in Figure 2.

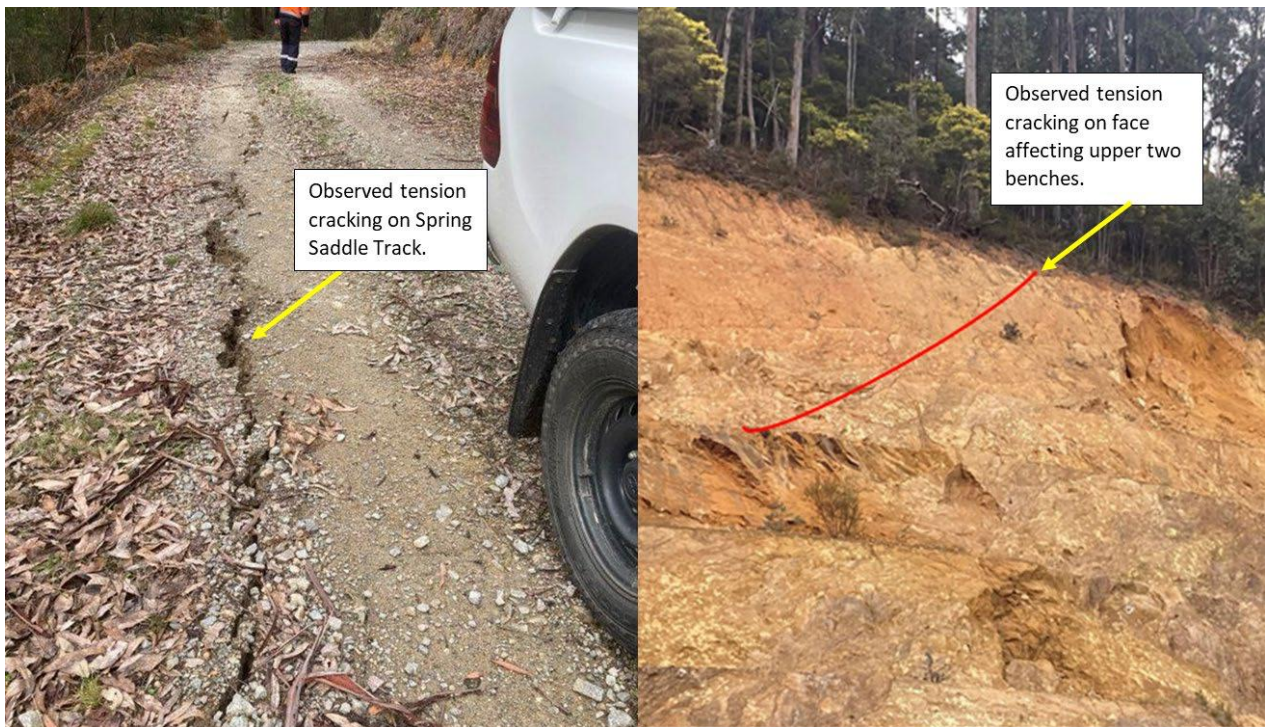
Figure 3: Left: Cracking observed on Spring Saddle Track, 28 September 2022. Right: Cracking observed in face of batter, 5 October 2022

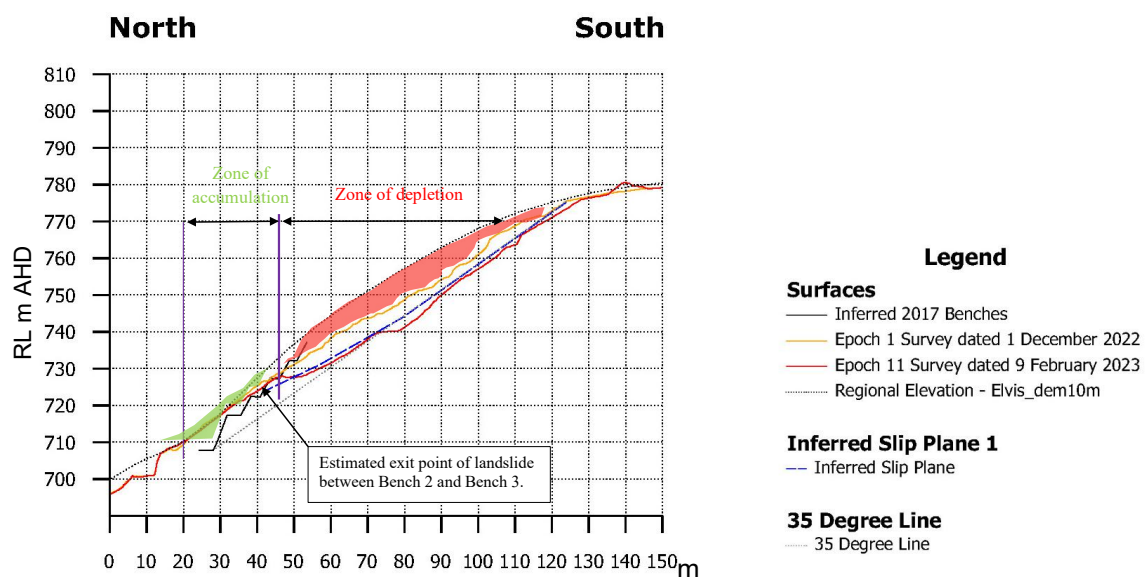
Comparison between LiDAR survey acquired before and after the landslide indicated a zone of soil depletion upslope of Bench 2 where material has detached and a zone of soil accumulation, where material has been deposited downslope of Bench 2. This is illustrated in the cross section in Figure 4. The location and geometry of the slip surface could be estimated through the survey comparison. Note that some material mobilised by the landslide was retained in the source area due to incomplete transportation to the zone of accumulation.

Figure 4: Indication of zones of accumulation and depletion associated with the October 2022 landslide

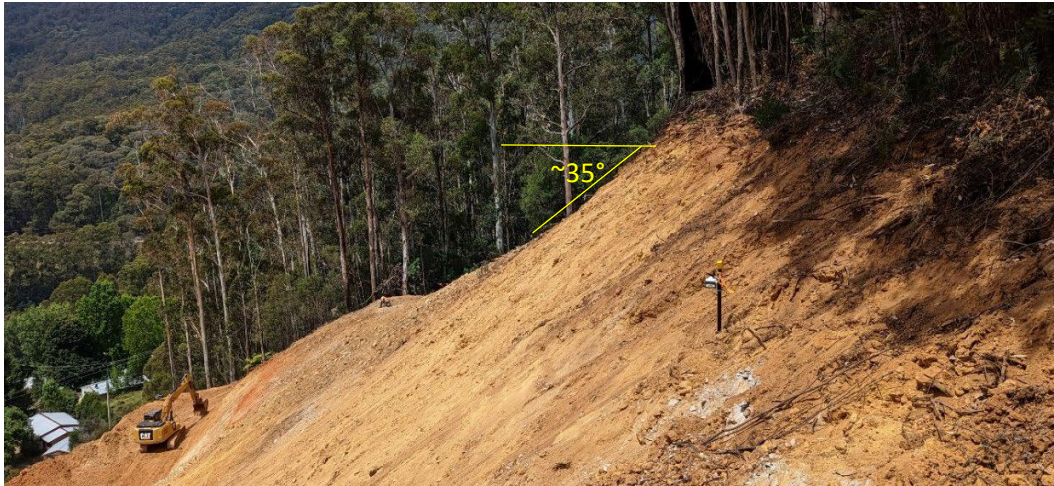
In early January 2023, debris clearance works sought to cut the slope bank to the landslide plane by removing the loose debris. Observations of the cleared surface indicate that the landslide plane was relatively shallow, with an angle of about 35° from the horizontal as indicated in Figure 5 and as confirmed by LiDAR and photogrammetry survey.

Figure 5: Crest of landslide, 12 January 2023 taken from Spring Saddle Track. Excavation has cut back to in situ material.

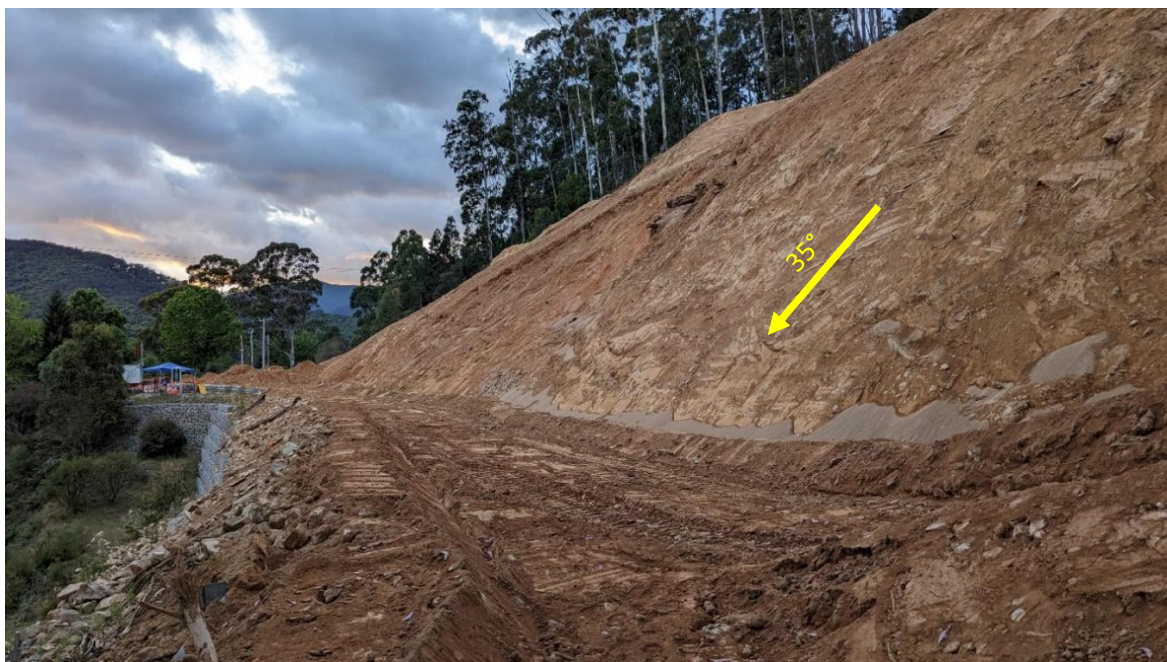
On 18 January 2023, in response to heavy rainfall (24 mm recorded at Falls Creek over the hours preceding the event), a crack opened within a batter slope about 10 m below the crest of the cutting made by the clearance works. Subsequent photogrammetry survey indicates the extent of the cracking and that it occurred on a slope of about 36° to 37° and regressed back to an angle of about 35° . Rills and gullies formed due to softening and erosion of the soils (Figure 8). Observations consistently indicated that where landsliding had occurred, it had occurred on sloping ground steeper than 35° , as measured from the horizontal and regressed back to 35° . This angle is consistent with the angle of repose for the debris at the base of the slope and suggested a friction angle within the soils of about 35° (Figure 6). The geomorphic evidence was consistent with triaxial evidence subsequently obtained.

Figure 6: Loose debris at toe of slope, 13 February 2023

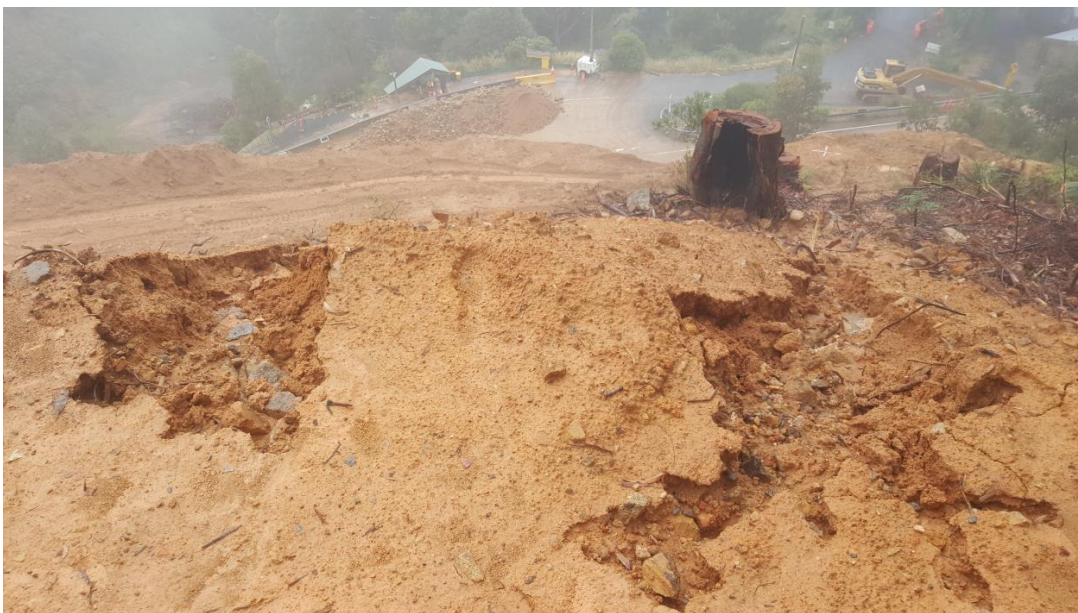
- Triaxial testing indicated an internal angle of friction consistently between 33° and 35°, consistent with the geomorphic evidence.
- Pinhole dispersion tests indicated the soils to be ‘erosion resistant’ whereas the Emerson class tests found the compacted material to be Class 5, moderately dispersive. This is consistent with the observations of gully erosion after heavy rains (Figure 8) and loss of trafficability, noting that rapid drying (within 24 hours) and return to trafficable conditions was observed.

Figure 8: Gully erosion after heavy rain, 18 January 2023

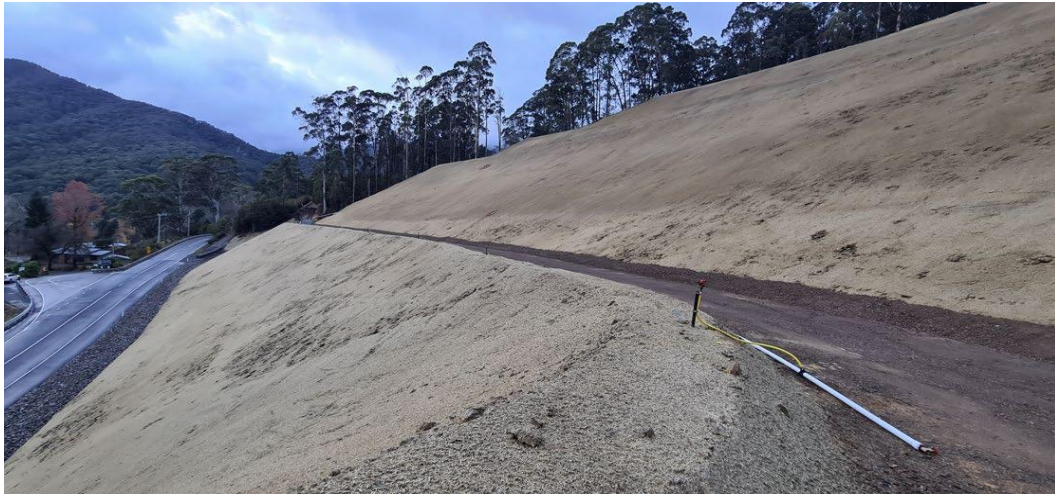
Figure 9: Far field view of remediated slope (bench 10 m wide)

- Providing 10 m wide benches to prevent debris reaching the road in the event there were to be instability on a batter slope. The overall slope angle was 27° and based on Equation 1 is estimated to have a factor of safety of about 1.4 under conditions where suction stresses are lost. The batter slopes themselves had a factor of safety approaching 1 under conditions where suction stresses were lost, necessitating the need to provide the benches to prevent landslides arising on the batters from reaching the road.

- Preserving the natural soil structure as far as practical. No fill was placed as part of the landslide remediation.
- Revegetating the slope using a mix of native vegetation to help preserve soil suctions.

- Providing bench drains to direct surface water off the landslide as efficiently as possible.
- Providing access tracks to help reduce surface water infiltration and to allow future slope maintenance such as clearing drains, removing debris and maintaining vegetative cover.

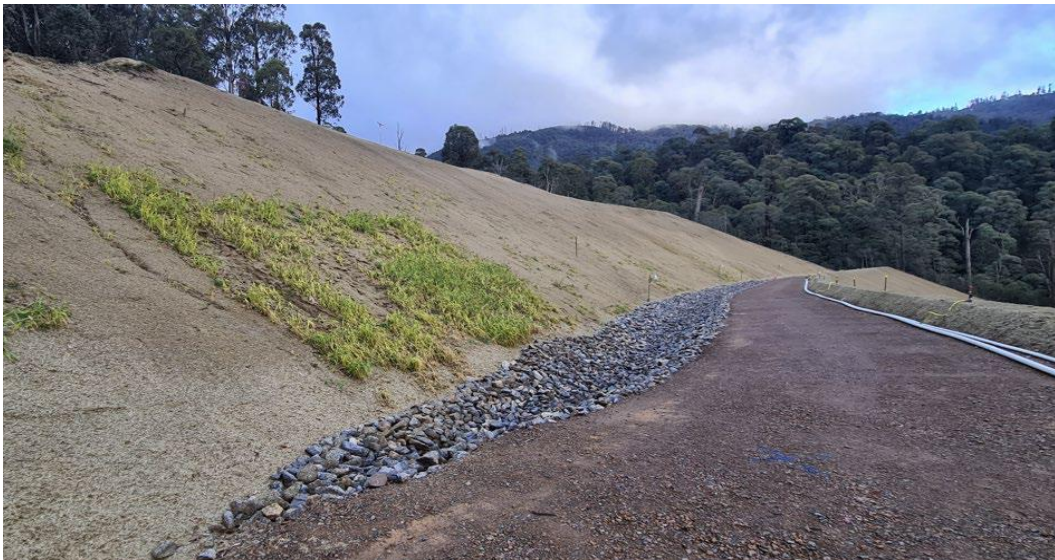
Figure 10: View along completed bench (bench 10 m wide)

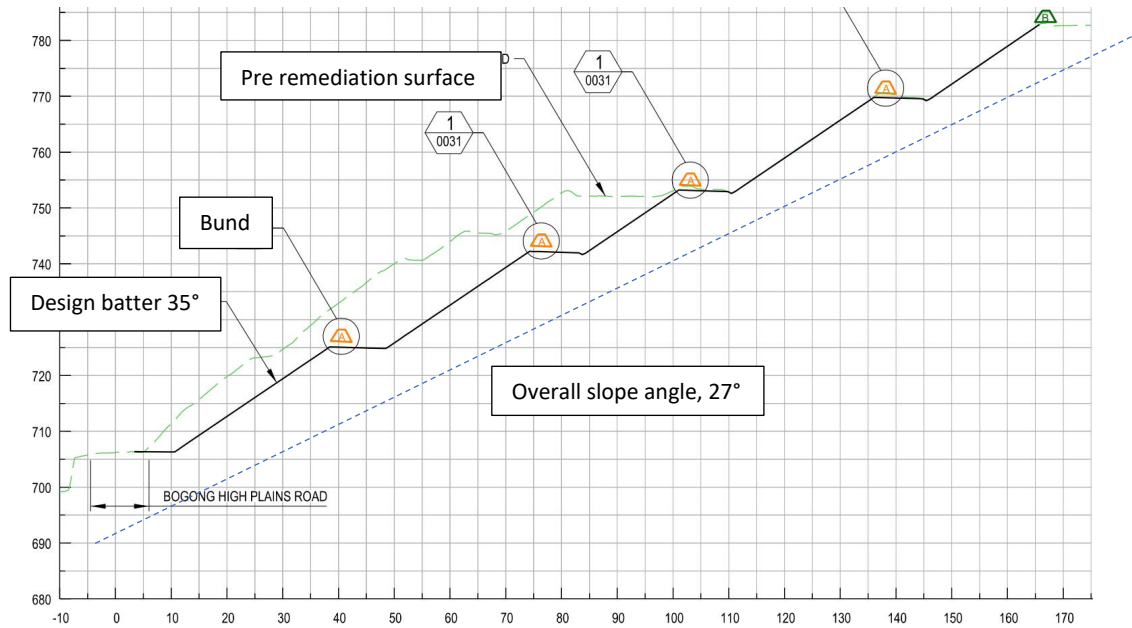
Figure 11: Typical cross section through remediated landslide (scale in m)
