WEST CUT TAILINGS DAM

G J HUNTER

D J DOUGLAS & PARTNERS PTY LTD, NEWCASTLE

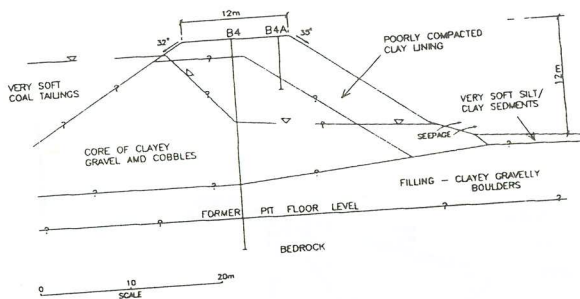
Figure 2: Section Through the Existing Embankment

The geotechnical investigation for the main embankment comprised the drilling of several bores within the embankment and some probing downstream of the embankment. Figure 2 is a section through the deepest point of the main embankment showing the measured geometry and interpolated subsurface conditions.

- The coal tailings were 'very soft' with a high proportion of highly plastic montmorillonitic clay fines.
- The downstream capping layer was a poorly compacted clayey sand/sandy clay material with a permeability estimated, by in situ testing, at 10^{-6} metres/second.
- The main core of the embankment comprised a poorly compacted granular material in a matrix of sand, silt and clay. The permeability of this stratum was considered to be relatively high as a result of water losses observed during drilling.
- Cobbles and boulders were encountered below 16 metres depth to the old pit floor level (20 metres).
- A layer of 'very soft' silt/clay sediments, 0.5 to 2 metres in thickness, underlain by boulders at the downstream toe within the deepest section of the embankment.

The phreatic water surface shown in Figure 2 was based on the following observations:

A stability analysis was carried out for the main embankment using the computer program XSLOPE; a two dimensional interactive slope stability program. The results of the analysis indicated that the existing embankment was marginally stable with the most likely failure mode being a slip failure in the downstream capping layer. An elevated phreatic surface in the embankment would most likely result in a slope failure.

It was recommended that the embankment be remediated as a result of its marginal stability and poor design.

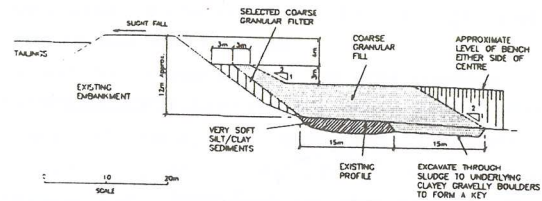
Figure 3: Proposed Remediation Design

It was considered that the very soft nature of the tailings and existing downstream stability problems precluded the use of the upstream construction method for raising the embankment. Therefore, the design for remediation and future augmentation suggested was by downstream construction. Figure 3 shows the proposed remediation design for the embankment.

- construction of a downstream berm consisting of granular waste rock filling won from the nearby stockpiles. The higher permeability of the granular filling in relation to the existing downstream clay capping layer would allow for control of the phreatic surface.

- the soft sediments directly at the toe of the embankment were left in place to avoid potential destabilisation of the embankment and possible risk to personnel working in this area during construction.

- removal of the soft sediments away from the downstream toe of the embankment and replacement with granular filling to achieve the proposed stability constraint.

- construction of a filter zone between the existing downstream capping layer and coarse granular fill to minimise the transportation of clay fines from the capping layer.

- reshaping of the crest such that rainwater would drain toward the tailings instead of down the downstream face of the embankment.

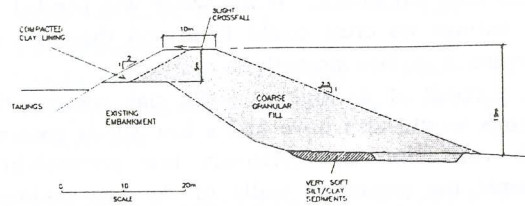
Figure 5: Augmented Embankment Design

The design for augmentation of the embankment was carried out at the same time as the design for remediation taking into account the aforementioned aspects of the site conditions and design considerations. Changes to the earlier design were the flattening of the downstream batter slope and omission of the filter zone. The augmented embankment design proposed is shown on Figure 5 and comprised the following:

- raising of the crest level a height of 5 metres;
- a 5 metre wide compacted clay lining on the upstream shoulder constructed at a batter slope of 2H to 1V;
- a 10 metre wide crest as required by the client;
- bulk granular waste rock filling in the main body of the embankment.
