Geotechnical considerations following a major haul road collapse Paddington Goldmine, Western Australia

John F. Kennedy
Soil & Rock Engineering Pty Ltd

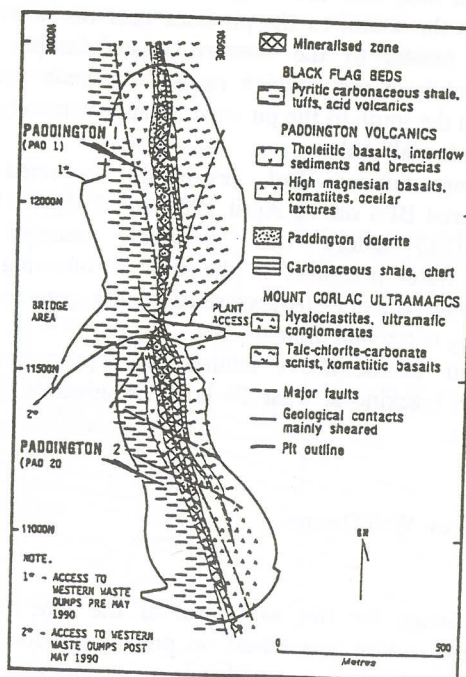
Figure 1: GENERALISED GEOLOGY OF THE PADDINGTON MINE AREA

The geology of Pad1, and an outline of the pit, is presented on Figure 1. The ore in Pad1 is hosted in the Paddington Volcanics, while the BFS occur in the west wall and the Mount Corlac Ultramafics occur in the east wall of the Pad1 pit. A brief summary of the

Failure did not continue to the south because the west wall merges with the south wall in that area. To the north of the failed area the strike of the wall swings 20° to the east, thus obliquely cross cutting foliation, resulting in lower potential for toppling. The presence of the basalt in that area also provides a buttress providing wall support (Note Figures 1 and 2).

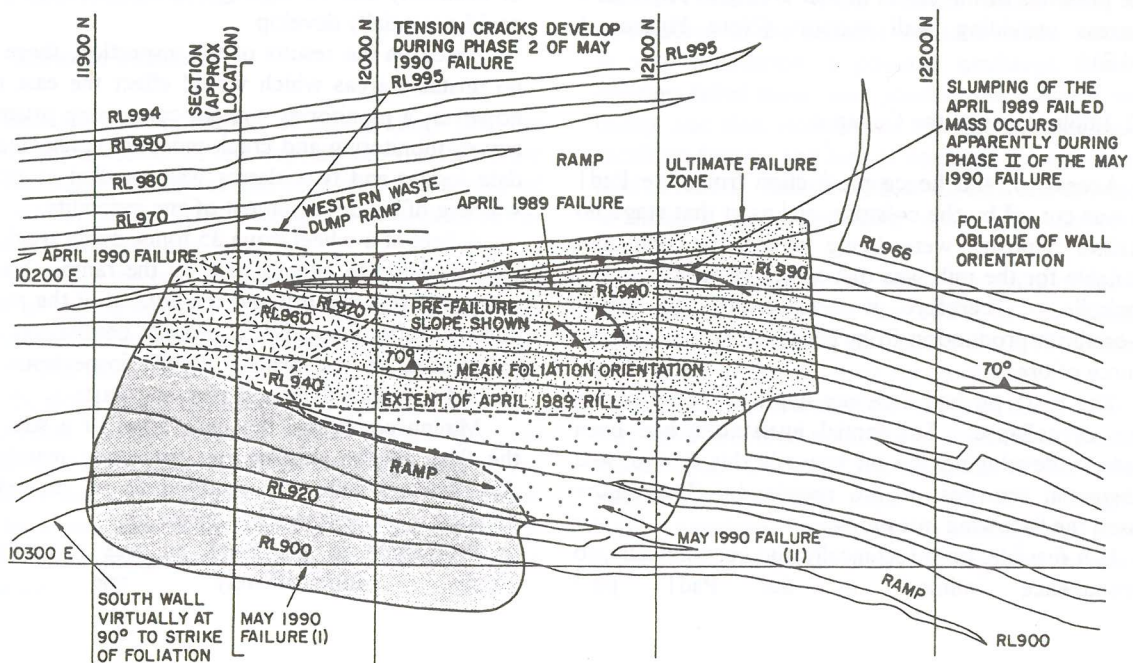
FIGURE 2. PLAN OF COLLAPSED WALL SHOWING EXTENT OF VARIOUS FAILURES

A major wall collapse occurred on the west wall of the Pad1 pit at approximately 8.35am on 8 May 1990. The failure began in the relatively fresh rock, which was intensively supported between the haul road and the pit floor and including the haul road, over a strike length of around 150m. Despite regular bench inspections, no tension cracking prior to the event was observed. Failure appeared to be initiated in the south, possibly by a small wedge or sliding failure at around 920mRL which resulted in loss of confinement in that area and overloading of the adjacent support, causing a chain reaction of cable bolt failures and rapid propagation of the failure to the north.

Less than 5 minutes after this first event, the fresh BFS above the haul road also failed by toppling, and slumping occurred in the pre-existing failed mass. Tension cracks opened up across the waste dump haul road.

The extent of the failure and the phases of the failure are outlined on Figure 2.

The first phase of the failure, which was a block flexure toppling failure, as defined by Hoek and Bray (1981), occurred independently of the April 1993 failure described in Section 2.2. The second phase of the failure was an extension of the first phase and may also have had elements of either a slide toe or slide base toppling, as defined by Hoek and Bray (1981). The second phase was triggered by the first phase, but may also have been influenced by surcharge loading.

Access to the base of the pit was regained by a cut back of the failed area. The design of the cut back comprised unbenched slopes separated by the haul road. The slope above the haul road was cut at 35° and the slope below the haul road was cut at 38°.

Access to the western waste dumps was re-established via a ramp cut from the bridge area at the southern end of the pit, to the west. Waste from the cut back was also dumped in a previously mined out area of the bridge, resulting in very short haulage distances.

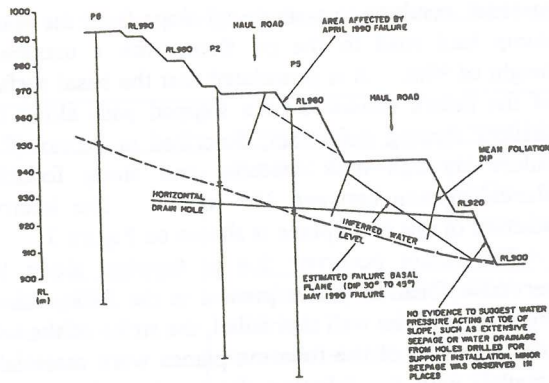
FIGURE 3. SECTION THROUGH COLLAPSED WALL, PAD 1

Slope depressurisation/dewatering was achieved utilising horizontal drainholes up to and over 100m in length. Horizontal drainholes were drilled into the wall by exploration drilling rigs at an angle of approximately +5°. Groundwater monitoring utilising simple standpipe piezometers indicated that the horizontal drainholes were successfully draining the slopes (Figure 3.)

material, resulting in a single rill slope from the waste dump haul road to the pit floor, with a maximum height of 90m. It is postulated that the basal surface of the failure consisted of a stepped path along the shallow dipping defect set, described in Section 2.1, failure through rock material and along foliation planes, dipping between 30° to 45° . The inferred position of this basal plane is shown on Figure 3.

Groundwater pressure was not considered to be related with the failure. (Note Figure 3).
