Flexible Solutions in Flexible Ground, Te Ngaere Bay Slip Repair

Tony Davies (MSc) Senior Engineering Geologist
GHD Ltd, Auckland, New Zealand

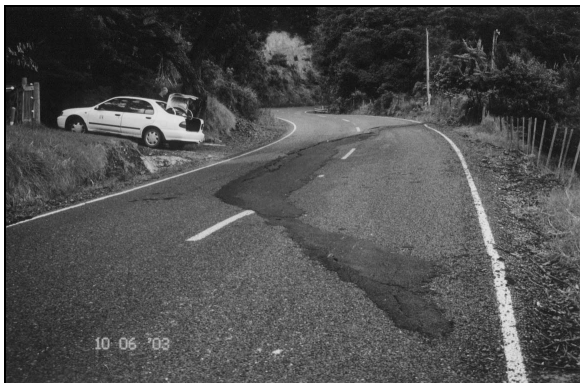
On Thursday 5 June 2003 a large crack appeared in Wainui Road above Te Ngaere Bay (Photo 1). The crack was initially sealed but continued to open up. By the 10th of June the road had subsided to the extent, there was difficulty in traffic traversing the area.

Photo 1. Head Scarp of Slip on evening of 10 June 2003

The failure affected a 25m long section of the road (Figure 1). The failure was defined by several cracks extending across the road. The cracks had vertical displacements of up to 200mm. At the location of the failure the road appeared to have been formed on a fill embankment.

The failure below the road appears to have occurred as a result of saturation of the fill due to an extreme weather event resulting in elevated porewater pressures along the fill/natural ground boundary resulting in instability.

The remedial solution adopted was a geogrid reinforced fill in conjunction with deep drainage. Although reinforced walls were rarely used on the Far North Network, from experience, it was known to be a very practical and flexible solution that could be easily modified during construction without huge cost increases.

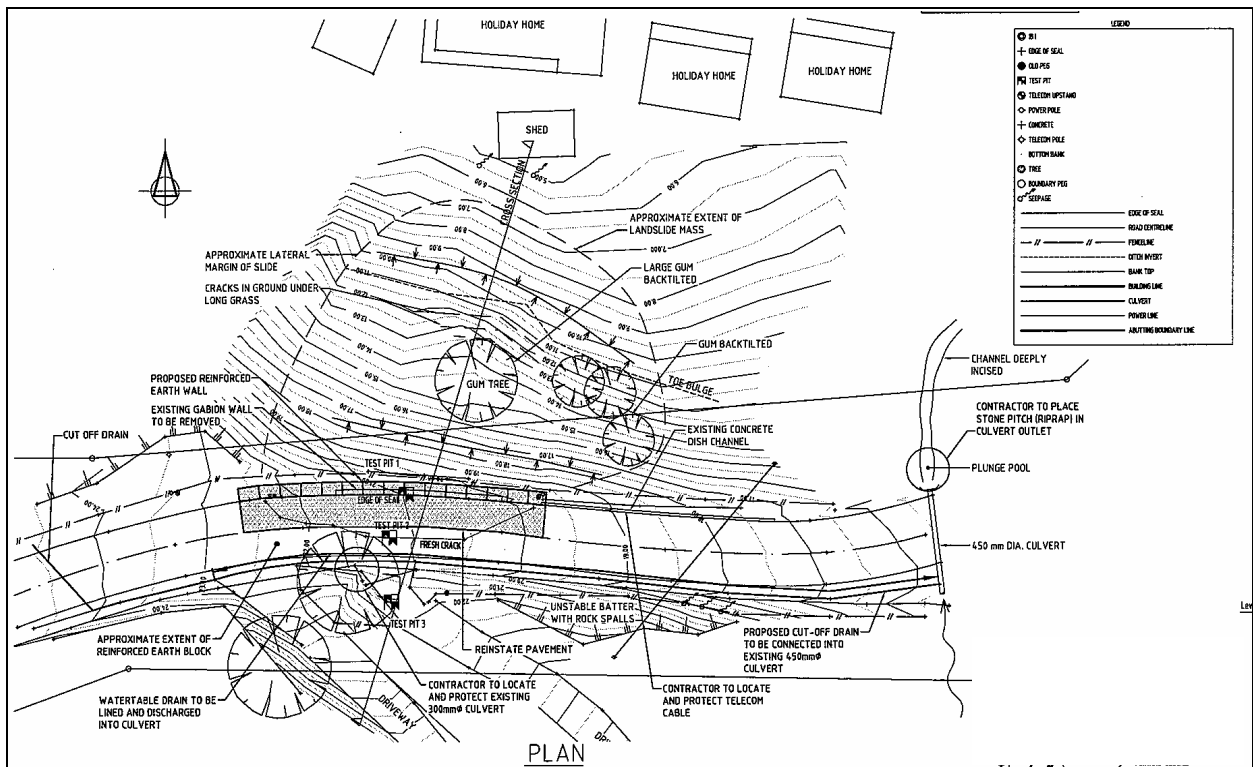
Figure 1. Site Plan

Ground conditions were immediately assessed by 3 shallow machine-excavated testpits. Due to the remote location and urgency, the investigations were undertaken using a small 2-ton excavator with a 3m reach. Investigations locations are shown on the Site Plan, Figure 1. Subsurface conditions are summarised on the section (Figure 2).

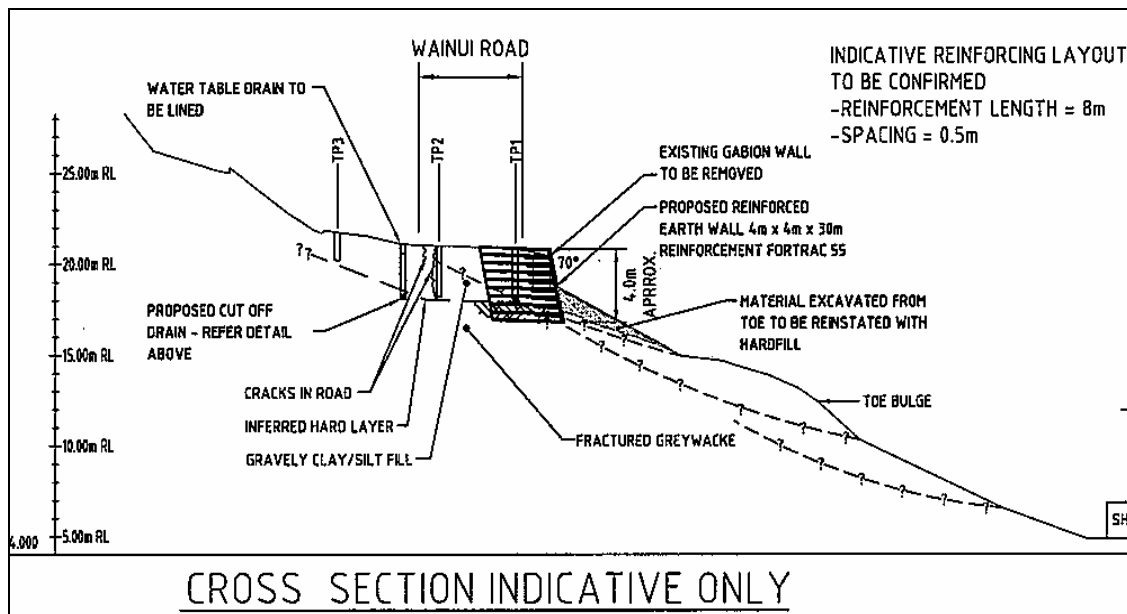
Figure 2. Section

The test pits encountered mixed, loose, wet, fill underlain by an apparent hard layer at least 2.8 meters down under most of the roadway width. After discussions with local contractors, it was revealed that the site used to be a gully where uncontrolled fill from local road widening projects had been dumped for many years.

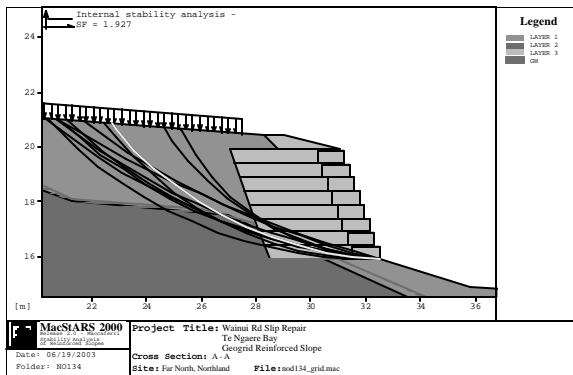
Figure 3. Macstars Reinforced Wall Analysis.

Maccaferri software Macstars 2000 was used to design the wall (Figure 3). Due to the limited subsurface investigations undertaken and the possibility ground conditions would differ from those assumed several different wall heights were analysed.

The reinforced earth wall would involve removal of the weak fill material underlying the road and replaced with compacted hardfill with a Fotrac 55 geogrid wraparound. The existing fill material was not reused due to high organic and clay content. The use of a locally available hardfill resulted in a higher strength fill, easy construction, lesser fill testing and monitoring requirements.

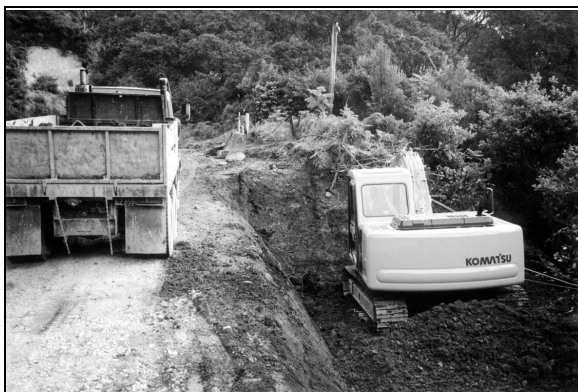
Photo 3. One lane remained open during construction.

A major design consideration was to maintain at least one lane of traffic during construction, as there were no alternative detour routes close to the site.

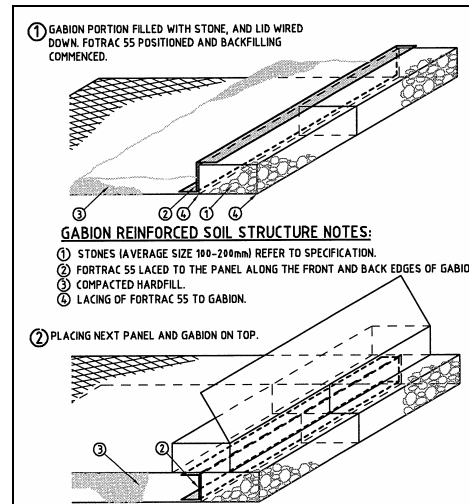
Figure 4. Gabion Facing

The design was initially modified due to a shortage of Fortrac 55 and Terramesh was substituted with 0.5m high gabion baskets used as the facing.

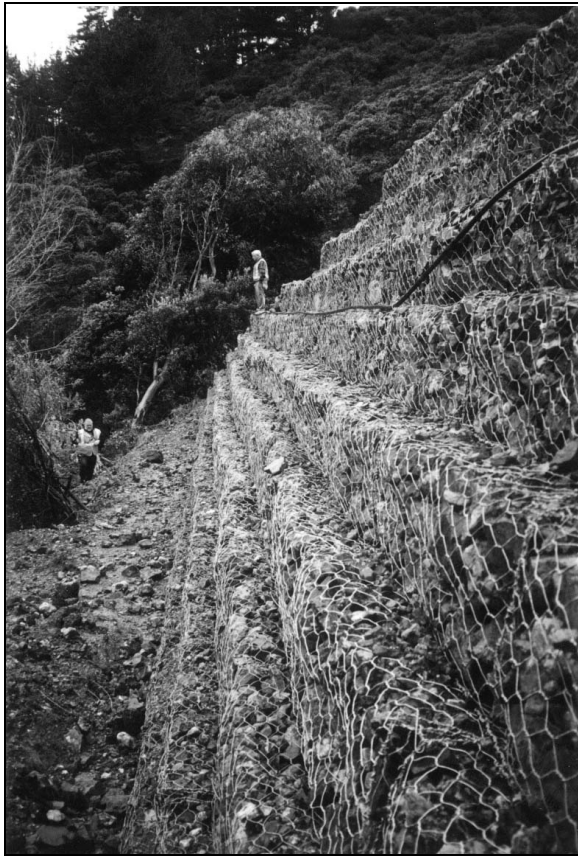
Photo 4. Completed wall

The design was modified a second time during construction when the assumed hard layer identified during the initial investigations at 2.8m below road level was discovered to be a layer of hardfill possibly associated with an old road.

Competent founding material was found to be a further 3m below this old road level. This was not unexpected and additional wall designs had been undertaken for just such an eventuality. The wall height was raised to 4.5m high with a 2m hardfill foundation pad excavated under the base. Groundwater was encountered in the base of the excavation and subsoil drains installed.
