Slope Stabilisation-Site investigation, Design and Application of Deep Soil Mixing

Cristien Gani
BE , MEngSt.

Geotechnical Engineer, Sinclair Knight Merz Ltd, New Zealand

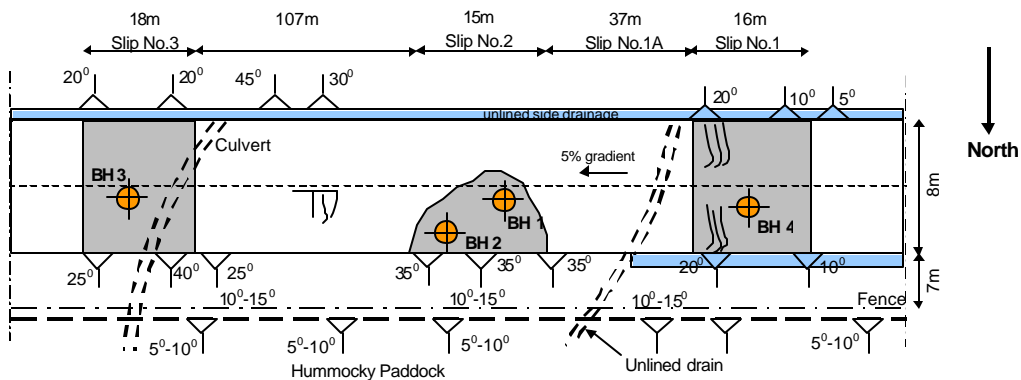
Figure 3. The geomorphology sketch of the site including borehole locations.

Previous slope failures have been re-surfaced at Slip No.1. Cracks that are perpendicular to the road are visible. The slip follows the slope of the road (approximately 5% gradient) for a distance of about 16m. The measured slope angle of the southern embankment batter ranges between 5° to 20° and the northern slopes are typically 10° to 20° .

Slip No.2 is about 37m downhill of the first slip. It is located on the eastbound carriageway and slightly encroaches into the westbound carriageway. An open crack is observed on the eastbound carriageway that starts at the edge of the road and extends to the centre line. This slip is approximately 15m long, and the embankment on the north is battered at approximately 35° . The measured slope angle below the embankment ranges between 10° and 15° .

Slip No.3 is approximately 107m downhill from Slip No.2. It straddles the eastbound and westbound carriageways. An open crack and minor settlement is visible within the westbound carriageway. The length of the slip is approximately 18m with embankment slope angles ranging between 20° and 40° . The measured slope angle below the embankment ranges between 10° and 15° .

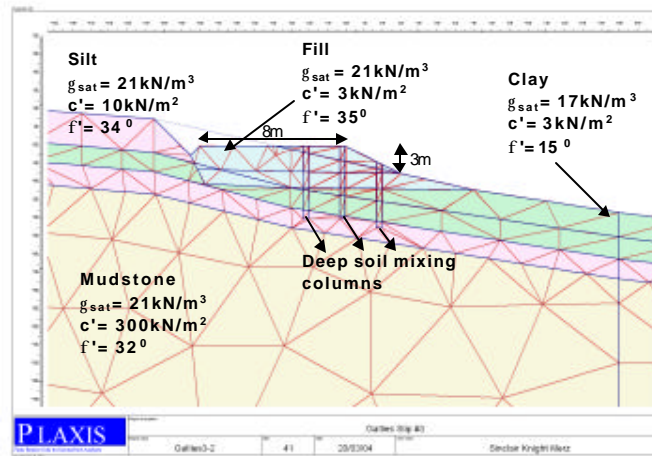
Figure 4. The cross section of slip (PLAXIS analysis model) and geotechnical parameters used on the analysis

Slip No.3 has occurred in a road embankment that has been constructed in a cut and fill slope. The rotational movement is unlikely to be the primary slip mechanism as no evidence of toe heave was observed. The depth of the fill material found indicates that settlement and slippage have been occurring for some time, and the road fill was probably re-graded and re-surfaced on more than one occasion in the past. These previous repair works has probably resulted in increasing the weight of embankment which causes further slippage. The on going creep movement reduces the strength of the soils and impacts on the bearing capacity of the subgrade.

High groundwater during wet periods and a lack of adequate drainage are likely to have contributed to the slip occurrence. Further, any leakage from the culvert crossing to the north of the carriageway would have contributed to destabilising the slope.

The pavement crack profile and geomorphology suggest that there is significant lateral creep movement towards the farmland, while some longitudinal movement is likely to be occurring as well. The slope angle to the north of the embankment ranges between 10° and 15° , which is sufficiently large to induce creep movement in the Northland Allochthon materials.

Once the actual slope failure is successfully simulated, deep soil mixing columns are introduced into the model. The columns are modelled as soil using volume elements. Properties of the composite material (cement/lime soil mixture)

The columns are positioned in such a way that a block of improved soil is created in the pavement and the slope below the road. This area is expected to remain stable even if further slip movement occurs below this area, so that the road structure will remain intact. The analyses are performed for normal groundwater conditions (expected groundwater during the winter months) and extreme events (full saturation of the slope and recharge-rapid drawdown analysis). The design factor of safety of 1.3 is required under the normal groundwater condition and 1.1 under the extreme events.

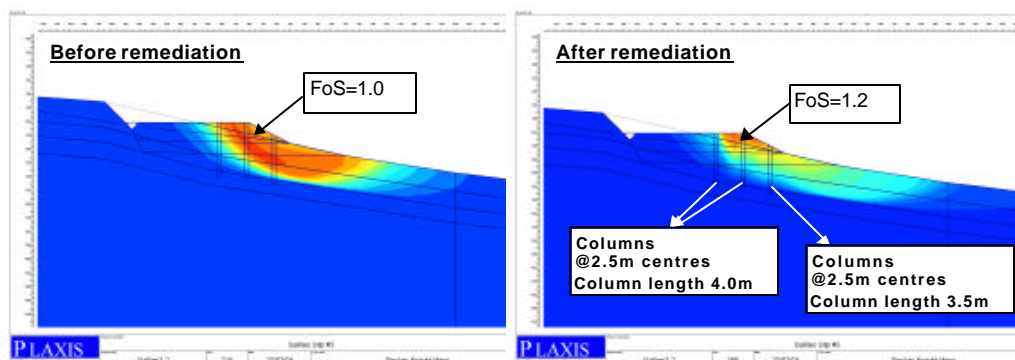
Figure 5. Slip mechanism and factor of safety before and after remediation – extreme groundwater conditions.

In this case, the analyses indicated that three rows of columns spaced at 2.5m were required to achieve satisfactory factors of safety under both groundwater conditions. The column length varies from 3.5m to 4.5m to maximise the columns' resistance to slope failure. The actual length of the columns are verified during construction. Figure 5 illustrates the simulated slip mechanism before and after the remediation under the extreme events. The calculated factors of safety are shown in Table 1.

The recommended column layout is shown on Figure 5 and Figure 6. The analysis also indicates that the columns are unlikely to fail by bending and shear under normal and extreme conditions.
