# Gabion Baskets: An Effective Means of Erosion Protection

Melanie Henry, Tonkin & Taylor Ltd

Takarau Gorge Road and Makara Road, located to the west of Wellington New Zealand are subject to regular erosion damage from adjoining streams.

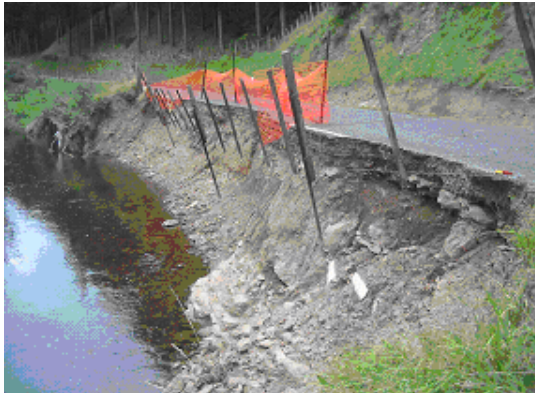
Below the roadway unprotected stream banks are often eroded during flood events due to the flow patterns of the respective streams. The erosion leads to localised slipping and the loss of sections of carriageway. Photograph 1 shows a slip below the road that has been caused by the undercutting of the bank.

**Photograph 1** Slip below road caused by undercutting of stream bank.

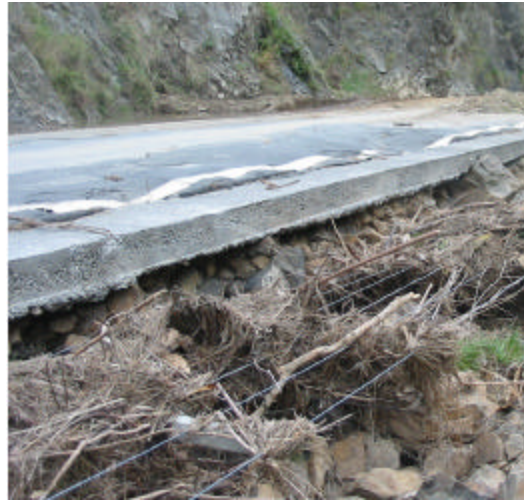
Internal erosion can occur due to the migration of fine material with floodwaters. This can eventually cause severe damage to the pavement as illustrated in Photograph 2.

**Photograph 2** Damage to pavement due to the migration of fine material.

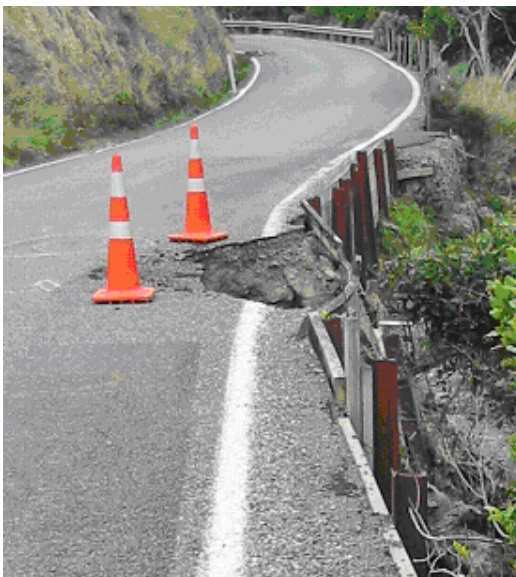
Photograph 3 shows a railway iron wall where localised scour has occurred beneath the wall. This has caused the backfill material to slump forming a hole. Localised scour can also occur at the end of the wall.

**Photograph 3** Undermined railway iron wall with loss of backfill material.

Based on the observed damage the design of pole walls need to consider the following:

- Potential scour depth to minimise the risk of undermining.
- Adequate founding depths for the poles.
- A geotextile filter fabric to limit the movement of fines.

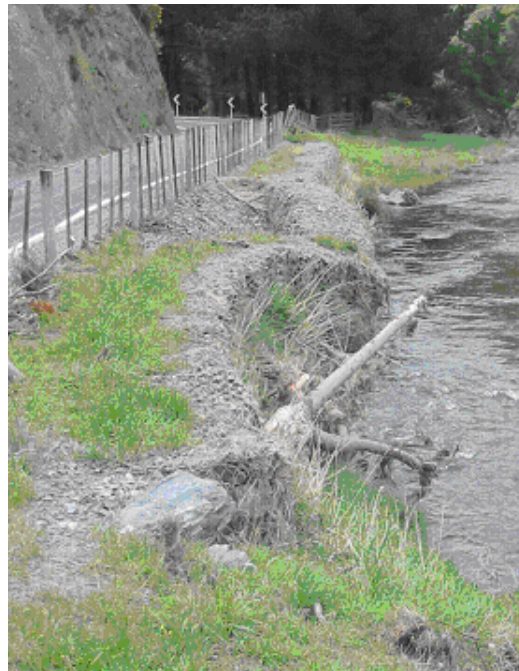
Despite this flexibility damage can occur to gabion walls during flood events. Photograph 4 shows a gabion wall that has been inadequately constructed. The wall was originally founded at streambed level. The stream has degraded, undermining a section of the wall and causing the wall to rotate. The design of gabion walls is discussed in the following section.

**Photograph 4** Gabion wall where the middle section has been undermined and rotated.

A hydrological assessment is required to assess flood levels and scour depths. In the case of Ohariu and Makara streams a scour depth of typically 1m has been assessed for design. To date gabion basket walls that have been embedded 1m below the

existing streambed level, or 0.5m below streambed level where the toe of the wall has been protected by a reno mattress, have been found to be adequate in large flood events.
