PHILIPPINES NATIONAL RAILWAY MAIN LINE SOUTH REVITALISATION PROJECT PHASE II

Tony Gourlay
Ove Arup & Partners, Sydney

A series of railway embankment slope stability failure located on the Main Line South between Gapo and Bongalon, 8 km to 10 km north of Legaspi City on the south-eastern corner of Luzon Island in the Philippines, was identified by Ove Arup & Partners in 1996. This paper describes the mechanism and reason for failure of one of the embankments (TP9383), the results of the ground investigation and the preliminary design of stabilising measures.

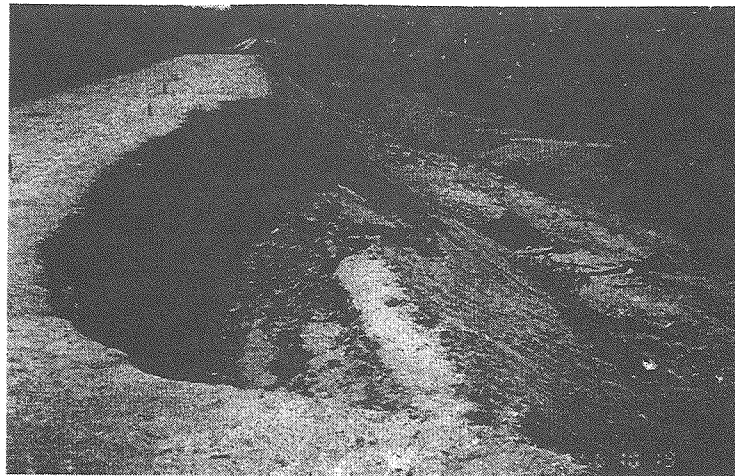
At the time of the site investigation (October 1996), the embankment had already slipped quite considerably. Measured displacements of up to 3 m (vertical) and 2 m (horizontal) were recorded at the back scarp of the failure surface at the top of the embankment (See Figure 1 below). Both vertical and horizontal displacements, as well as large open cracks, were observed down the batters of the failing embankment. A mound of soil was also observed at the toe of the embankment which probably represented the failed material from previous slips as well as this most recent failure. The length of the slip is approximately 22 m at the top of the embankment which then fans out to a length of approximately 47 m at the toe of the embankment.

Figure 1 Photograph showing backscarp of embankment failure

Photographs of the original embankment prior to reconstruction indicate that there were three distinct slips which had occurred on the eastern side of the embankment in the past. The locations of these old slips coincide quite well with the locations of the current slips. This would tend to suggest that the newest slips were simply a reactivation of the old ones. It is understood that the remedial works involved excavation and reconstruction of the upper parts of the embankment, but did not extend to the location, excavation and replacement of the slip plane itself

The stabilising option adopted by the Philippines National Railway comprised constructing a bridge over the slip area. This option was selected because it was the most cost effective and could be completed within the project time scale.

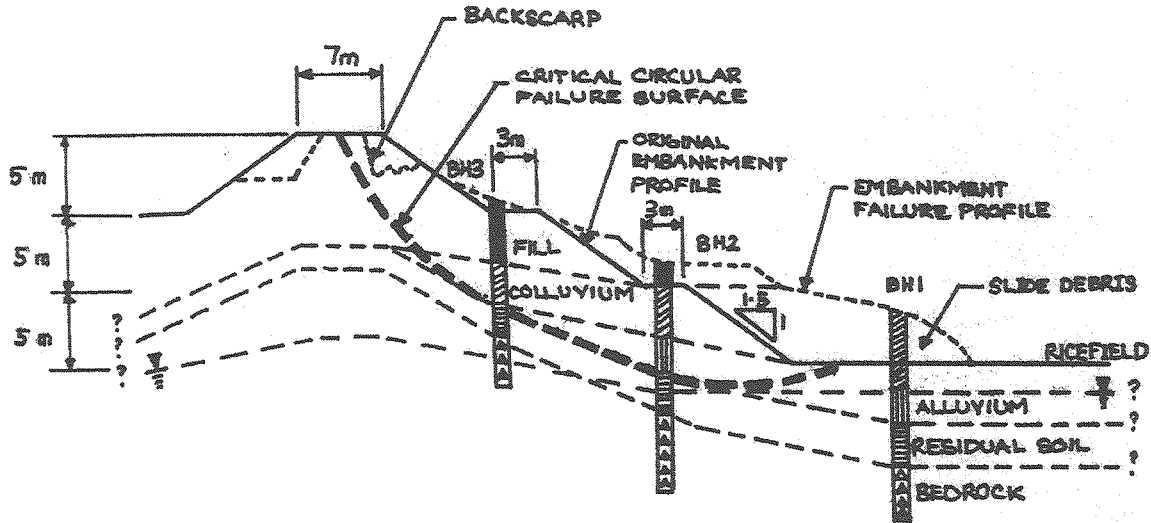
The subsurface profile adopted for analysis is shown in Figure 2. The profile generally comprised up to 9 m of fill overlying 3 m to 4m of soft colluvium (medium-high plasticity silty CLAY) which in turn overlies 2.5 m to 4 m of soft flood plain alluvium (medium-high plasticity silty CLAY) near the toe of the embankment.

The colluvium and alluvium are located above a layer of residual soil, relatively consistent in depth, overlying a fine grained igneous bedrock (Basalt & Dacite). The bedrock appeared to rise toward the top of the embankment, suggesting the embankment was originally constructed on top of a rock outcrop carved by the action of a meandering river.

Figure 2 Embankment Cross Section
