RESIDENTIAL DEVELOPMENT ON COASTAL CLIFFLINES

C.K. OLDHAM

HARRISON GRIERSON CONSULTANTS LTD
AUCKLAND, NEW ZEALAND

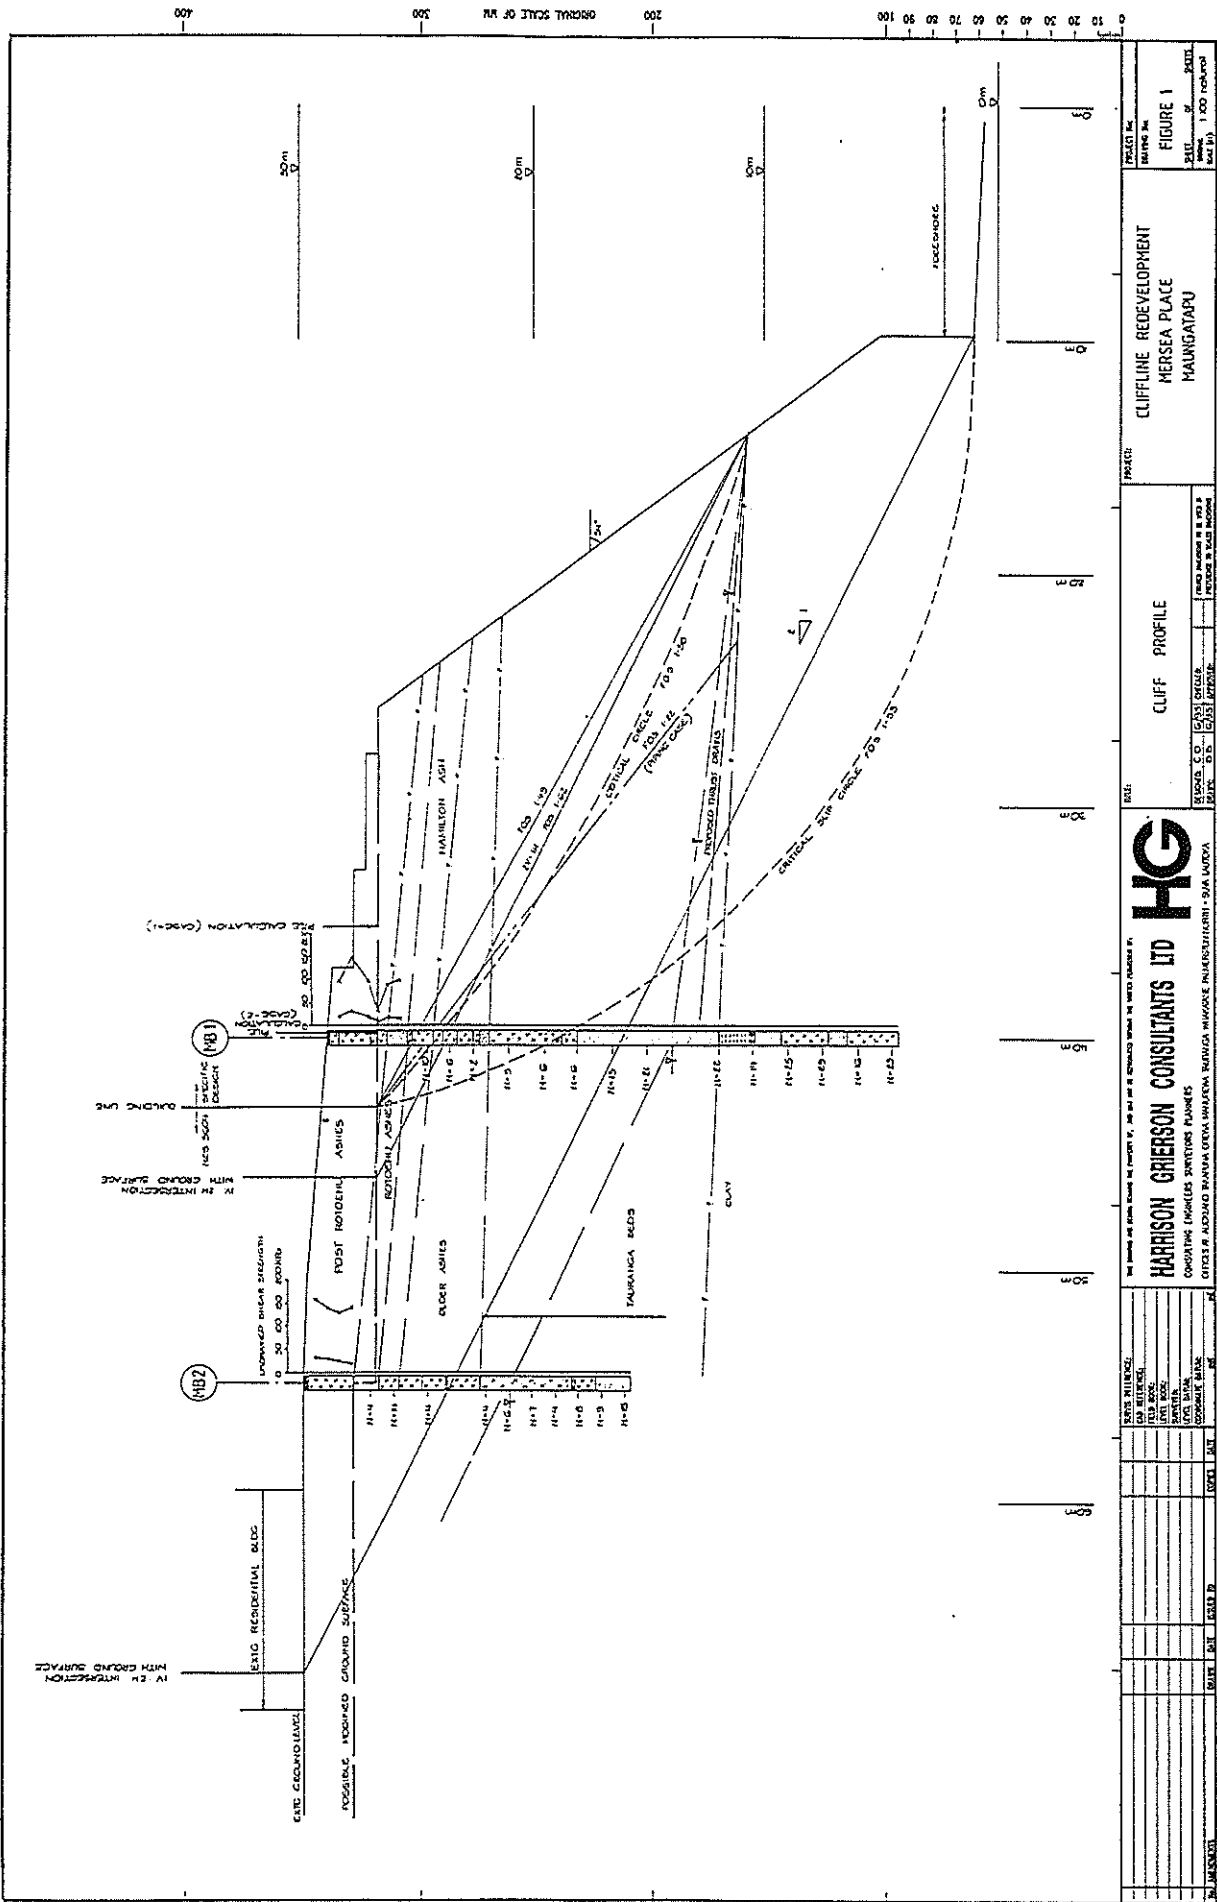
Figure 1: Cliff profile

Based on a visual inspection of the site and the data provided by the developer it was apparent that a significant part of the area to be redeveloped was located seaward of the nominal 2H:1V profile projected from the toe of the slope. It was therefore determined that the stability of the coastal slope required assessment to determine its influence on the proposed development at the site. The coastal slope geometry and a stratigraphic profile, through the cliff is shown on Figure 1.

A possible development option was to cut down the ground surface by 1.5m to 3m below existing as shown on Figure 1. Based on the revised parameters, existing groundwater conditions and the proposed modified ground surface it was determined that the existing cliff slope had a theoretical factor of safety of less than the minimum value of 1.5 required by the Local Authority. Various slip circles were analysed to determine the slip circle with a theoretical factor of safety of 1.5, which is plotted on Figure 1. The slip circle was further analysed for the case where cohesion equals zero under existing groundwater conditions which yielded a theoretical factor of safety(FOS) of 1.28.

It was determined that the critical slip circle with a back scarp located at the previous Recommended Building Line Limitation (RBLL) had a factor of safety of approximately 1.58. It was further determined that a 2H:1V line extending from the top of the clay layer at the cliff face intersected the proposed ground surface approximately 3m behind the RBLL, which had a factor of safety value of 1.62 for a planar failure and the existing ground water conditions. A planar failure surface from the clay layer at the cliff face extending to the RBLL location yielded a theoretical factor of safety value of 1.49 for the existing groundwater conditions.

By iteration the minimum theoretical factor of safety for a non circular failure was 1.22 for existing groundwater conditions assuming that a piping layer developed along the clay interface for a horizontal distance of 9m into the slope. The back scarp of the failure was located to be coincident with the RBLL determined in the original analysis. This value was considered to be satisfactory provided that groundwater levels are maintained at existing levels. It was therefore recommended that thrust drainage be installed at the site immediately above the clay layer to intercept any ground water seepages and to maintain the existing groundwater conditions. The various failure planes and the proposed thrust drains are shown on Figure 1.

Based on the above results it was considered that the original RBLL on the site had a satisfactory stability state provided that the groundwater level does not rise above the inferred existing levels and that piping erosion does not occur. The installation of appropriate drainage measures should maintain the ground water levels at the levels inferred to exist at the site in the long term. It was our opinion that horizontal drains thrust from the cliff face coincident with the top of the clay layer as shown on Figure 1, should provide sufficient drainage to maintain the existing ground water conditions. The critical slip failure mechanism assumes that piping develops along the clay surface. The installation of thrust drainage with suitable filter cloth should minimise the potential for piping erosion to occur.
