# DRAINAGE OF THE CAIRNMUIR LANDSLIDE, NEW ZEALAND

C. R. WATTS

Electricity Corporation of New Zealand, Clyde Hydro Group

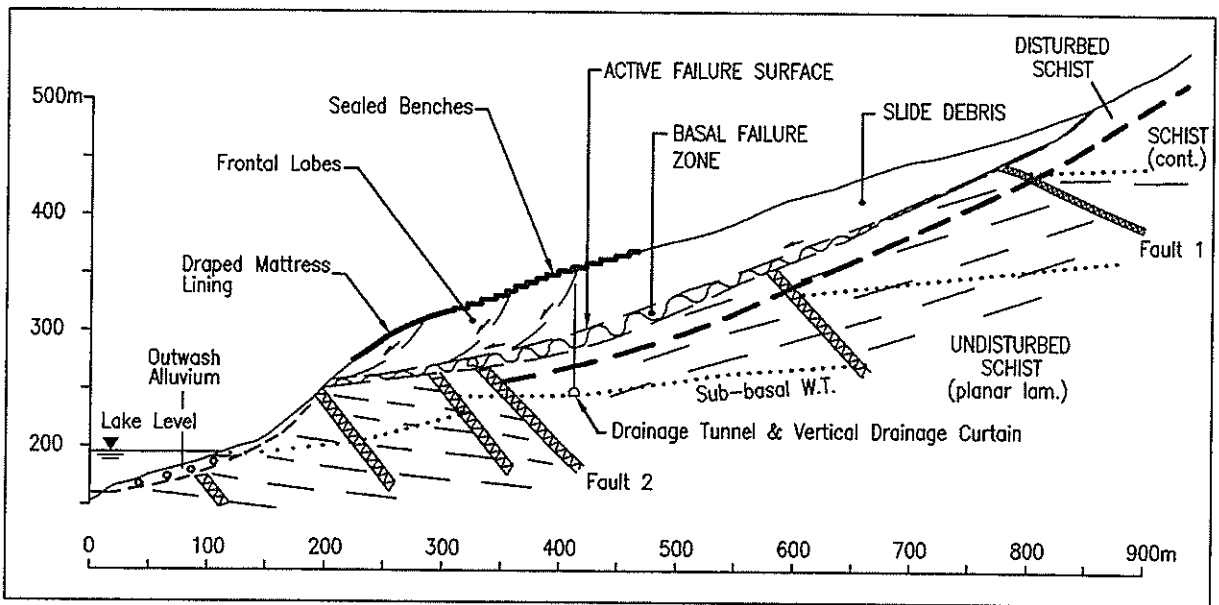
Figure 2. Typical cross section

The Active Segment, a 40-70m thick translational slide composed of schist debris, is 600m in length with an average width of 450m. The segment has an average slope angle of 20° which increases to more than 35° at the toe and head of the slide (Figure 2). The Active Segment occupies a generally deflated basin and fresh scarps (up to 1.5m in height) extend around its perimeter. Frontal Lobes at the toe of the slide are surrounded by a set of arcuate fresh scarps (up to 3m in height). Approximately 400 sinkholes were present over the surface of the Active Segment, generally associated with tension zones and formed in lines along active scarps.

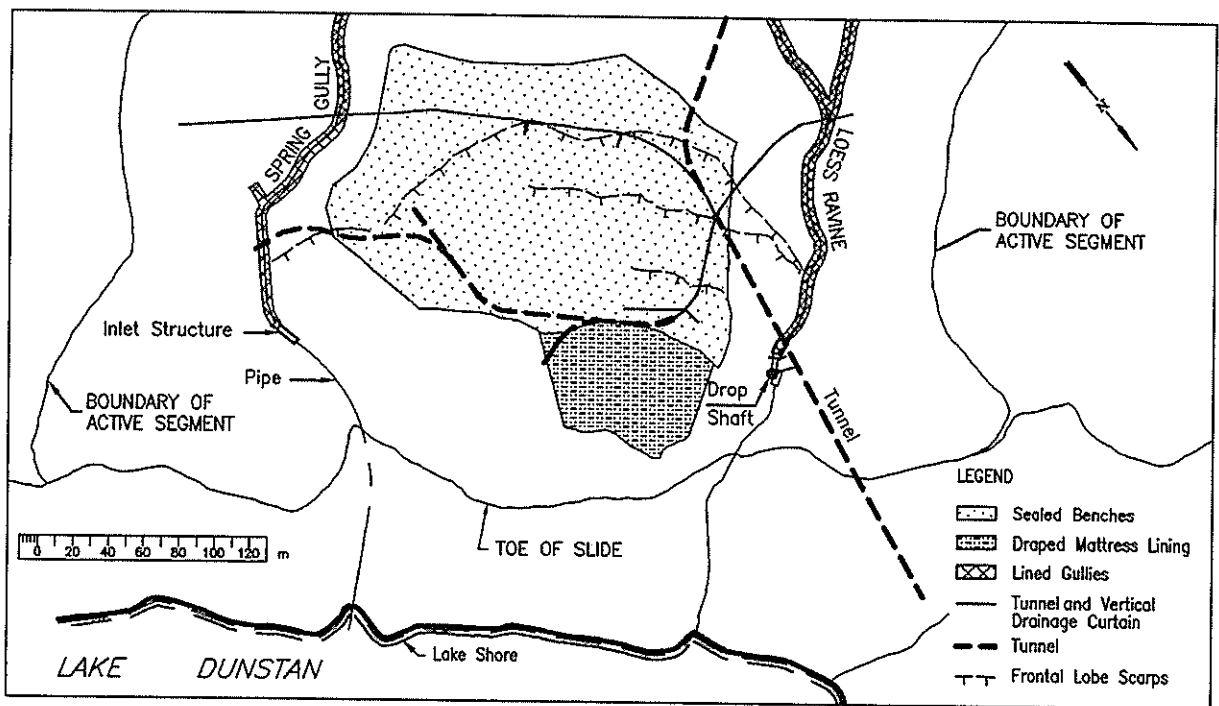
Figure 3. Plan of stabilisation measures

Two types of drilling have been used at Cairnmuir to drain the perched aquifers; “target” drilling implemented to drain specific targets and a “drainage curtain” installed from the sub-basal drives across the full width of the Active Segment just behind the Frontal Lobes (Figure 3). The curtain, consisting of 200 drains drilled at 5m centers and extending 15-30m through the AFS, was installed to intercept groundwater migrating downslope from the upper slide mass before it could influence the more active Frontal Lobes. Most of the drainholes produced only small flows of less than 1 l/min, but a limited number flowed initially at 50-150 l/min. All high initial flows reduced rapidly (2-14 days) also indicating that the compartments are relatively small.
