## Embankment Failures – Local Experiences

E. G. Maynard<sup>1</sup>, BE (Hons) Nat Res, MEM, GIPENZ

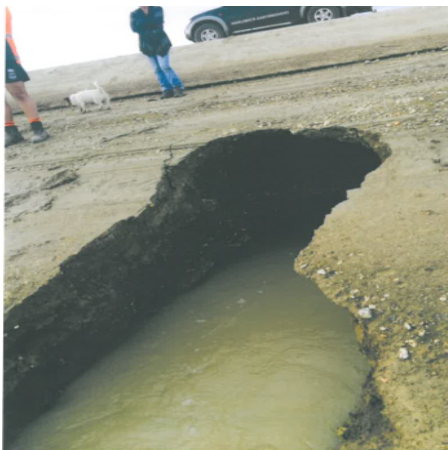
Figure 2.

*Figure 2. Case Study A – Foundation piping failure at downstream dam toe immediately post failure;  
Figure 3. Case Study B – Erosion of spillway throat and deposited sediment down plain post failure;  
Figure 4. Case Study C – Piping failure around conduit viewed from the downstream toe during failure;  
Figure 5. Case Study D – Crest overtopping during flood.*

### 3.1 Case Study A: Foundation Piping - DS0172

**Failure mechanism:** Seepage at the foundation contact leading to headward void migration and subsequent piping failure soon after first-filling. This is one of the most common form of distress on initial filling of a reservoir.

- Planar compaction surfaces with rare clumps of turf that would tend to facilitate piping
- Permeable gravel lenses providing an environment that readily transmits high pore water pressures at the foundation interface
- Sinkholes observed in the reservoir floor suggesting permeable gravel lenses do not meet filter compatibility with overlying silt

**Remediation:** Undertake engineering inspection of the stripped foundation, investigate the persistence of permeable strata at/near foundation level, reduce compaction thickness, utilize a sheepsfoot roller. A new keyway and additional shoulder material was formed on the upstream dam slope.

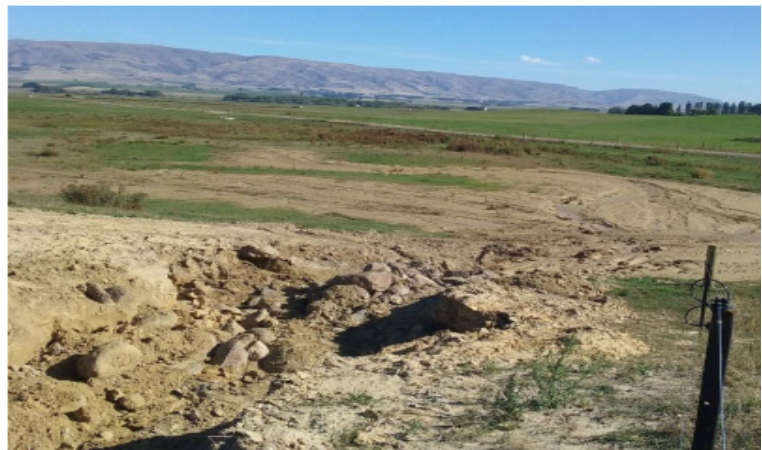
Figure 3.

### 3.2 Case Study B: Spillway Failure - DS0173A

**Failure mechanism:** Erosion of the spillway lining and part of the embankment during sustained rainfall of moderate intensity (20-30mm of rain over 24hrs).

- Incompatible liner materials, being coarse graded riprap overlying erosive/dispersive silt
- Coarse riprap tending to induce turbulence causing entrainment of finer soils
- Hydraulically steep spillway (embankment slope ~15-20°)
- Flows of damaging magnitude entering the reservoir from an external source, possibly from sidling runoff beyond the natural catchment conveyed into the reservoir via a water race

**Remediation:** A new spillway with riprap liner and geotextile underlay was formed into natural soil.

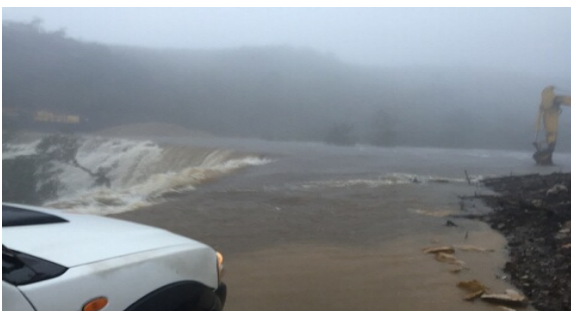
Figure 5.

### 3.4 Case Study D: Embankment Overtopping

**Failure mechanism:** A significant rain event overwhelmed three bypass culverts, causing water to build up behind the embankment resulting in subsequent crest overtopping and scour to the downstream slope.

- Hydraulically steep slope batters (embankment slope ~45°)
- Insufficient pipe strength resulting in at least one bypass culvert being crushed under the embankment weight
- Debris from upstream clogging the bypass culverts
- Significant rainfall, probably in excess of the design event expected for this structure

**Remediation:** The culverts were upgraded with stronger, larger pipes with debris screens. A new high-level spillway was provided at the true left abutment. Embankment slopes were eased.

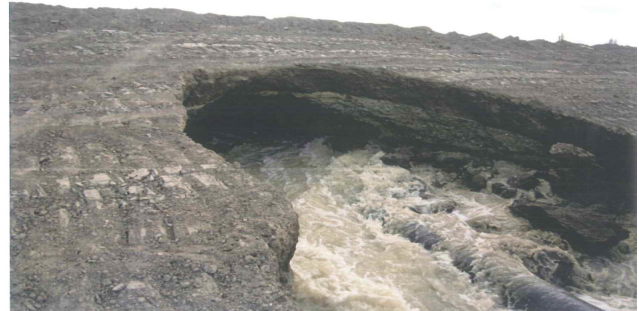
Figure 4.

### 3.3 Case Study C: Piping of the Conduit - DS0176

**Failure mechanism:** Piping of soils along the outside of the conduit caused by tractive hydraulic forces from the reservoir leading to erosion of the downstream toe and subsequent headward breach migration, i.e. FEMA's Failure Mode 3 (Federal Emergency Management Agency FEMA, 2005). Failure occurred shortly after first filling.

- Lack of provisions for the safe passage of seepage along the pipe without entraining fines
- Accounts from the contractor are of the inlet screen displacing laterally under high wind causing uplift, permitting water ingress along the conduit
- Trenching method and inability of compaction plant to suitably compact fill around the conduit
- Fill around the pipe being potentially dispersive and/or erosive
- Silty gravel layers near the foundation toe

**Remediation:** The pipe was re-laid with the inlet screen secured. A filter diaphragm and filter drain was installed for the downstream pipe section. New clayey silt was imported and compacted around the pipe by a small mechanical tamper.
