Seismically induced land damage on Whitewash Head, Christchurch, New Zealand

Charles. C. Mangos¹

¹Graduate Engineering Geologist, Infrastructure, Aurecon NZ, Unit 1, 150 Cavendish Road, Casebrook, Christchurch 8051, New Zealand, PO Box 1061, Christchurch 8140, New Zealand; email: Charles.mangos@aurecongroup.com

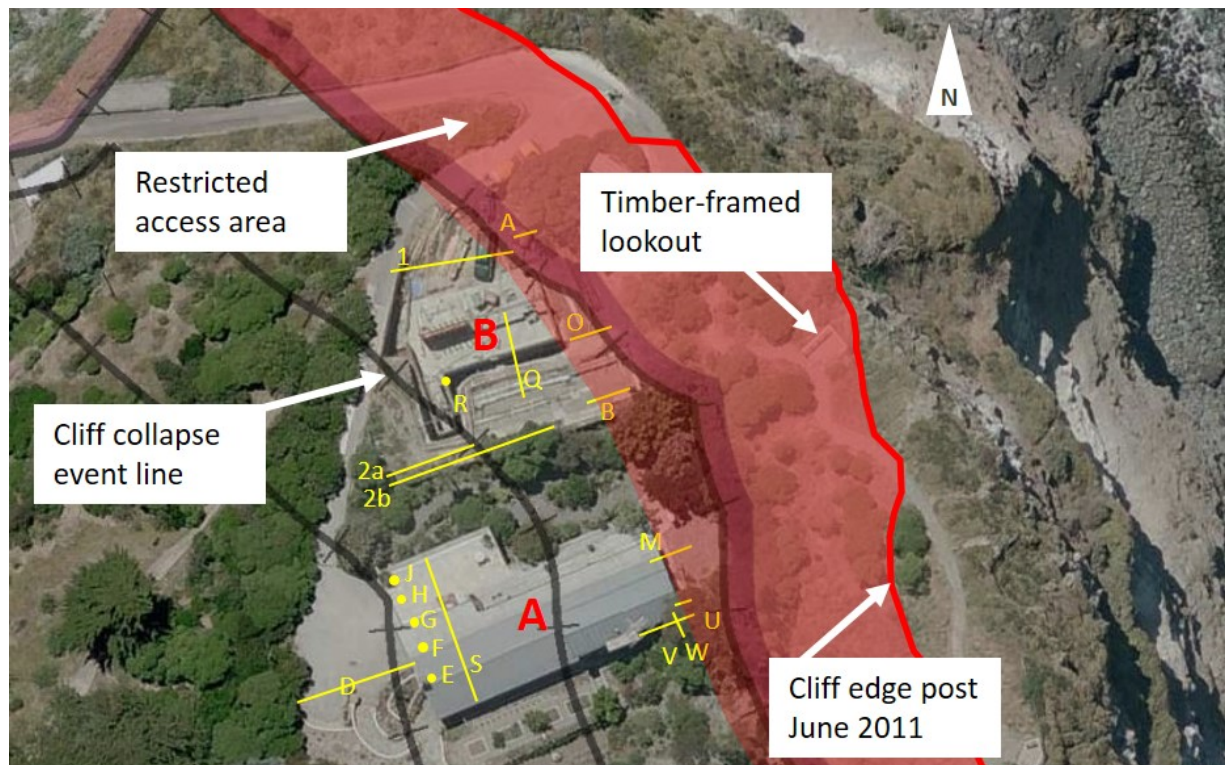
Table 1 lists tell-tales measurements four days prior and three days after the Valentine's Day earthquake (VDE). Since the VDE most tell-tales measurements have remained the same post VDE, however one particular measurement showed a significant change (point 'WWH_M'). This particular tell-tale was set up to measure over a >100mm crack in a stone and concrete patio on Property A (Figure 2). This crack runs sub-parallel to the cliff face and is the closest tell-tale to the cliff edge while just outside of the second cliff collapse event line, see Figure 2.

Measurements from another Tell-tale 'WWH_W', positioned to measure between the concrete block retaining wall and ring foundation on Property A. It too indicated some movement with a 4mm increase in the baseline measurement. This movement vector aligns with the tilted pile in Figure 5(a).

Figure 2. Tell-tale locations at Property A and B. Tell-tales are shown in yellow. The dots are vertical measurements and the lines are horizontal measurements. The 'cliff collapse event line' is defined as the point which the cliff may retreat up to in a significant seismic event. (Aurecon GIS base imagery 2009/2010).

Further destabilization of the cliff caused by the VDE has led to the necessity for the demolition methodology for these two structures to be changed. Based on the deformation observed by members of Aurecon and GNS, amendments include an already restricted access area near the cliff edge, see Figure 2, to be brought further back and the requirement for a larger specialized remote controlled excavator with greater reach that can bring down the structures from a greater distance than required before the VDE. Current monitoring techniques have proven to be effective at documenting movement on Whitewash Head and can continue to be utilised in the new methodology.

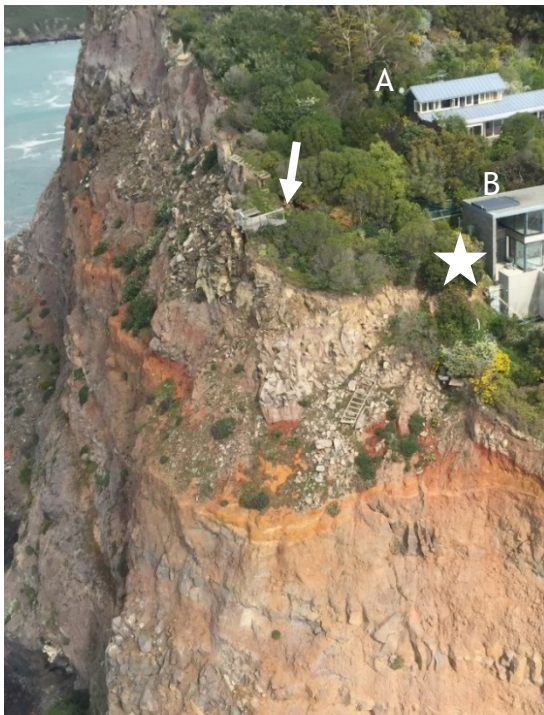
Figures 3(a) and (b), taken before and after the 14 February 2016 aftershock, show how the cliff face below Property A and B has further retreated. The majority of material has fallen from the upper third of the cliff and it has accumulated down the bottom, see Figure 4. This same area of the cliff retreated in the February and June 2011 events.

Figure 3(a). 65 – 85 m high sea cliff below Property A and B Whitewash Head, Scarborough. Note: timber framed lookout (24/09/2016 Aurecon).

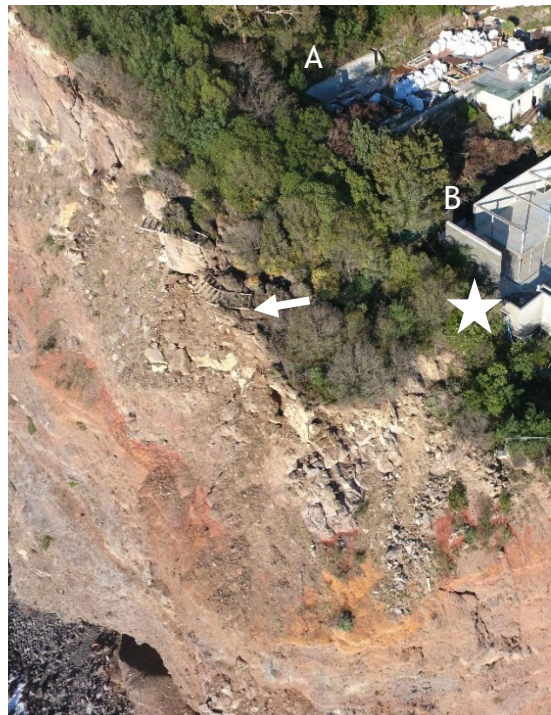
Figure 3(b). 65 – 85 m high sea cliff below A and B Whitewash Head, Scarborough. Note: missing timber-framed lookout, vegetation, and visible crack sub-parallel to cliff face (14/06/2016 Aurecon).

Further inspection with a UAV showed large (>1m³) size rocks precariously perched on the cliff with daylight showing between them and the cliff, see Figure 3(b). This means there is the potential for more boulders to fall and the cliff to retreat in future seismic event. However, it is possible that “fretting

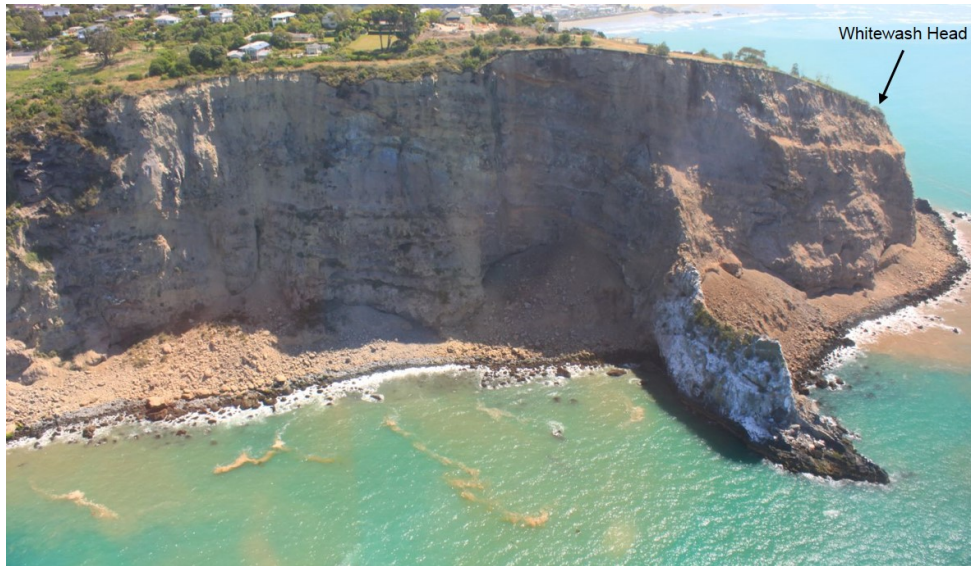
Figure 4. Talus at the base of approx. 100 m high sea cliff and sediment in the sea below Searidge Lane, Scarborough (14/02/16 Aurecon).

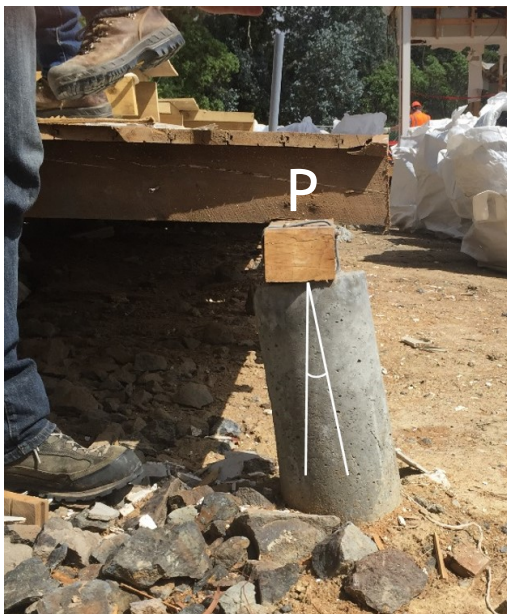
Observations made by Engineering Geologists during a site walkover four days after the event revealed a tilted concrete pile on Property A, refer to Figure 5(a), although this may have already been tilted in an event prior to the VDE as it was in an area recently exposed by the Contractor. However, this pile does indicate movement on the site. It appears there has been vertical displacement and horizontal movement towards the cliff edge. This hypothesis is supported by evidence from the aerial photo showing a series of cracks in structures on Property A that run sub-parallel to the cliff, see Figure 5(b).

Figure 5(a). Tilted $>10^\circ$ concrete pile (P) on Property A (18/02/2016 Aurecon).

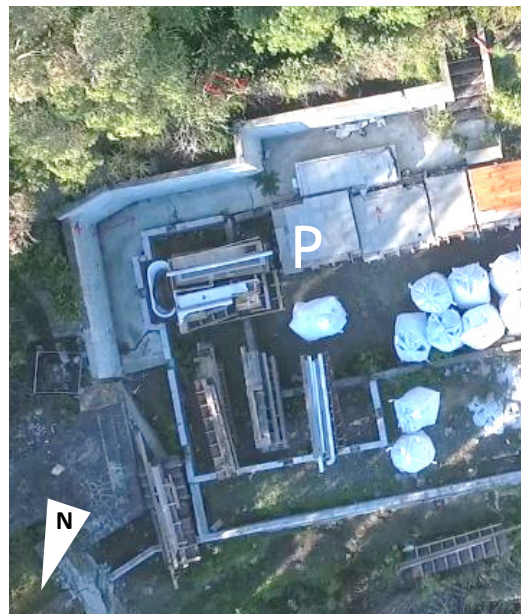
Figure 5(b). Cracked and displaced reinforced concrete ring foundations and retaining walls on Property A (18/02/2016 Aurecon).
