# Back Analysis and Closure Considerations for the North-East Pit Wall at the Globe Progress Gold Mine, Reefton, New Zealand

Dylan Meehan<sup>1</sup>

<sup>1</sup>Department of Geological Sciences, University of Canterbury, 20 Kirkwood Avenue, Christchurch, New Zealand;  
Now at: Engineering Design Consultants Ltd; PH 021 959 732; email: dylanm@edc.co.nz

In April 2015 a kinematic slope failure occurred on the north-east (NE) pit wall at the Globe Progress gold mine in Reefton, New Zealand. The failure involved planar sliding, toppling and translational slumping through the entire height (220 m) of the wall. A probabilistic back analysis using Rocscience's 2D limit equilibrium software, Slide, was undertaken to determine rock mass strength parameters that led to failure. Back analysis results were then carried into a post closure model, also using Slide. The post closure model examines how the stability of the NE pit wall will respond to increasing pit water levels as the mine is transitioned into a pit lake. The back analysis found that to replicate the April failure, the greywacke – argillite bedding planes required an apparent cohesion of 32 kPa and a friction angle of 28°. It

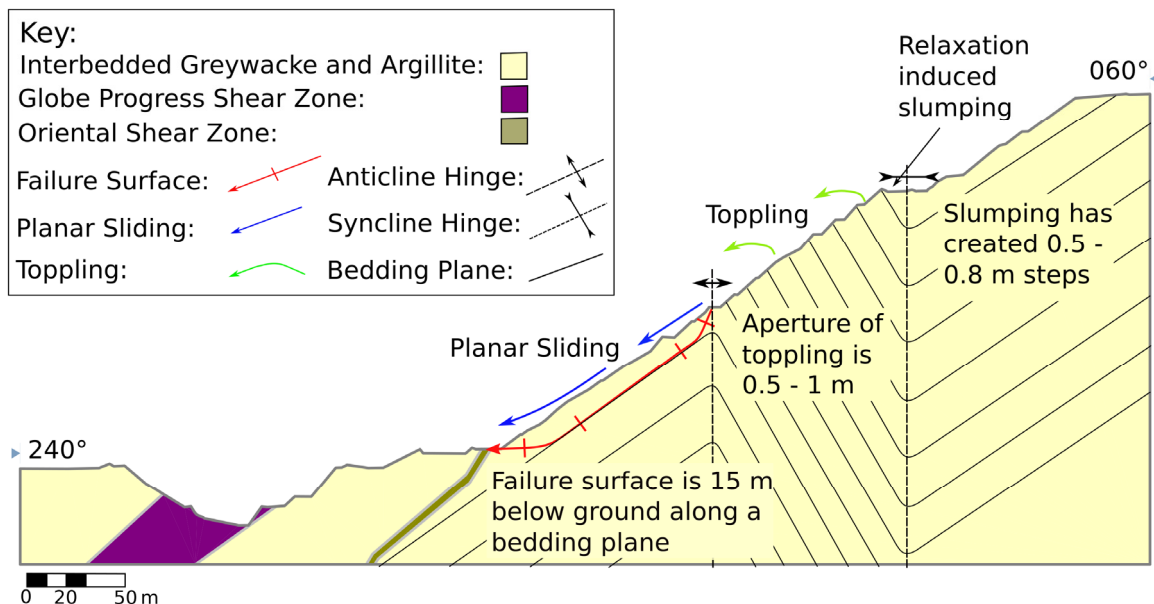
On 24 April 2015 a significant slope failure occurred on the NE wall of the pit, following two months of heavy rain. A schematic engineering geological model of the wall was developed (based on scanline structural data and mapping), that illustrated the April 2015 failure was structurally controlled (Figure 2). Beds dipping into the pit on the western limb of the anticline resulted in planar sliding from the lower parts of the slope. This induced toppling on the eastern limb of the anticline where the beds above the sliding failure are dipping out of the pit. Translational slumping was also initiated at the top of the pit wall due to relaxation of the beds below. During the failure OceanaGold staff reported hearing cable bolts snapping, indicating the failure plane was within the cable bolts 15 m deep operational zone (PSM 2015). The 90 m wide failure is bound on the northern side by the Oriental Shear Zone and on the southern side by an unknown structural feature.

Figure 2. Schematic engineering geological model through the NE pit wall

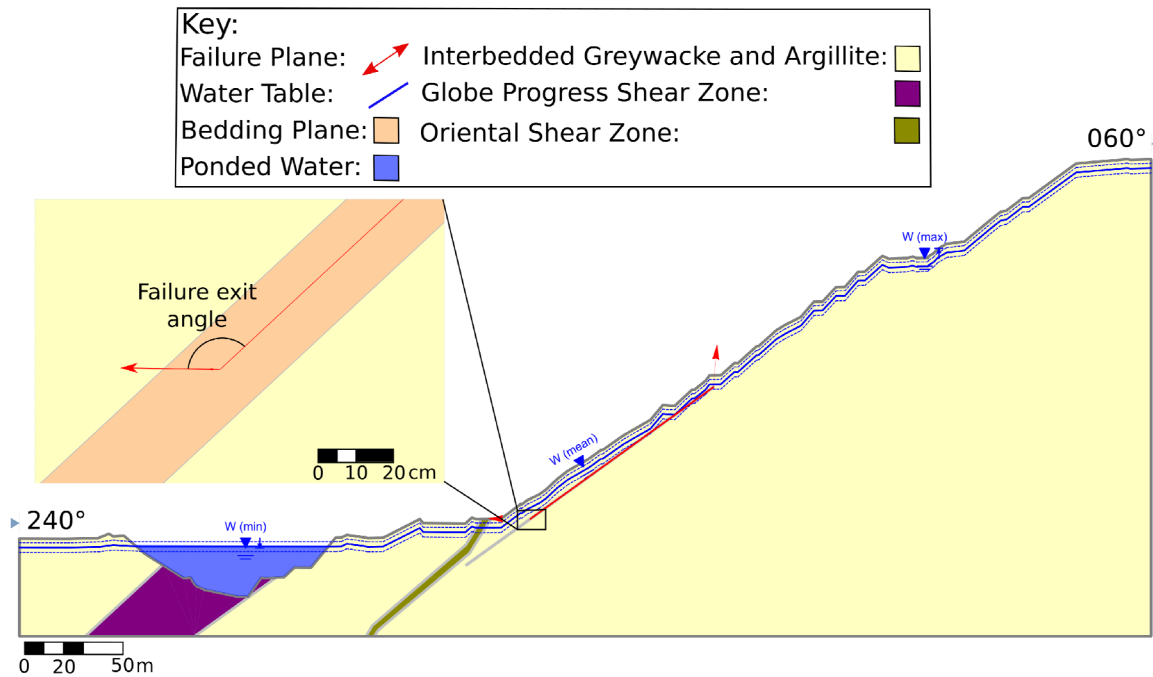
The back analysis model (Figure 3) was established in slope stability software using topography obtained from a Digital Terrain Model (DTM) of the NE pit wall taken in March 2015. The argillite bedding failure surface (enlarged section of Figure 3) was set as a 200 mm thick zone 15 m below ground, using structural data (Figure 2). The water table was allowed to vary between 2 m and 7 m below ground (OceanaGold 2013). The rock strength parameters used in the model were taken from Tables 2 – 4 apart from the bedding plane data. The bedding plane parameters were reduced from the laboratory obtained results to the lower bound of one standard deviation. This was due to the model not corresponding to the observed failure with the laboratory tested rock strength parameters. The reduced bedding plane mean cohesion and friction angle used were 50 kPa and 25°, respectively.

The back analysis focuses on the failure plane along the argillite bedding. It is inferred that following heavy rainfall, water would have infiltrated the bedding planes along joints through the rock mass. The model ran the analysis 1000 times within the range of cohesion (40 kPa – 110 kPa) and friction angle (15° – 36°) bedding plane parameters, determining which combinations of parameters would lead to failure of the pit wall within the defined constraints. The failure toe exit angle was chosen as 180° (from horizontal) to replicate what was observed in the pit.

Figure 3. Stability model used to perform a back analysis of the kinematic failure on the NE wall. Enlarged section shows failure surface along the bedding plane interpreted to have failed

From 1000 model iterations, 54 models resulted in a factor of safety of 1.0 and thus gave parameters for the April pit wall failure to occur. These results averaged to an apparent cohesion of 32 kPa and a friction angle of 28° along the bedding plane. The results plus the strength of the Oriental Shear Zone and the greywacke at failure are shown in Table 5.

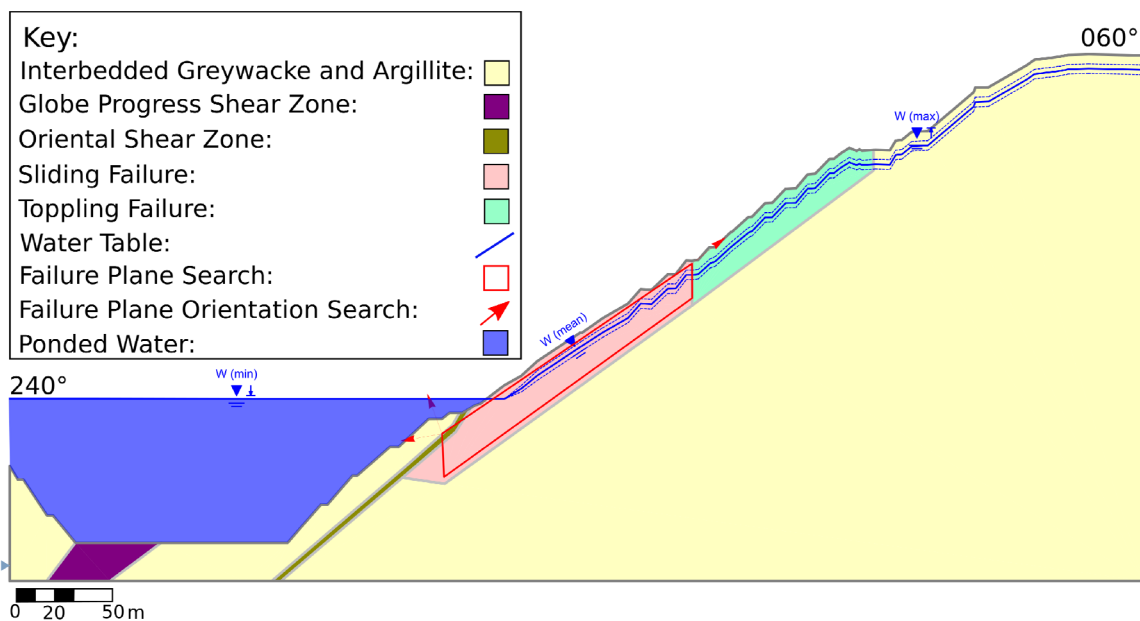
The post closure model (Figure 4) was produced from a June 2015 DTM. The area of planar sliding was inserted using a failure surface block search allowing the software to choose the most likely place of failure within the block. Failure was constrained to a dip of 36° along the bedding planes. The exit angle of the failure was set to choose the most likely angle between 170° and 250° from horizontal.

Figure 4. Representative model (75 m water depth) to analyse the post closure water table

The lowest factor of safety during filling of the lake is 1.2 at 75 m water depth, the factor of safety then increases as water level increases. This implies rising pit water levels are not expected to induce pit wall failure under the saturated conditions modelled, without other external factors. There are two possible reasons for failure not being induced as compared to the April 2015 failure. The first is the weight of water within the pit will buttress the pit wall. Figure 5 supports this by illustrating the pit wall is least stable when the water depth is 75 m, which corresponds to the pit water saturating the toe of the

slide only, with very little buttressing support force (Figure 4). As the water fills above 75 m the factor of safety increases due to a corresponding increase in buttressing force. The second possible reason for a stable post closure wall is the altered geometry. Since April 2015, due to both the failure that occurred and further mining within the pit the shape of the wall has changed favourably.

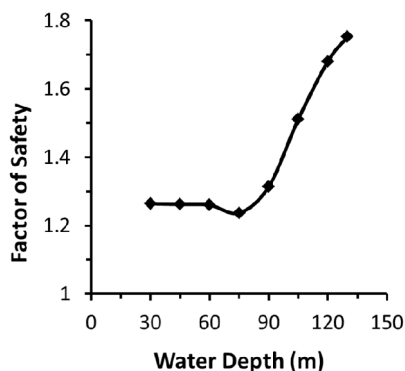
The post closure model outputted eight factors of safety for the NE pit wall during the two year C&M period and subsequent filling of the pit (30 m – 124 m water depth). The different models effectively determine how the wall would respond over the filling period (Figure 5).

Figure 5. Plot of factor of safety versus water depth
