## **“Seeking Relief” Rising Pore Pressures in Earth Dams – A Case Study**

N. P. Burrows<sup>1</sup>, NZGS.

<sup>1</sup> Riley Consultants Ltd, P.O Box 100253 North Shore, Auckland 0745, PH (09) 489 7872; email:nburrows@riley.co.nz

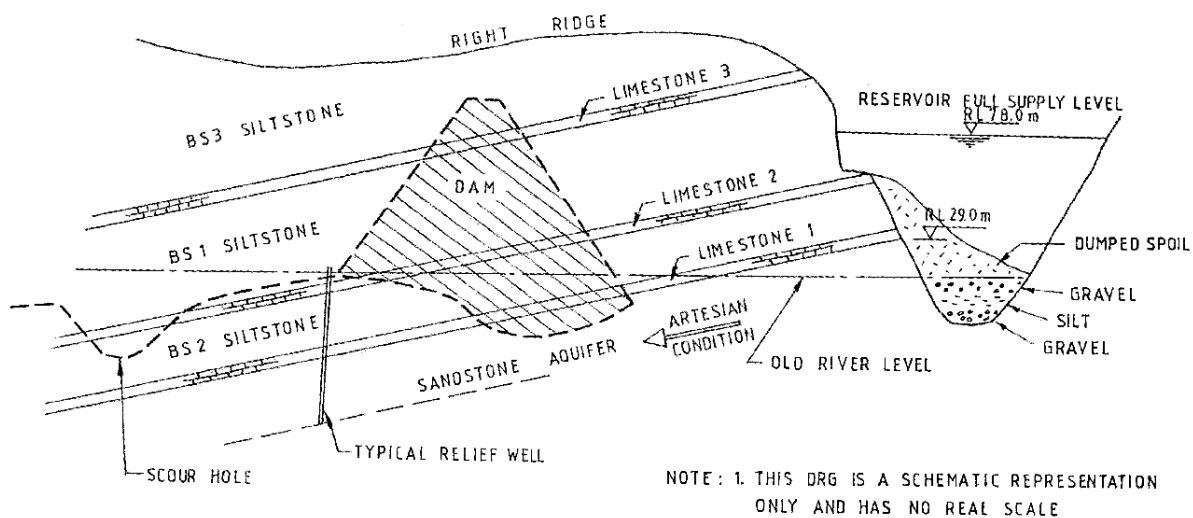
The geology encountered on-site during construction is shown schematically in Figure 1. The geological units were primary alternating limestone and sandstone/siltstone layers. The upper layer consisted of superficial protective tailrace backfill/riprap comprising large, irregular boulders from ground level to between 4m and 7m depth. A 1m thick, extremely strong limestone layer (Limestone 2) underlies the riprap layer. The base depth of Limestone 2 is deeper nearer to the powerhouse than by the right abutment. The boundary between the Limestone 2 and the underlying BS2 siltstone/sandstone was observed as a sharp contact. BS2 siltstone/sandstone material comprised minor marine fossils found in the form of shell fragments. Another sharp contact was observed into an additional strong limestone layer (Limestone 1) with large shells, whole and fragmented. The final underlying layer is blue grey massive sandstone similar to BS2. An aquifer has been identified within this lower sandstone layer (BS2) and is capped in place by the Limestone 2 unit above.

Figure 1. Schematic geological and artesian profile at Patea Dam

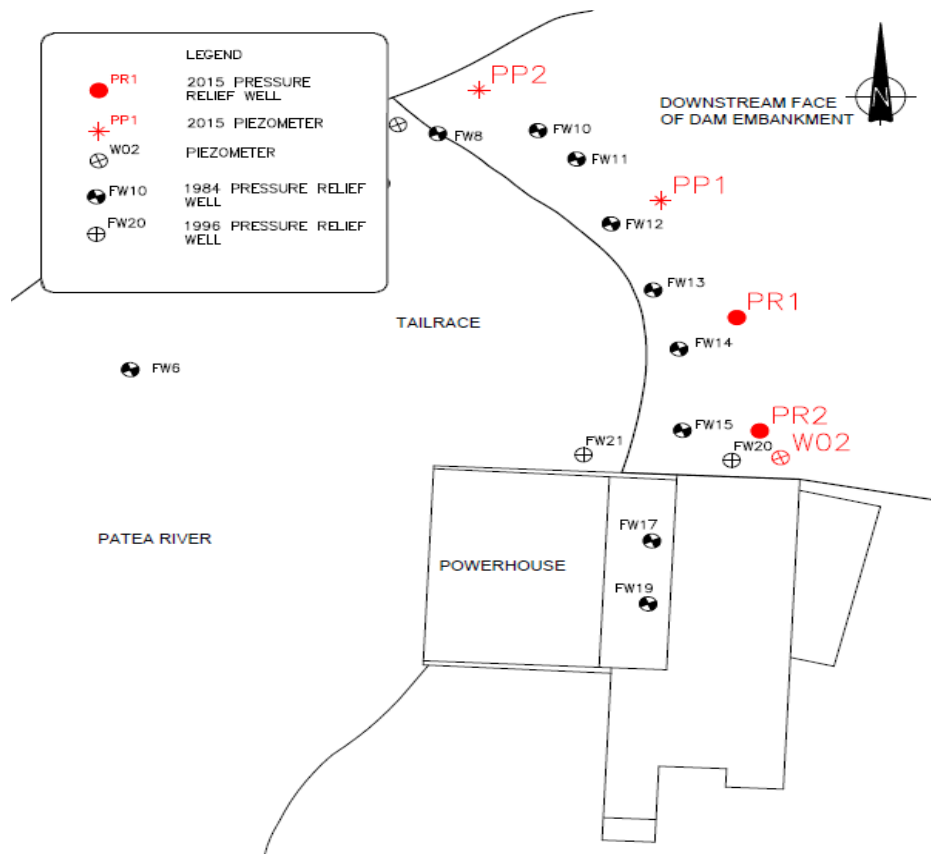
Figure 2. Patea dam remedial measures site plan

Two pressure relief wells (PR1 and PR2) were drilled to a depth of 38.5m and 40m respectively below the dam toe ground surface. Two open standpipe piezometers (PP1 and PP2) were drilled to a depth of 19m (1m into the aquifer) to replace existing damaged standpipe piezometers. The new pressure relief wells and piezometers were drilled at the dam toe marginally upslope of the original monitoring points. This allowed for monitoring of groundwater flows, groundwater depths, and to provide a safety buffer between the site crew and the variable tailwater levels for relief well installation. The locations of the above remedial measures are shown in Figure 2.

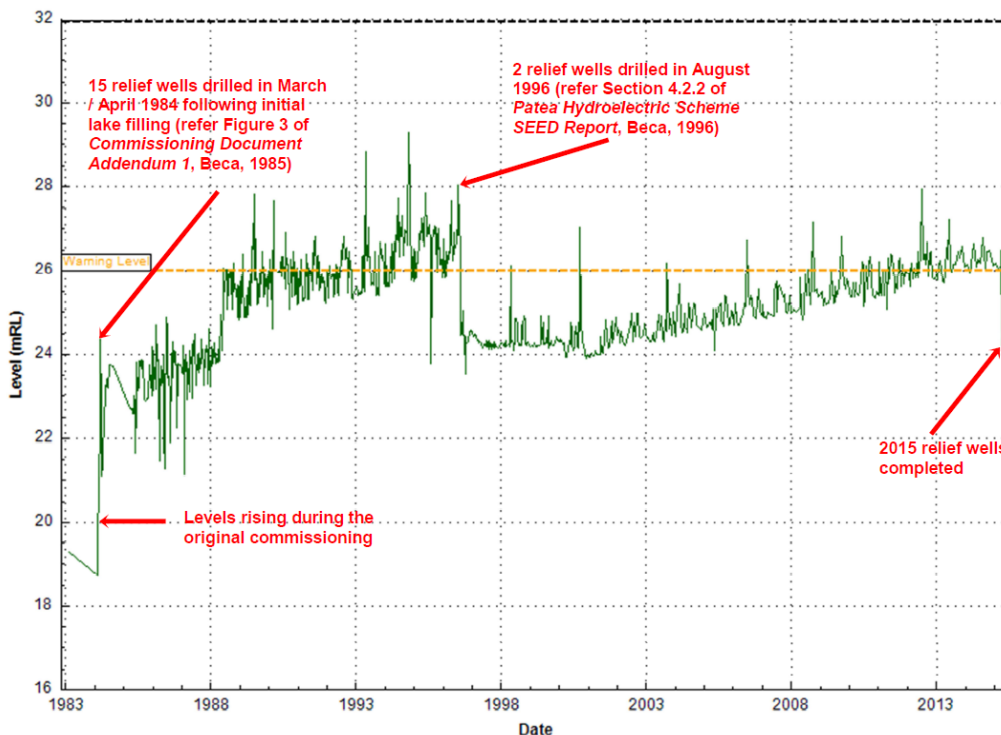
Following the installation of the 2015 relief wells, foundation piezometer W02 responded with a noticeable decrease in piezometric levels. Figure 3 highlights the W02 pressure trends and when relief wells were installed. Current W02 piezometric levels are the lowest since mid-2005 and are approximately 2m lower than the monitoring system warning level of RL 26m. This suggests an increased FoS above 1.5. Foundation piezometer W02 is a key piezometer as it has historically exhibited good response to relief well installations.

Figure 3. Annotated time series plot for foundation piezometer W02 (entire instrument history)

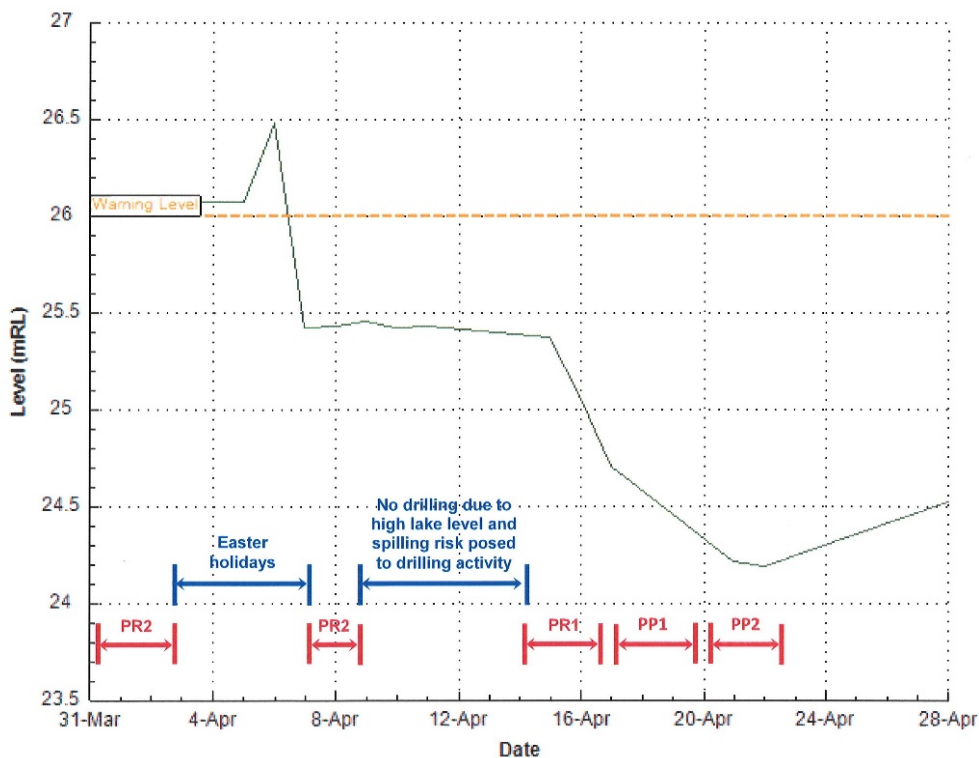
It was also noted that a gradual 1.2m decrease of piezometric levels occurred during drilling of PR1 to the newly installed Piezometer 1 (PP1), and Piezometer 2 (PP2) from 15 to 22 April 2015. Monitoring over this time also showed a piezometric level increase of 0.5m on 6 April 2015 followed by a 1m step decrease on 7 April 2015. It is unclear what caused W02 to increase and decrease from 6 to 7 April 2015, particularly as no drilling occurred during this period. Prior to Easter, PR2 drilling had only progressed into the (upper) Limestone 2 layer. One possibility may be a foundation response following a period of heavy rain and increased reservoir level. It is considered the W02 pressure decrease from 15 to 22 April 2015 was caused by the drilling and installation of PP1, PP2, PR1, and

PR2. The artesian pressure responses described during the duration of the 2015 relief well programme is shown in Figure 4.

Figure 4. Annotated time series plot for foundation piezometer W02 during installation (four week period)
