Case History of an Unusual Embankment Failure

Andrew Campbell, Maunsell Pty Ltd

Summary: The partial failure of a 7.5m high surcharged embankment constructed over soft clay and peat is described. Extensive instrumentation within the embankment and its foundation gave only partial warning of the impending failure. Failure occurred during the final lift of surcharge and resulted in a 0.6m wide tension crack approximately 100m long down the centre line of the embankment. Unusual features included the fill material, lack of pore pressure dissipation during construction despite installation of wick drains, limited lateral deflection prior to failure, near perfect symmetry of the failure and the remedial measures implemented.

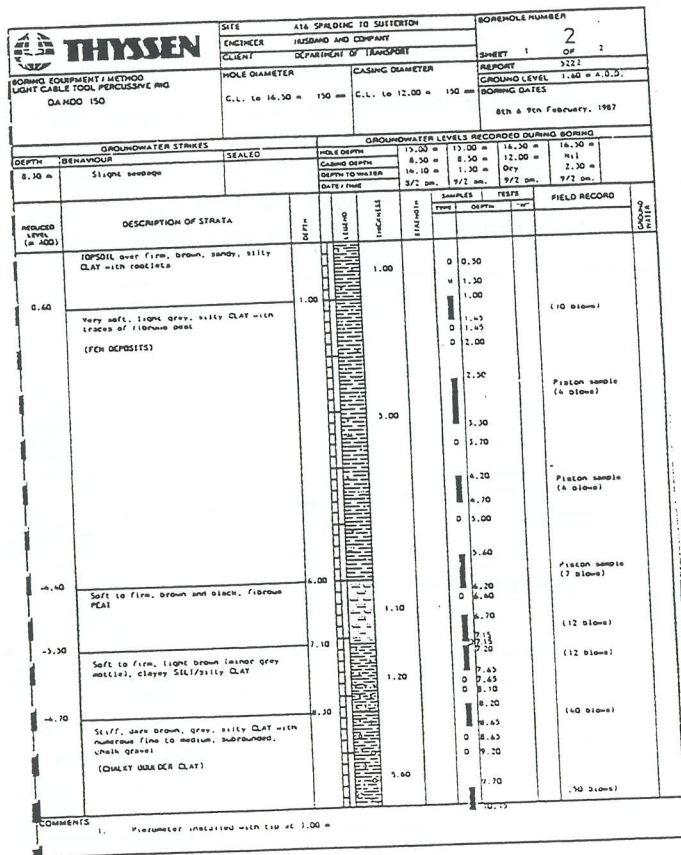
Figure 2: Borehole Log at Ch 1200

The ground conditions immediately under the failed section of embankment are shown on Figure 2 and comprised a 1m thick desiccated crust of firm silty clay, 5m of soft to very soft silty clay with traces of peat, 1m of soft fibrous peat, 1m of soft to firm silty clay, 6m of stiff Chalky Boulder Clay then Oxford Clay.

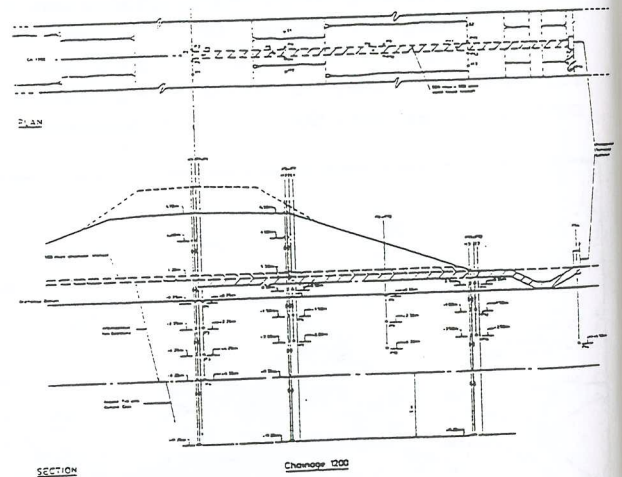
Figure 3: Arrangement of Instruments at Ch 1200

Instrumentation at Ch1200 comprised 24 hydraulic piezometers, five magnetic extensometer settlement gauges, four inclinometers, one hydrostatic profile gauge and one settlement plate. The arrangement of instruments is shown in Figure 3. All piezometers were connected to terminals on the right hand side of the embankment.

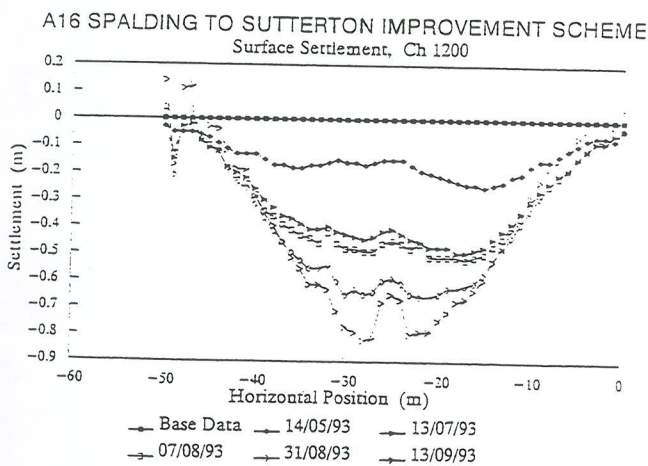
Figure 13: Hydrostatic profile gauge readings

hydrostatic settlement gauge plot indicates that the embankment had split and rotated although the toe inclinometer readings still showed no lateral movement at ground level and only minor movement in the peat. Small swallow holes appeared in the surface of the surcharge along with a very faint step along the centreline. A trial pit was excavated into the brick fill however no crack was observed. The following day the four inclinometers were unreadable as were four of five extensometers and the hydrostatic profile gauge. A metre of surcharge was removed over a 150m length in a bid to prevent complete collapse. Over the following weeks, the centreline extensometer kinked and became unreadable. New inclinometers were installed at the toes.
