Geotechnical Aspects of the Sydney 2000 Olympic Site

Roberta Lindbeck, Douglas Partners Pty Ltd, Sydney, Australia

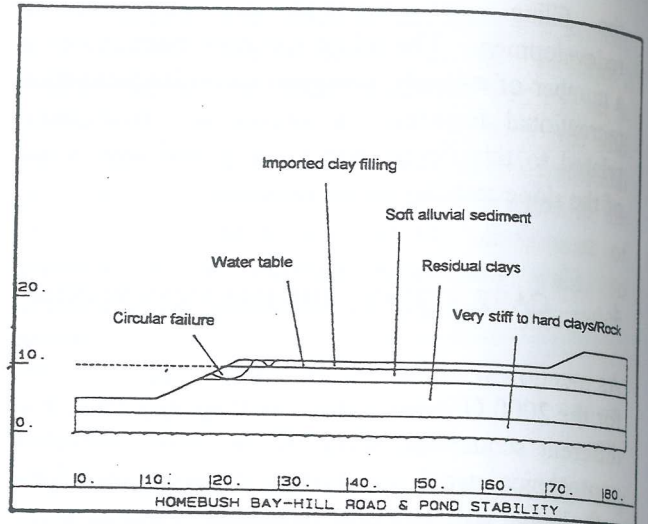
Figure 4. - Stability Analysis of the Pond Slopes

The results of the CPT indicated man-made filling overlying soft silty clay and very stiff to hard clay. The depth of filling and the thickness of the soft silty clay varied across the investigation area. The layer of filling was found to be generally 4 m to 5 m thick, however, was as thin as 1 m to 2 m in some locations. The layer of soft clay underlying the filling was found to be about 0.8 m to 2 m thick⁴. The soil profile can be seen in Figure 4.

Thus, in the stability analyses of December 1997, a strength of $S_u=10$ kPa was assumed, based on the results of site specific field data. The results of the analyses indicated that the factor of safety of the ponds would be satisfactory if the slopes were maintained at no steeper than 1:2 (V:H)⁷. The graphical output of the stability analyses are shown in Figure 4.

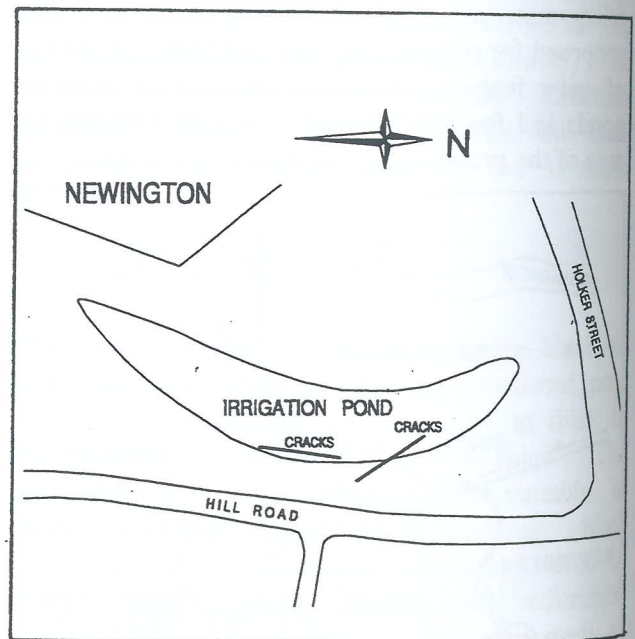
Figure 5. - Plan of the Failed Pond

Whilst the initial design slopes for the ponds were specified to be 1:2 (V:H), excavation conditions during construction allowed slopes of 1:1.3 (V:H). In January 1998, during construction, an entire section of the edge of one of the ponds slumped, resulting in post failure slopes of 1:6 (V:H). It was found that the layer of soft clay had failed, causing the overlying clay filling to move along the soft clay layer. Large transverse cracks were visible at the head of the slide.

A plan of the pond, showing the cracks is included in Figure 5.

Using the pre-failure geometry of the slope, and trialling various combinations of strength parameters, stability analyses were undertaken to achieve a factor of safety less than 1.0. This back analysis indicated that the strength of the soft clay was as low as $c_u=5 \text{ kPa}$ ⁸, as opposed to the value of 10 kPa, which had been used in the stability analyses and was based on field CPT results.

There are obvious differences between the strength assumed for the purpose of stability analyses and the strength calculated from the back analysis of the failed pond. It is considered that the differences could be attributed to variations in conditions between the CPT locations and where the pond failure actually occurred.

The CPT were located near the Irrigation Ponds, but not directly at the locations where failures occurred. Thus, the resistance of the soft clay where failure occurred had not actually been measured. The importance of accurately locating tests when relying heavily on site-specific field data is evident in this case study.

Using the amended strength parameters, stability analyses were undertaken on various stabilisation options. It was found that a supporting layer of crushed sandstone, covering the face of the soft clay layer, resulted in improved stability. A 3 m thick layer of sandstone with a slope angle of 1:3.5 (V:H) resulted in a factor of safety of 1.4⁹.
