Excavations In The Brisbane CBD

David Qualischefski

This paper highlights the geological and geotechnical engineering aspects of some recently completed deep excavations in the Brisbane CBD.

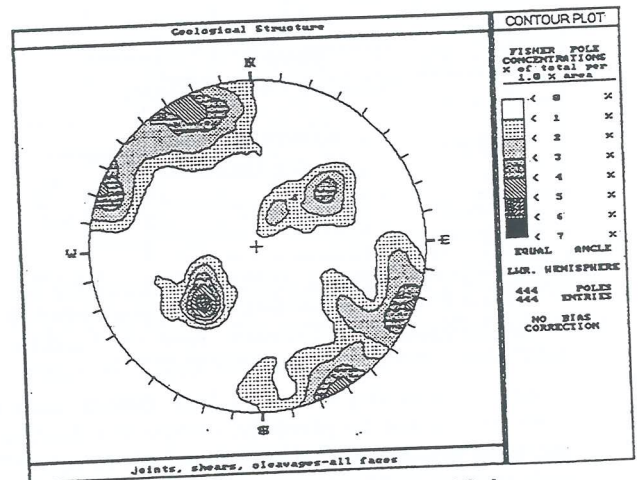
Figure 3 Stereographic Plot of Poles

About 440 geological discontinuities were mapped during the course of the works. Mapping data were assessed using the 'DIPS' computer software. Figure 3 shows the resulting lower hemisphere stereographic projection contoured plot.

Two persistent cleavage directions C1 and C2 were identified, one superimposed on the other (i.e. both sets are present within the strata). These are summarised in Table 5.

The face mapping also revealed that sheared zones were generally parallel to the cleavage, but often dipped more steeply. Conjugate shear zones were also noted on the George Street face and dip at 20° to 45° opposite to the cleavage.

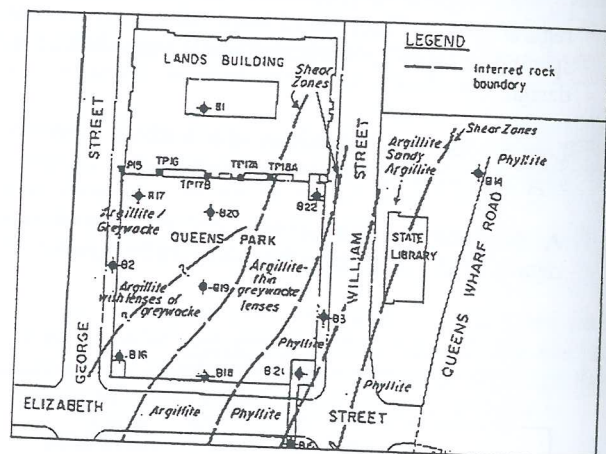
Figure 4 Rock Types Encountered in the Excavation

The distribution of the principal rock types ie argillite, phyllite, and greywacke, is shown on Figure 4. A number of shear zones are also shown.

Zones identified in the investigation were mapped as continuous structures across the excavation. These sheared zones were generally less than 200mm wide and comprised firm clays grading to extremely low strength rock as infill materials. Some clay seams within the crush and shear zones extended below full excavation depth.

The encountered sheared zones tended to deteriorate quickly once exposed. These materials slake, potentially undermining the slope if not locally stabilised. Rock bolts which fasten shotcrete and mesh panels were used to seal these sub-vertical clay filled shear zones which were relatively continuous (i.e. 10m to 20m long) in the Elizabeth Street, George Street corner.

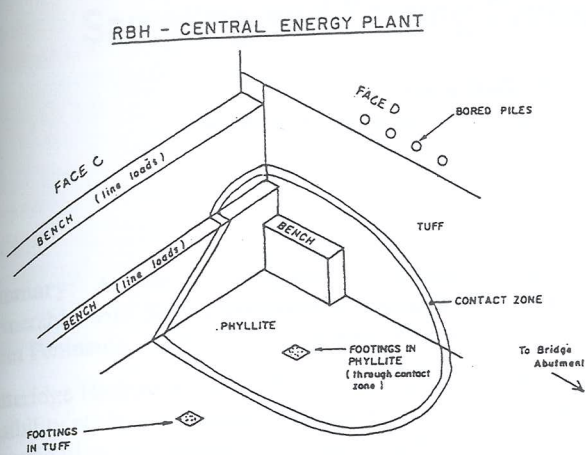
Figure 7 Intersection of Faces C & D

The intersection of faces C and D showing the orientation of the contact zone as it daylights in faces and dips below the floor of the excavation is shown in Figure 7 below.

Due to the orientation of the contact zone and the vertical excavation of face D, a 5m to 13m high block of jointed high strength tuff was surcharging the 10m long planar surface of the contact zone. A large planar failure into the excavation was possible.

A check of the orientation of the contact zone behind the face and the length and capacity of the anchors installed above the contact zone indicated an adequate factor of safety (FOS) against planar slide.

On face D where a major plane of instability was present the building foundations were changed to bored piles which were sleeved through tuff and contact zone and transferred the building loads to the underlying competent phyllite.

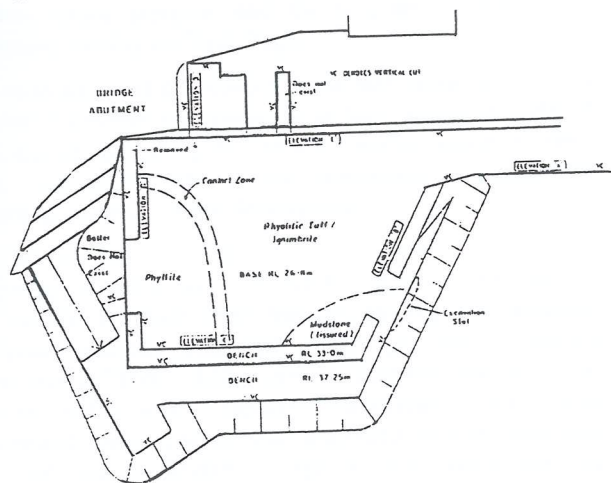
Figure 8 Plan showing rock types and discontinuities

An intrusive dyke was encountered below RL 29 in the south-west corner of the excavation, at the intersection of faces B and C. The dyke comprised very low to low strength tuffaceous mudstone which was friable and highly fissured. The mudstone dipped at 45° to 50° into the excavation and plunged north.

The different rock types encountered in the excavation and the location of the contact zone and the intrusive dyke structure are shown in Figure 8.

The contact zone and intrusive dyke, which both dipped beneath the floor of the excavation and behind faces B, C, and D, had stability implications for the proposed building and excavation faces.

Due to the poorer quality materials of these major discontinuities, careful assessment of the bearing capacity and associated settlement of high level building foundations located at the floor of the excavation was required. Where insufficient depth of competent tuff existed above the contact zone/dyke materials, bored piles were redesigned to transfer building loads to the underlying phyllite.
