## Tairāwhiti Roads Storm Damage: Determining factors for the best remediation solution to a mass number of slope failures

### ABSTRACT

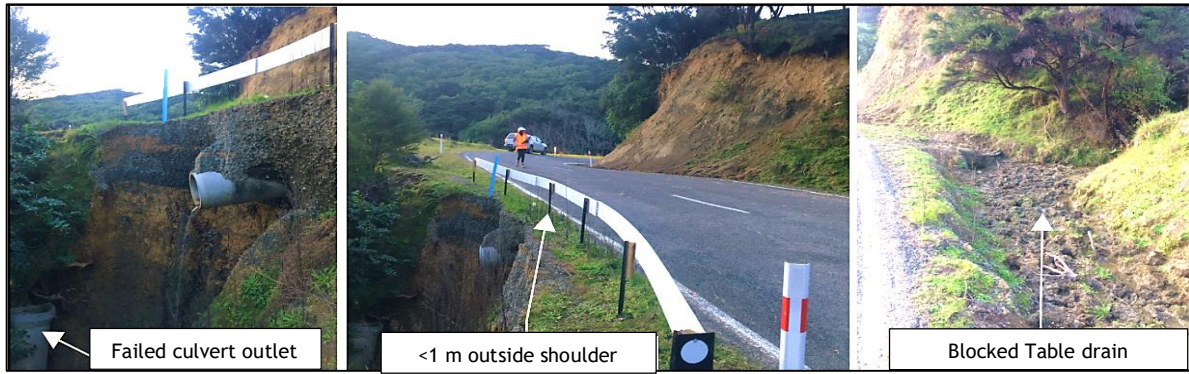
Figure 4: Anaura Road RP6.18 – Example site of scour from uncontrolled stormwater.

As stated previously water is a fundamental driver of failure. Uncontrolled storm water or a high ground water table resulted in translational failure of saturated soils on the underlying bedrock and scour of the downslope sidling fill. Understanding the condition on site of the table drain or nearest culvert and how to better control storm water was essential for long term stability of the slope. Figure 4 shows a typical scour failure resulting from undersized and ailing storm water infrastructure.
