Successful Remediation of Dual Pipeline Stress Within a Complex Landslide

ABSTRACT

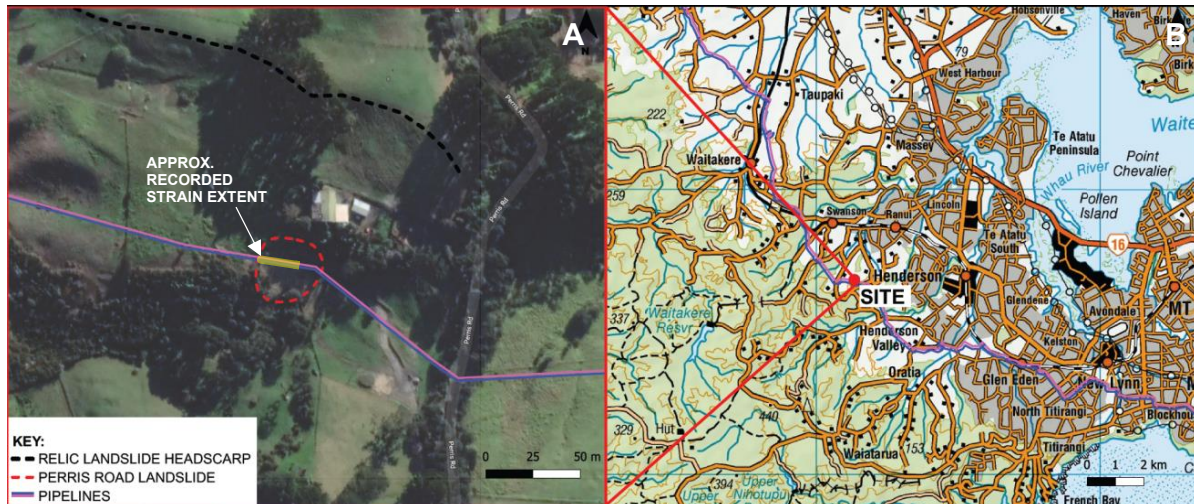
Figure 1: (A) Overview plan of the site and landslide features; (B) Site Location

The geology encountered during the DSI was generally consistent with the published geology and consisted of landslide debris underlain by relic, blocky landslide debris most likely derived from ECBF soils described in the published geology. The recorded strain was located within the inferred mapped landslide boundaries (Figure 1). No evidence of recent instability was identified during mapping of the relic landslide (Figure 1).

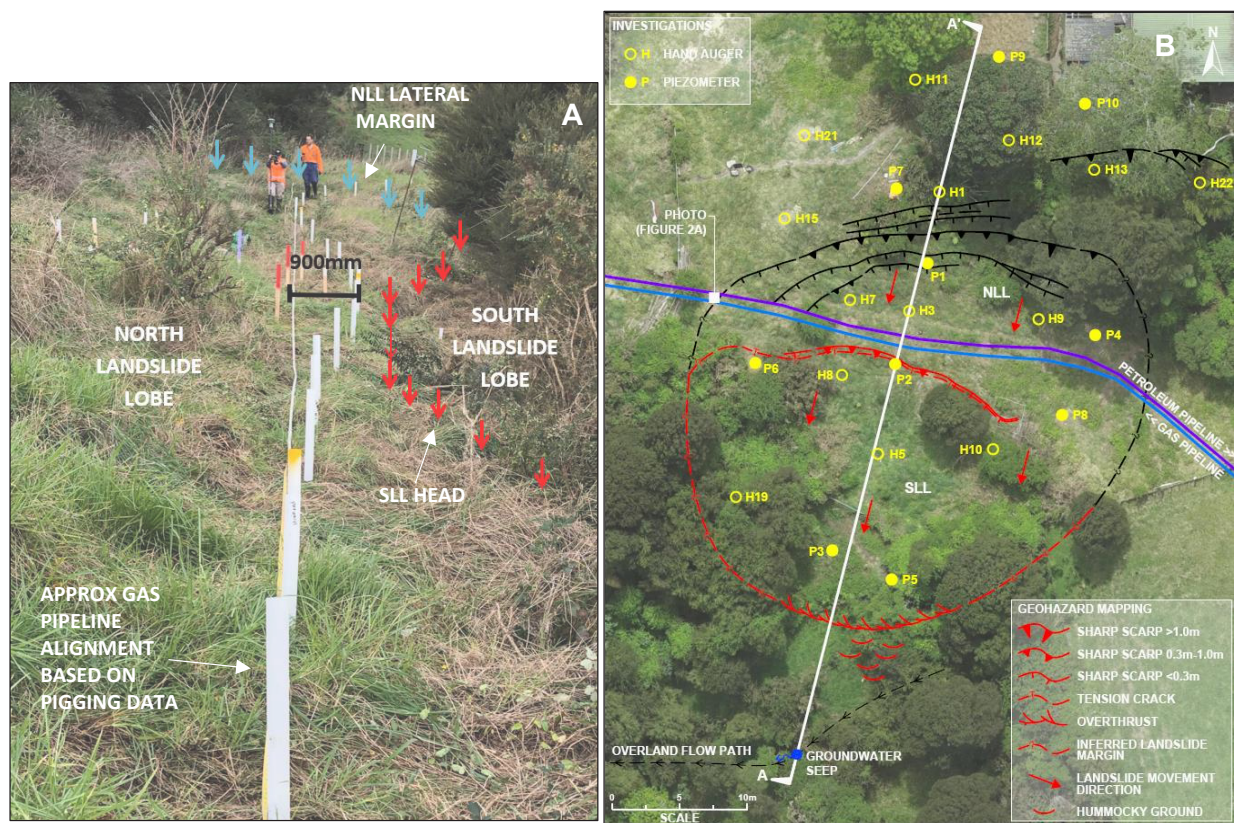
An inferred conceptual landslide model for the site instability was developed based on the DSI investigations. The landslide was inferred to compose of two landslide lobes: (1) the North Landslide Lobe (NLL); and (2) the South Landslide Lobe (SLL; Figures 2 and 3). The basal landslide failure plane was inferred to have a maximum depth of 4.2m below ground level (bgl) and be within landslide debris associated with the relic landslide features present on the upper slopes (Figure 1). The landslide failure direction was inferred to be approximately south ($\sim 194^{\circ}$), perpendicular to the pipelines.

Figure 2: (A) Photo facing east across the landslide showing the inferred downslope deflection from assumed as-built alignment of the gas pipeline. (B) Simplified engineering geology sketch plan. Section A-A' shown on Figure 3.

The pipelines are located within the inferred boundaries of the landslide for an approximate length of 40m (Figure 2). The inferred lateral margins of the landslide extended beyond the suspected deflection area. A suspected horizontal deflection of approximately 900mm from the assumed as-built alignment over a pipeline length of approximately 26m was inferred based on field observations (Figure 2). Based on the inferred landslide movement direction, some vertical deflection of the pipelines was also interpreted to be likely within the landslide. This is consistent with there being a vertical component of pigging strain at the site.

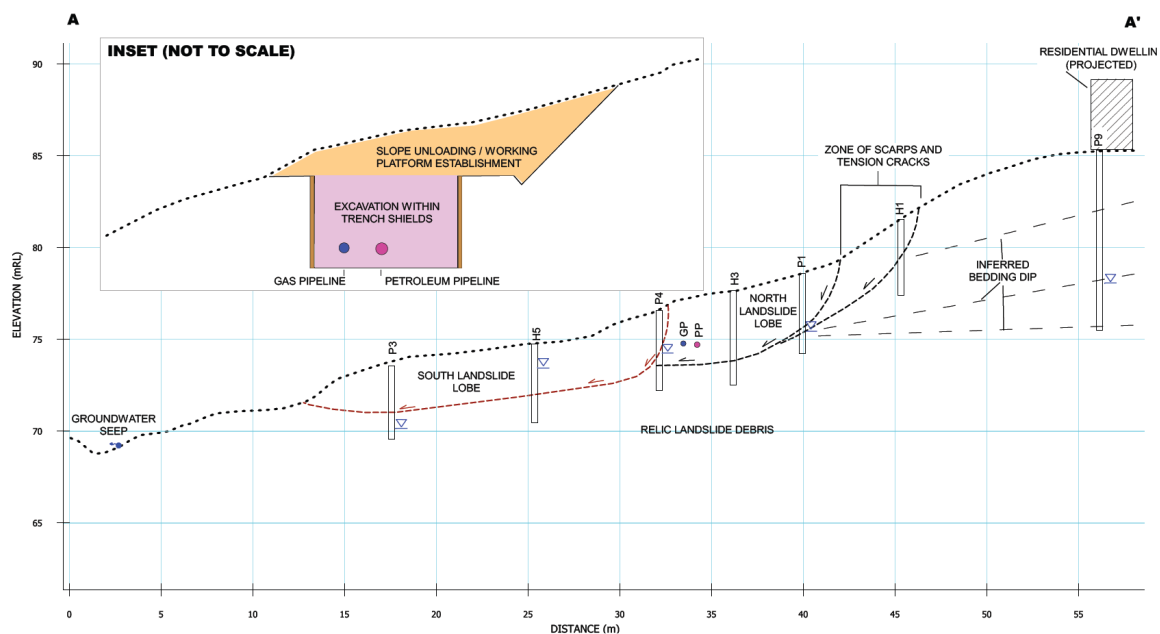
Figure 3: Engineering geological cross-section. Refer Figure 2B for section location. Inset: Simplified schematic of PSRT excavation methodology.

Key findings from the DDGI included identification of additional NLL instability upslope of the pipelines and inferred downslope dipping bedding in the ECBF in the area upslope the landslide. Figure 3 shows an engineering geological cross-section of the updated conceptual landslide model following the DDGI works.

The pipelines were potholed to complete a pre-excavation baseline survey. Approximately 1-2m of soil was removed from the slope in the PSRT area to form a level working platform and provide a slope unloading function (Figure 3 inset). Pipeline cover was removed to within 0.5m of the crown of the pipelines using an excavator and trench shields. The remaining 0.5m of soil overlying the pipelines was removed via hand excavation to expose the pipelines (Figure 4B). During pipeline exposure and destressing works, the pipelines moved back towards the approximate original straight-line pipeline alignment. Pipeline defects were repaired and permanent crossings underneath the pipelines were retrofitted to complete the subsurface drainage network. Trench shields were then removed, the PSRT was backfilled, and the site was reinstated.

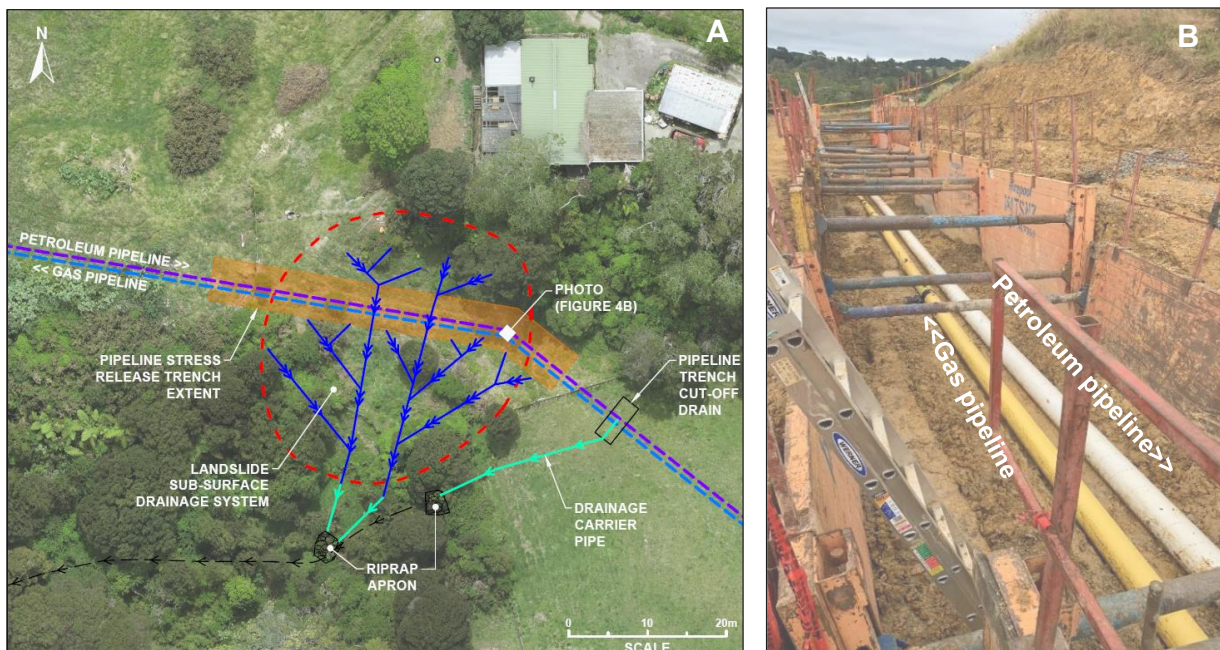
Figure 4: (A) Remedial works overview plan. (B) PSRT during Phase 4 (Stage 2) works. Photo facing west.

The preferred remedial option (landslide drainage and PSRT) was divided into two work stages: Stage 1: Installation of landslide subsurface drainage, including a pipeline trench cut off drain east of the landslide; and Stage 2: PSRT – Excavation and exposure of the pipelines to relieve land movement related stress/strain, pipeline integrity checking, coating repair works, backfilling and reinstatement. Figure 4A shows the layout of the subsurface drainage network and the extent of the PSRT.

Subsurface drainage construction works were completed from April–May 2021 and comprised installation of 164m of 1.5–3m deep subsurface French drains, a pipeline trench cut-off drain east of the landslide, 25m of buried carrier pipes carrying the drainage discharge to three culvert drainage outlets, 13 buried drainage inlet risers at the head of subsurface drain stems, and two drain flow monitoring points. Subsurface drain pipeline crossings were installed during Stage 2 following excavation of the pipeline stress relief trench (PSRT).
