# STRUCTURAL CONTROLS OF THE OTWAY RANGES AND HAZARDS FOR ROAD USERS

Dane Pope  
PSM, Geelong.

## ABSTRACT

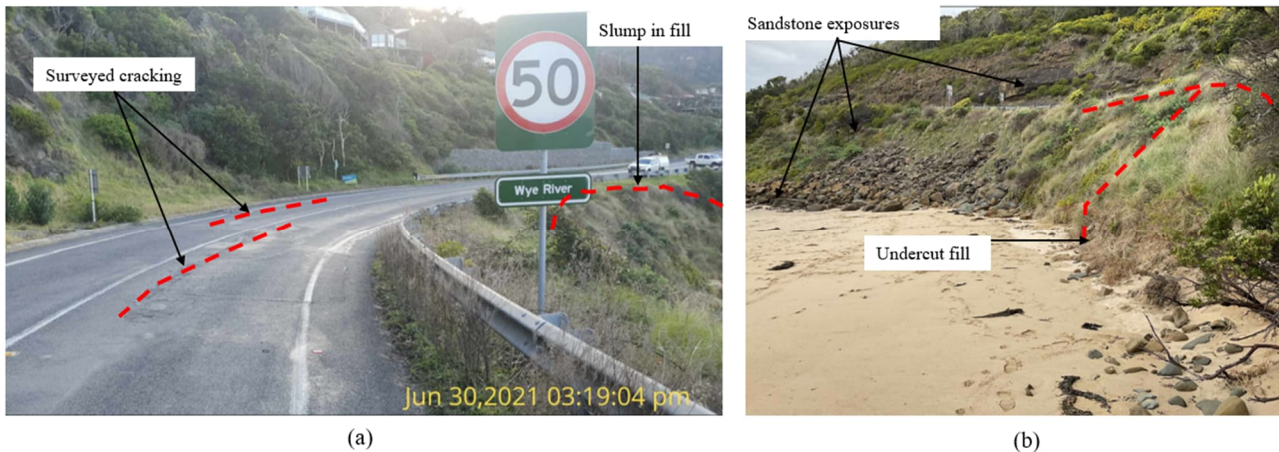
During the 2021 DTP site walkover significant cracking of the pavement was identified (refer to the red cracking on Figure 2 (a) and Figure 3) as well as relatively narrow landslides at the crest of the fill batter, Figure 2 (b) and the yellow shaded areas on Figure 3. These landslides commenced immediately north of the inferred location of the fault, Figure 3. The back scarps of the landslides were steep (approximately  $63^\circ$ ) and the translational slides mapped indicated evidence that movement had occurred in a “two wedge” mechanism, Figure 5.

**Figure 2: (a) Pavement cracking in proximity to fill failure looking towards Morley Avenue (b) Looking south towards the Wye River headland with undercut fill slope highlighted**

Mitigation of the hazards incorporated a combination of a cantilevered bored pile retaining wall with capping beam, inclusion of sub-surface cut off drains to the west of the roadway and improvements to kerb and channel with discharge of surface and sub-surface water further north where natural dune slopes were present along with a wide shoulder.

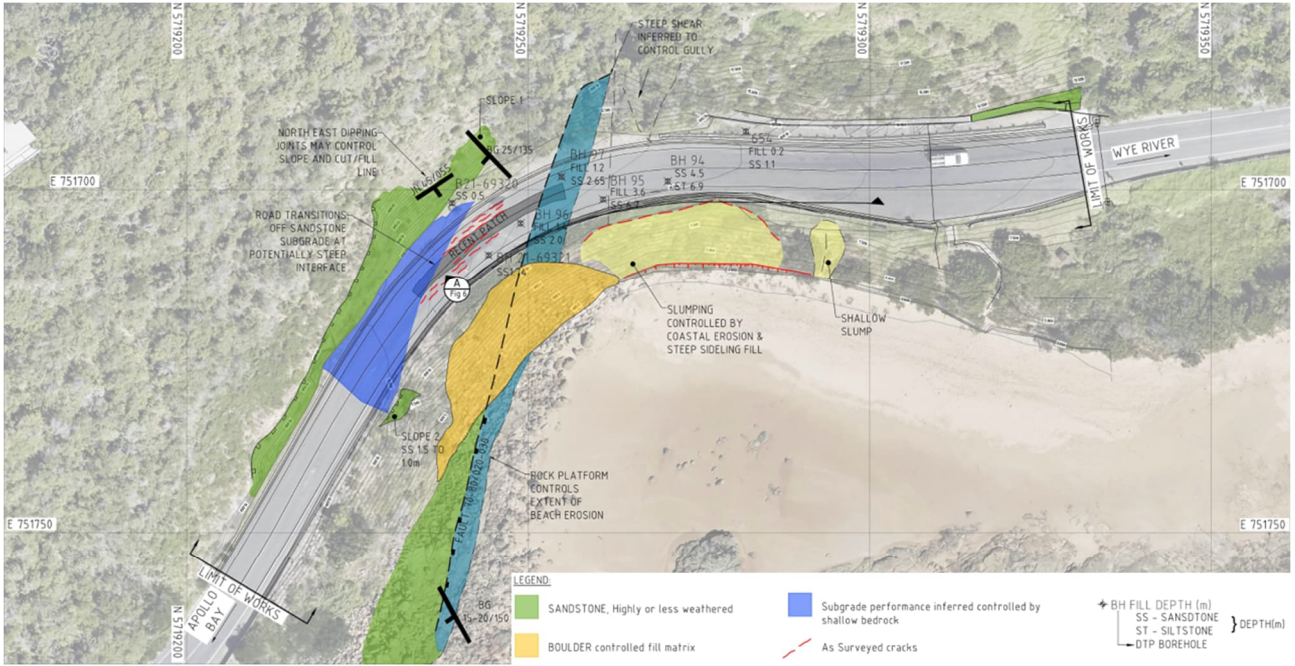
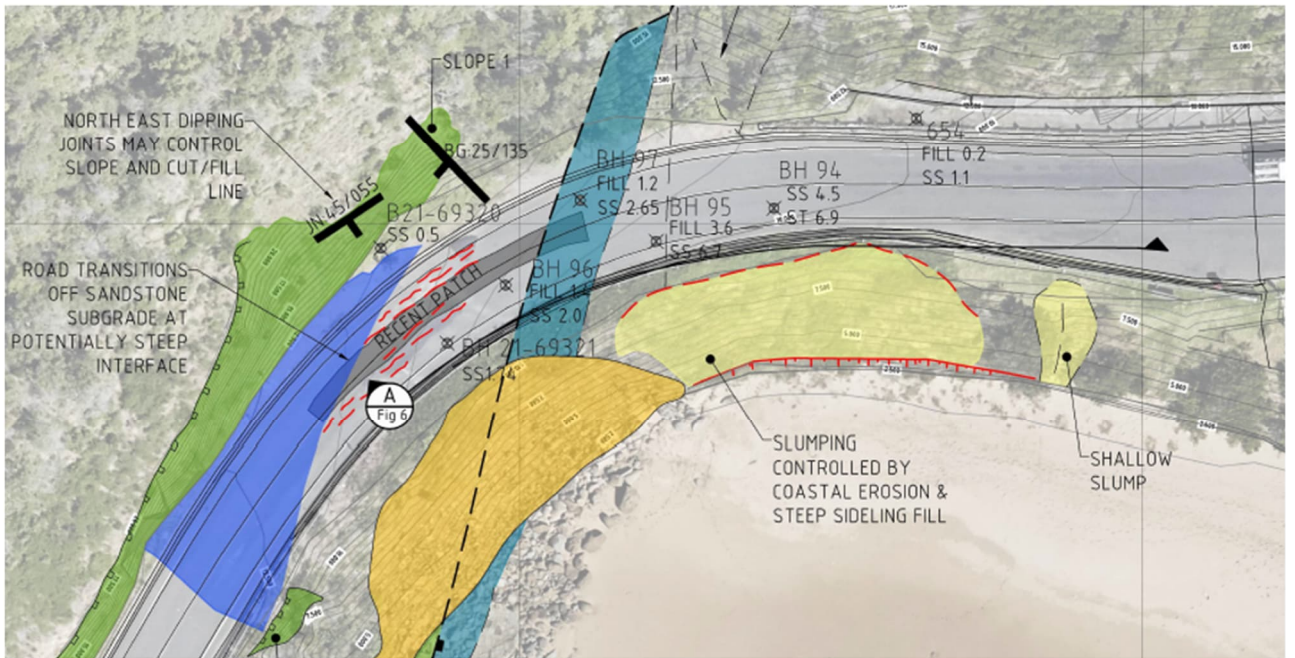
Figure 3: (a) Site plan with pavement cracking in red and translational slides in yellow (b) Detail

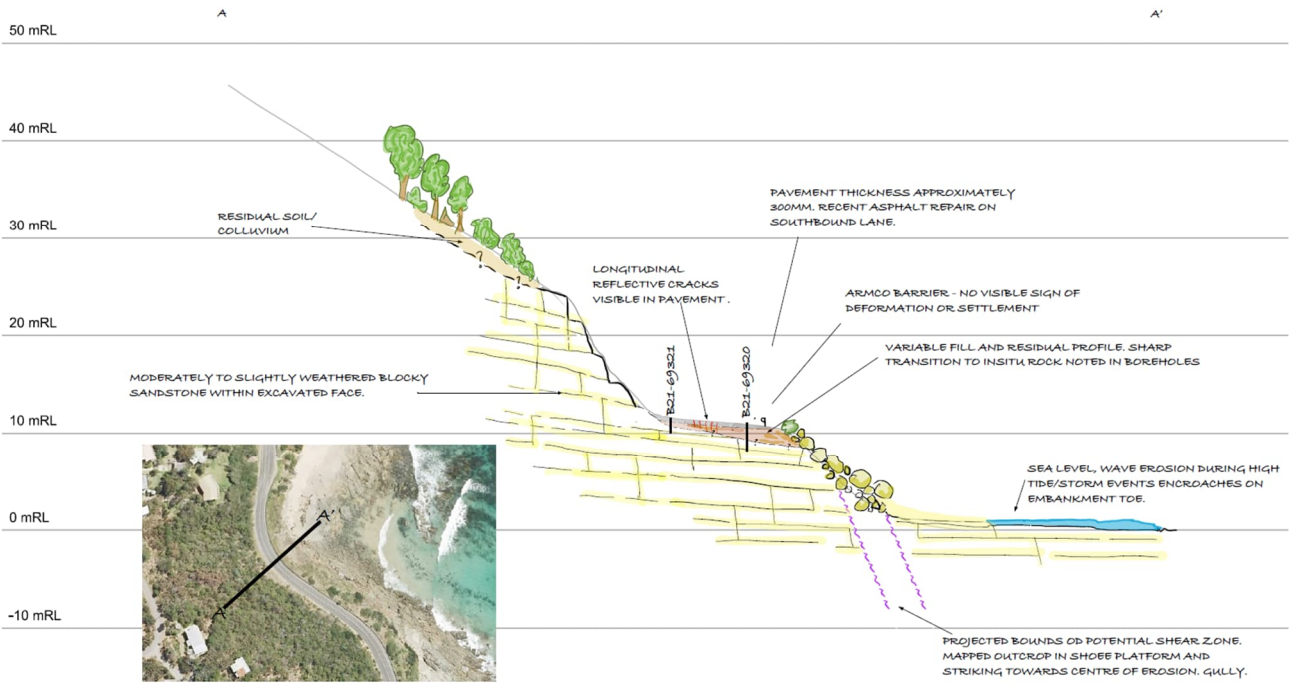
Figure 4 Cross section A-A'

During development of the conceptual geological model the abrupt transition in depth to bedrock was evident in the boreholes, Figures 4 and 5. This occurred broadly where the Wye River bound lane turns towards the north off the Point Sturt headland and immediately adjacent to a steep gully to the west of the roadway, Figure 3. The boreholes on either side of the blue fault zone (dip/dip direction of 70 to 80/020 to 030), Figure 3, indicated that the depth to bedrock changes from 2.0 m at BH96 to 6.7 m at BH97 over 12 m horizontally. On review of the LiDAR it was evident that a gully with moderate to steep convergent slopes was immediately adjacent to the fill slope. At this time, the depth to bedrock in areas of observed pavement steps/cracks, Figure 3, was not understood. A secondary targeted investigation was completed in this area and which identified that bedrock was very shallow in the Wye River- bound lane (0.5m below pavement) and up to 2 m deep in the Apollo Bay- bound lane, Figure 4.

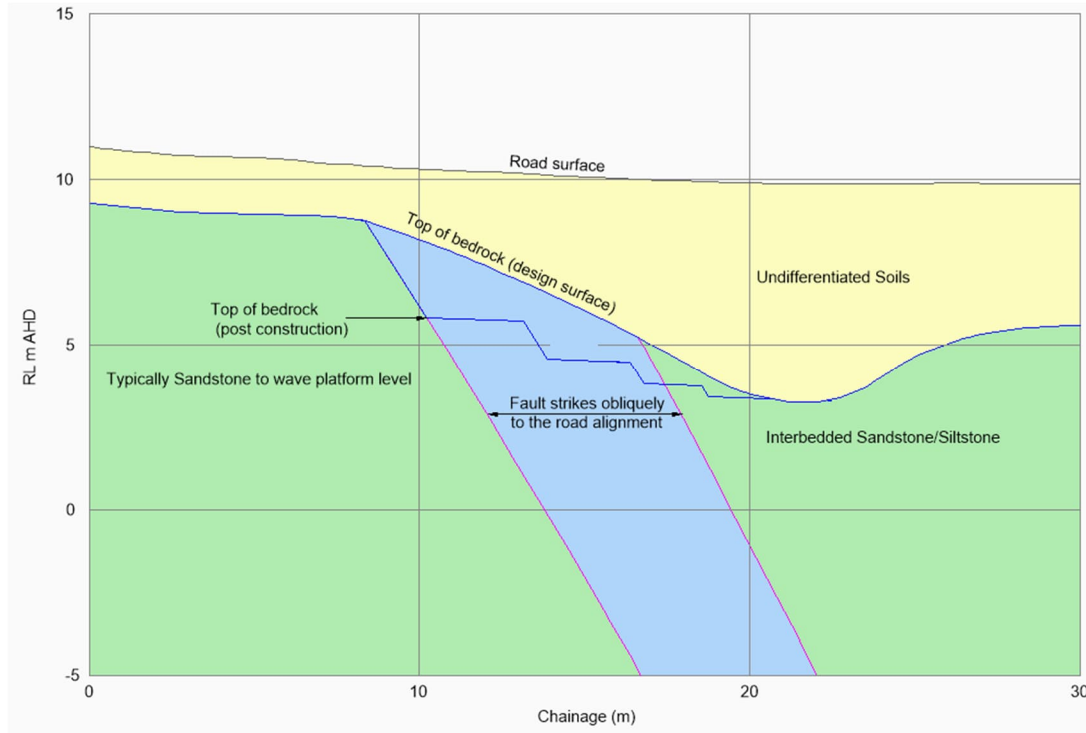
Figure 6: Long Section. Refer to Figure 3 (b) for Section location

stage may have been present on the southern extent of the site where the buried geometry of bedrock was very steep to sub-vertical, Figure 6. The author later encountered a very similar issue at St Georges River, Lorne, Figure 1, and notes that geometry of the buried platform must be considered in scoping both geotechnical investigation and design.

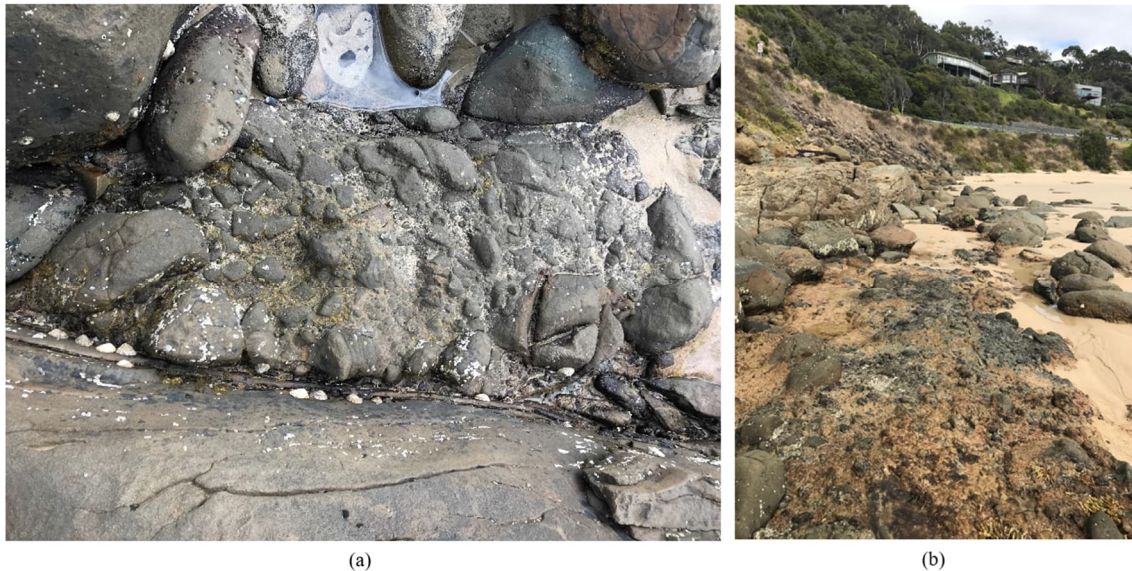
A persistent fault was logged in 2019 as part of a separate investigation, Figures 7 (a) and 8. The author notes that the infill may include partially recemented boulders associated with Quaternary variations in sea level and erosion/deposition (Gill, 1979). The fault zone is inferred to have had a series of tightly spaced joints that were evacuated by erosion. This fault zone is inferred to control the abrupt change in depth to bedrock, Figures 3 to 6 and the location of the gully west of and above the road, Figure 3. Broadly the intersection of the fault with bedding (and bedding parallel shears) is inferred to control the location and axis of the gully.

**Figure 8 (a): Fault with re-cemented boulders/cobble infill which strikes sub-parallel to the gully. Location is highlighted in blue in Figure 3. (b) Looking along strike of the fault towards the GOR and Morley Avenue properties**

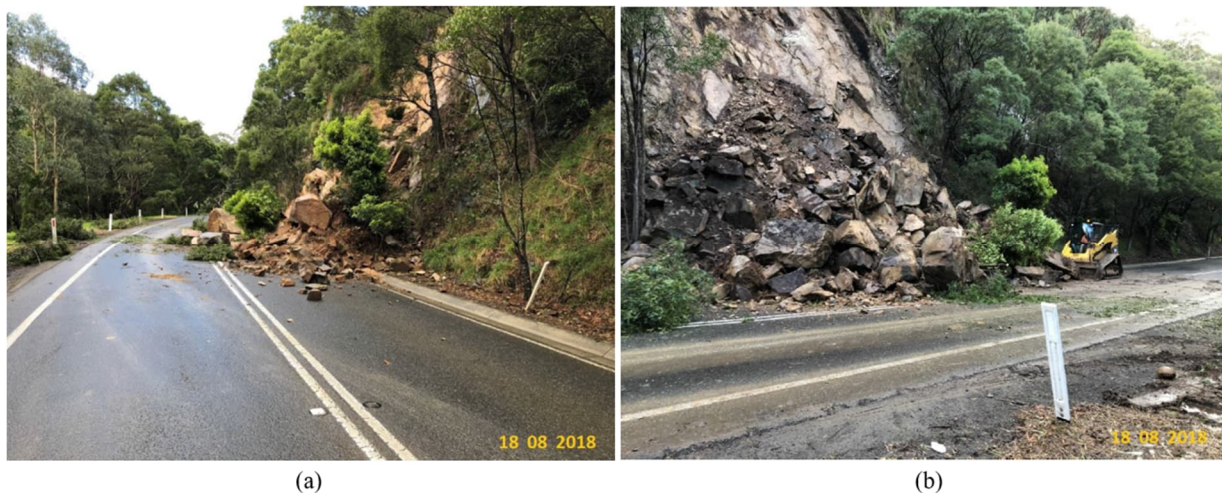
At CH 1.2 km along Skenes Creek Road a thin wedge failure in sandstone bedrock occurred following heavy rainfall on 18 August 2018. The runout initially extended across both lanes and with most of the failure volume (volume in the order of  $50 \text{ m}^3$ ) in the lane immediately adjacent to the slope, Figure 9. The landslide was cleaned up, but parasitic rock falls continued and between 10 to 11 August 2019 rockfall was documented by DTP to have reached the kerb of the opposing lane. Debris impact cracked the kerb. The site required a landslide risk assessment to DTP guidelines followed by conceptual to detailed design advice.

Figure 9: Excerpt from DTP failure records from 18 August 2018 (a) Looking north (b) Looking east

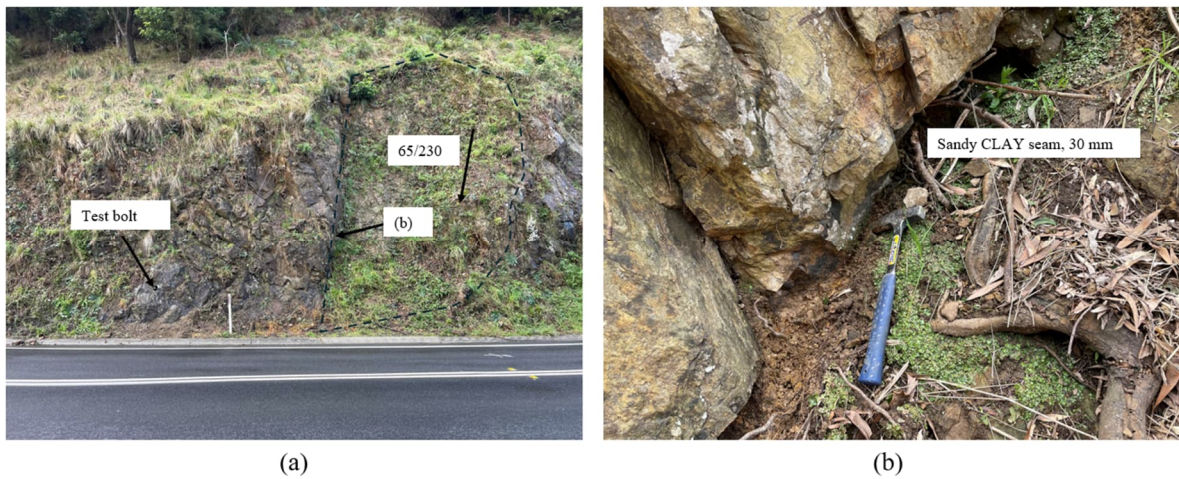
Figure 11: Planar slide at Ch. 115 of Figure 12. (a) Test bolting location and extent of failure (b) Sandy CLAY seam identified as the infill on the sliding plane

Proprietary pattern bolt and mesh systems were the preferred DTP design solution and with the design considering the planar/wedge mechanisms as well as the capacity of the mesh to restrain colluvium, smaller blocks in the sandstone and slaking rock mass in the interbedded sequences. Testing of short bond lengths well in advance of construction validated the adopted bond strengths that were established based on field mapping estimates, Figure 11a.

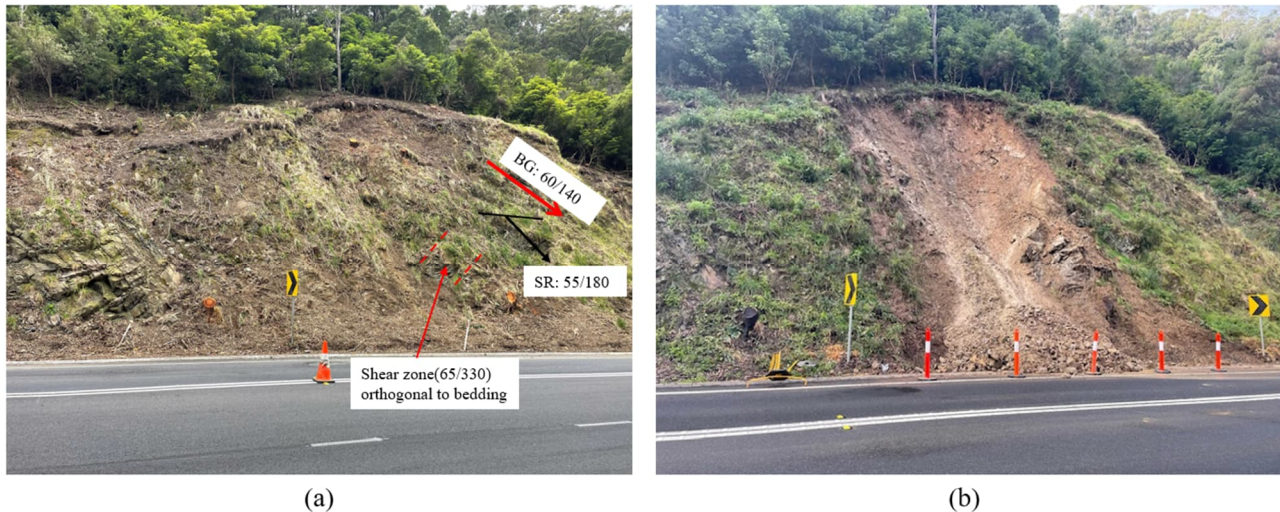
Immediately prior to mobilisation for remediation of the cuttings, a further small landslide occurred, Figure 13. At this location up to 2m of colluvium was overlying a laminated sequence of slake affected siltstone and sandstone of very low strength and with significant shears parallel to dominant joint sets and bedding in this area. The lower portion of the failure was controlled by a wedge formed from the intersection of south dipping shears ( $55/180$ ) with a shear zone dipping orthogonal to bedding ( $65/330$ ), Figure 13. In a zone approximately 120 m long, no less than six similar landslides were inferred to have occurred between the widening of the road in the 1960s and 2022. For a frequency of landslide events of approximately 1 every 10 years, the assessed risk level exceeded typical target DTP levels of "low to moderate" risk or "no further action" required.

**Figure 13: Extent of landslide at location (5) of Figure 12 (a) left hand side in November 2021 (b) right hand side in June 2022**

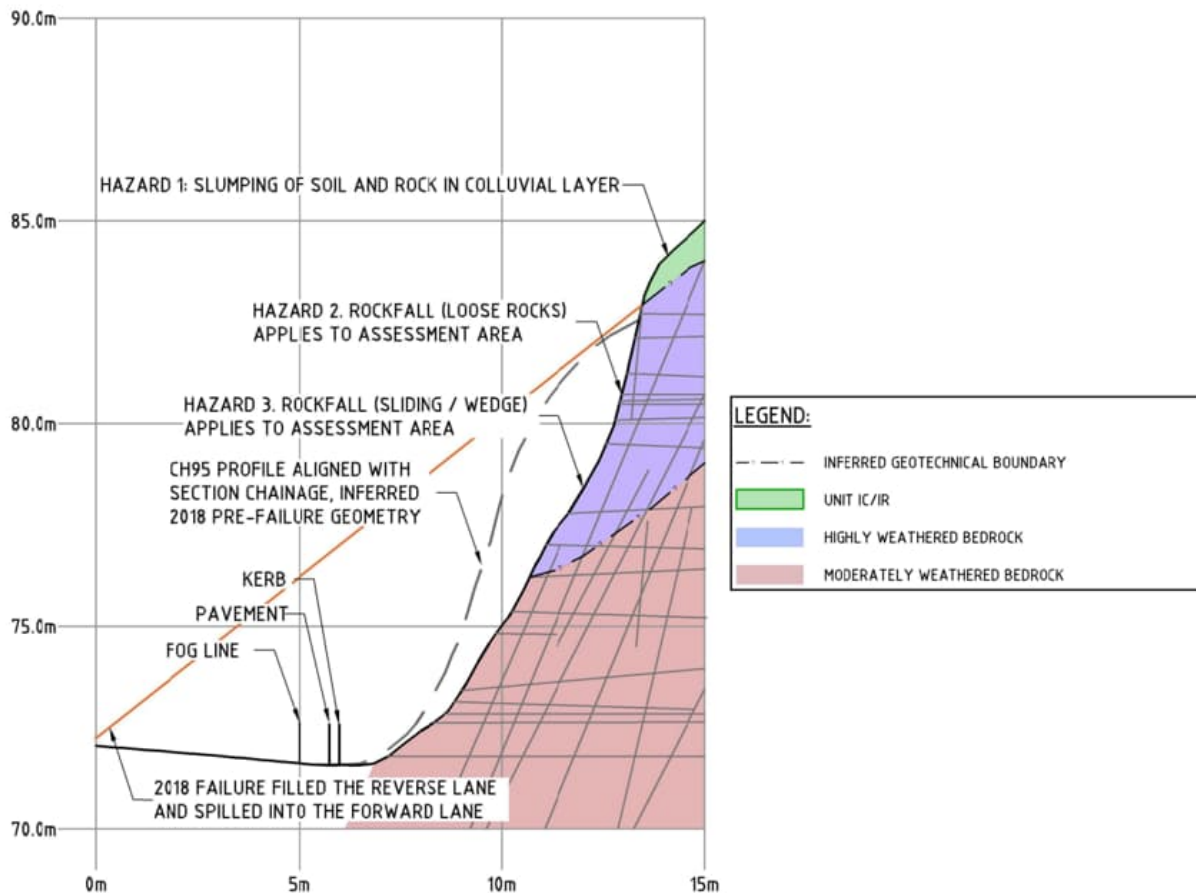
Figure 17: Section 1 with geological model and hazards

The typical block sizes from Table 2 are used to inform the likely size of blocks that may be impacted by a vehicle. A summary of the three hazards is presented in Figure 17 and includes vehicle impacting debris from the colluvial layer (Hazard 1), vehicle impacting debris from rockfall (Hazard 2) and a vehicle impacting debris from a much larger mass associated with planar/wedge failure in the rock mass (Hazard 3).

To mitigate the hazards, two domains were established with the boundary at the contact between the blocky Sandstone and in the interbedded Sandstone and Siltstone at Ch. 60, Figure 12. Both mesh drapery and spot bolting techniques were considered inappropriate due to the highly fractured nature of the rock mass and the observed failure volumes likely to damage drapery systems and require high maintenance.

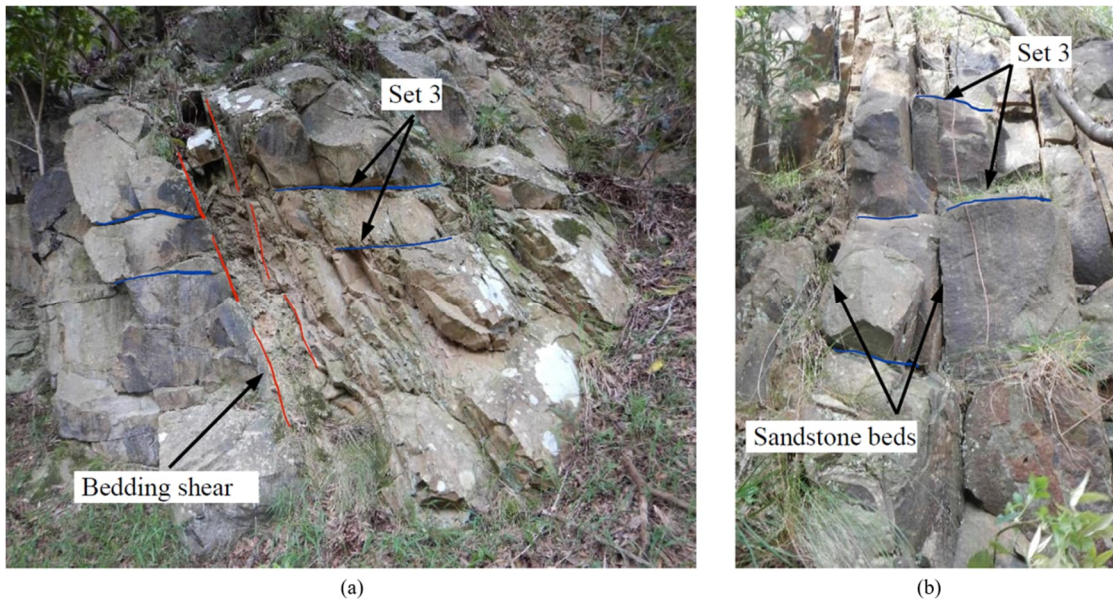
Several shears and shear zones were mapped. Examples included bedding parallel shears Figure 18 (a), where bedding trends are highly variable within the shear zone, shears sub parallel to Joint Set 2, Figure 19 (a) and the closely spaced joints of Joint Set 1, Figure 19 (b).

**Figure 18: (a) Bedding shears and low angles joints at Ch. 60 (Set 3) (b) Sub-vertical sandstone beds at Ch. 147**

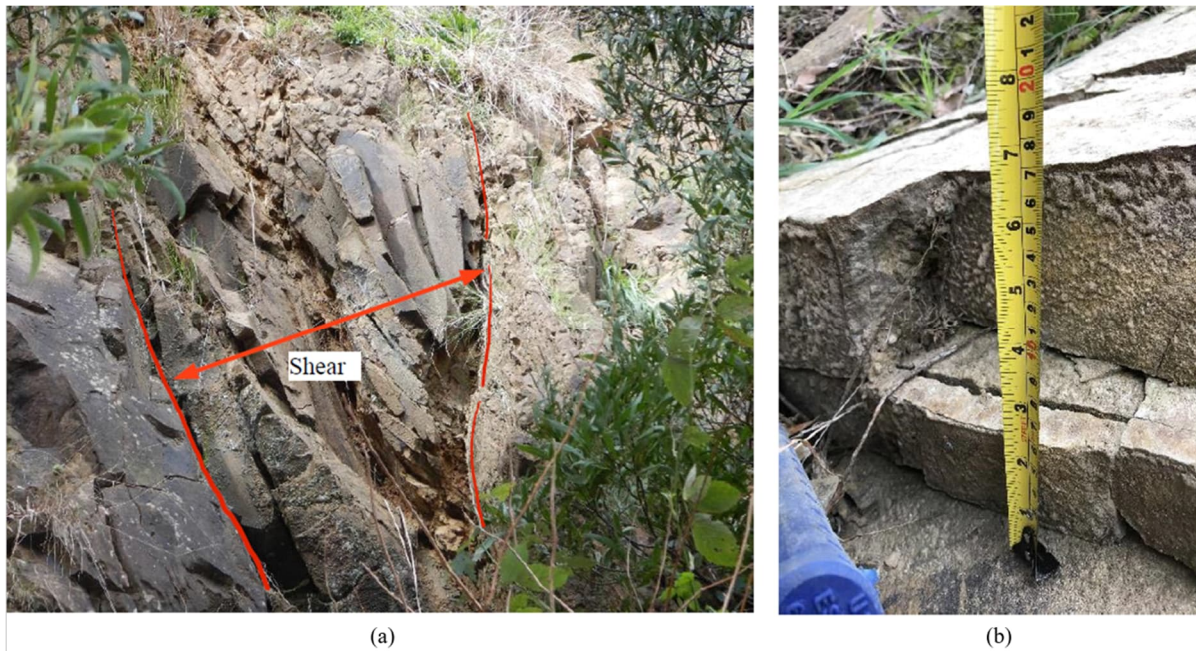
Figure 19: (a) Shears of Joint Set 2 at Ch. 149 (b) Lower bound joint spacing of Joint Set 1 at Ch. 85
