PROCEEDINGS
2018 AUSTRALIAN GEOMECHANICS SOCIETY
VICTORIAN SYMPOSIUM
**Geotechnics and
transport infrastructure**

Highways, water, ground investigation and data – a cautionary tale

T. Creighton¹ and B. Waite²

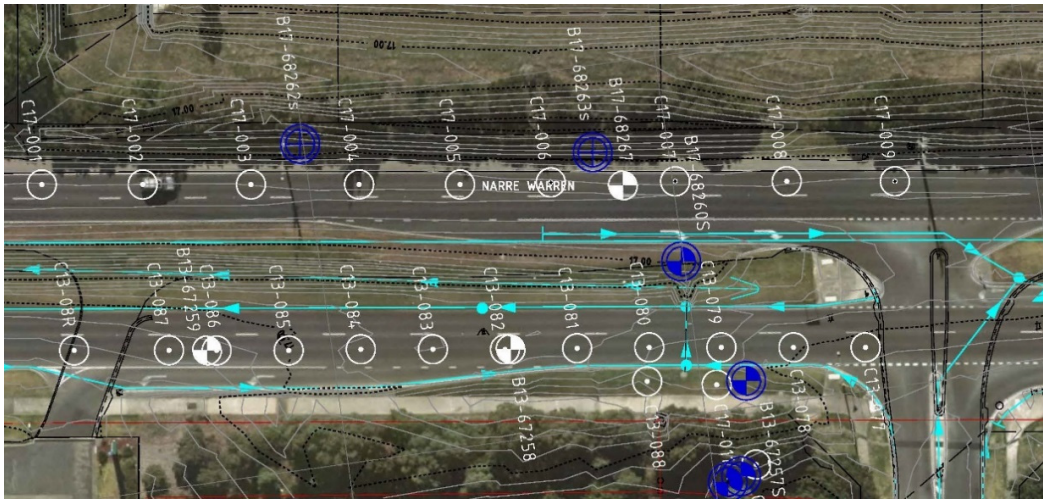
Figure 4. Site investigation locations (north to right)

The first investigation (2013) to specifically investigate the settlement problem included three boreholes and twelve CPTs. The locations were specifically targeted along and adjacent to the section of the southbound carriageway (see Fig. 4) where settlement most affected the road.

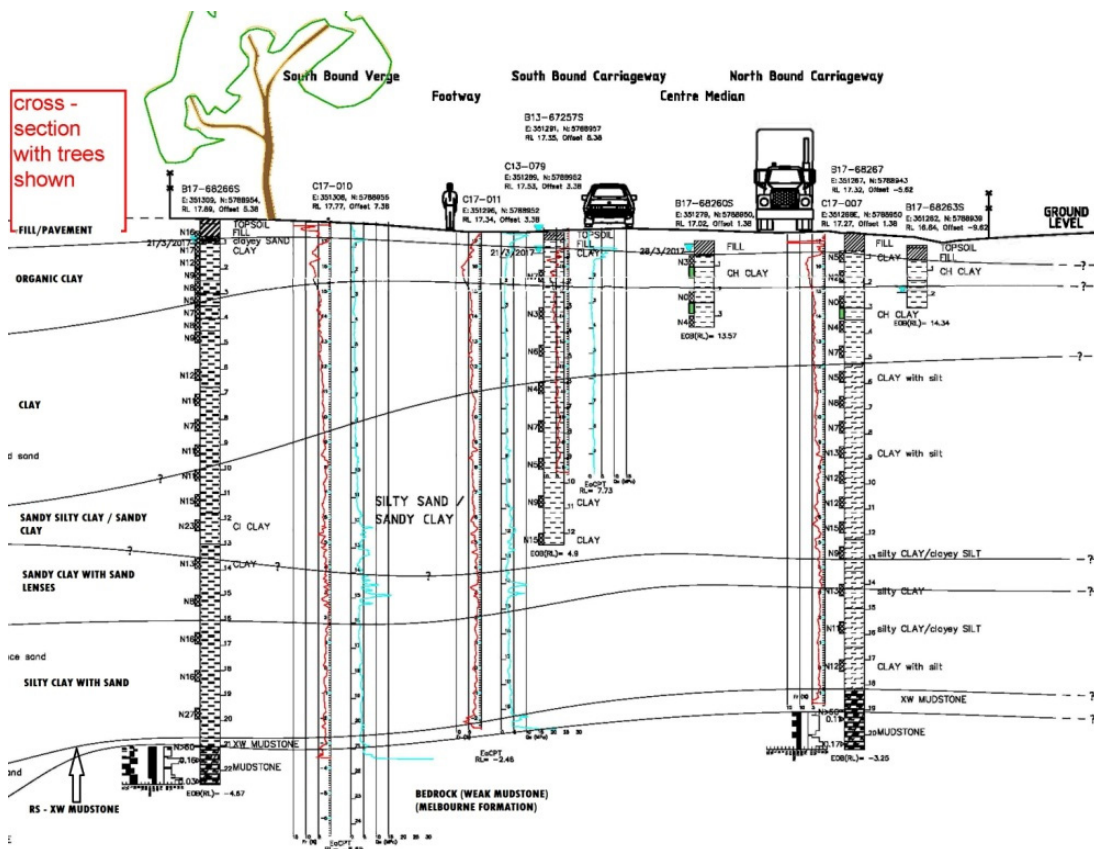
Figure 5. Model section (east to left)

The field investigation work and increased coverage of borehole and CPT information confirmed a geological stratigraphy across the site as shown in table 1 below. The CPT testing in the paludal cover recorded high friction ratios in the upper 4m of soil, suggesting the prevalence of organic clay across the site from ground level to 4m depth. The investigation locations for both the 2013 and 2017 investigations are depicted in Figure 4. The additional groundwater monitoring points provided the groundwater observations described in Table 2. The CPT also confirmed the existence of perched water tables within the first metre below much of the site, and deeper water bearing intercalations of coarser material with rapid piezometric response, confined by high plasticity clay units, producing a water table encountered at between 6m and 8m below ground level, but with static head at or near to ground level. Chemistry of the (deeper level) water from the 2013 borehole indicated it to be

representative of regional groundwater, rather than derived from leaking services. A summary cross section through the affected area from east to west is shown in Figure 5.

The settlement of the southbound carriageway was regarded as most probably resulting from a localised deep area of very soft natural organic clays. This carriageway had apparently shown little settlement in the two years immediately following construction, but for the ten years afterwards had undergone settlement at an average of 40mm per year. There appeared to be no clear defining explanation for the quantum of settlement observed, with a mostly undrained environment and without the presence of significant thicknesses of peat, but it appeared most likely to be the result of a combination of services construction work (in the years prior to the road duplication) to a floor depth of 4.7m below ground surface, and re-use of locally excavated clay for backfill, combined with the effects of the trees that grew from saplings to maturity on very soft organic clays. as in Figure 6.

As well as reconstruction of the highway drainage to an operable state, two separate solutions were recommended to repair the road. That for the southbound carriageway involved the construction of a mechanically stabilised rock platform with geosynthetic separation layers, to bridge the problem area and allow it to settle at an even rate in line with the rest of the road alignment. For the northbound carriageway, a conventional softened subgrade repair was specified.

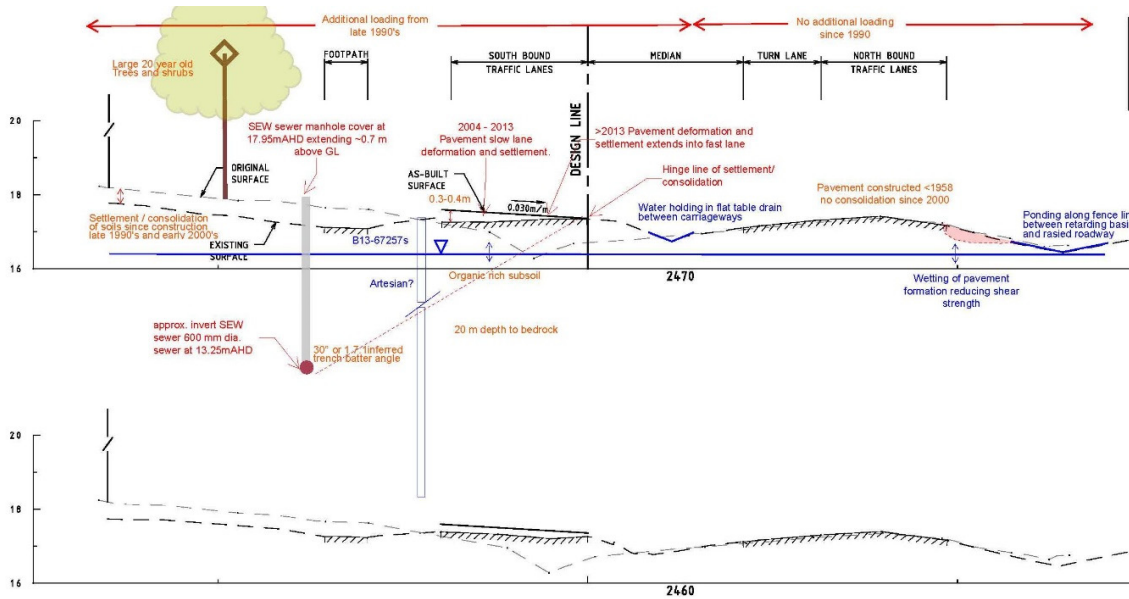
Figure 6. Interpreted section (east to left)

On the northbound carriageway, the damage was recent and appeared to result from wetting of the subgrade, caused by damage to the drainage infrastructure along the road median resulting from the extreme settlement taking place along the southbound side of the road.
