# Monitoring geohazards and trigger level response on Deans Head in the Port Hills, Christchurch

Z. J. Pletz<sup>1</sup>

<sup>1</sup>Aurecon Ltd., Unit 1, 150 Cavendish Road, Casebrook, Christchurch 8051, New Zealand; PH 03-366 0821; email: zoe.pletz@aurecongroup.com

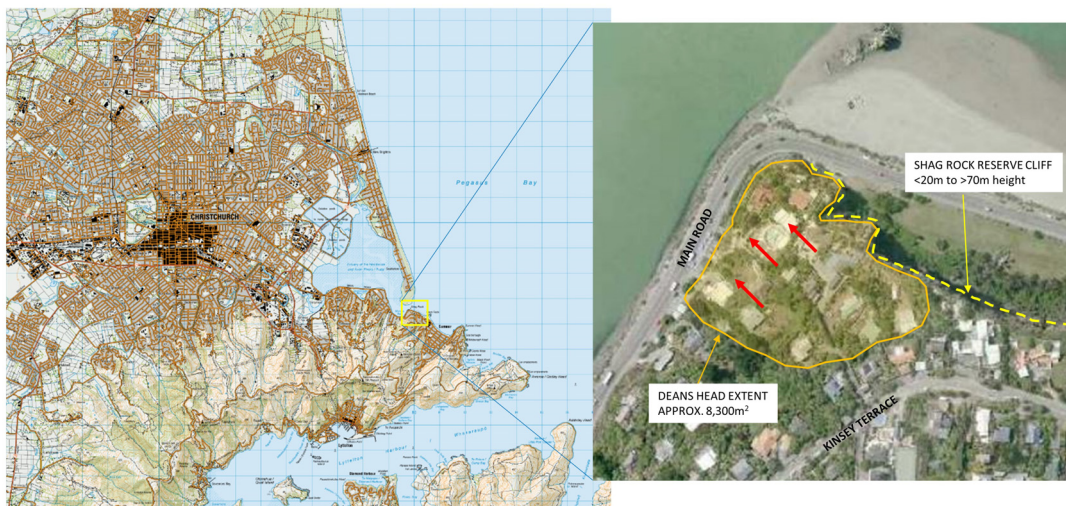
Figure 1. Deans Head site area, extent & indicative landslide direction (in red), LINZ and LiDAR, 2011

The Deans Head site area is located in the Christchurch suburb of Sumner and covers an area of approximately >8,300m<sup>2</sup>. The site is located on a gentle to steep sloping hillside (averaging 20°-30°) above Main Road. Main Road forms a key lifeline route between the Lyttelton Port and Christchurch. The site comprises two main geohazards, cliff collapse (and retreat) along the northern fringes of the site (mainly Shag Rock Reserve) and a mass movement (landslide) area containing an estimated 46,000m<sup>3</sup> of soil material that could be triggered by potential rainfall events (Massey et al., 2014). From surface movement and slope displacements, landslide direction has been modelled in a northwest direction (in relation to the site). The site features and indicative landslide direction is outlined in Figure 1.

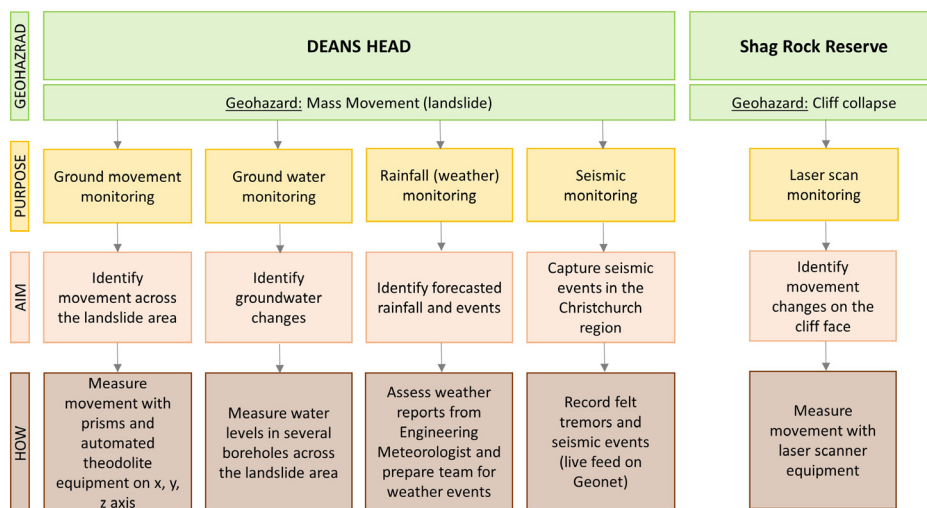
Figure 2. The main geohazards (mass movement and cliff collapse), monitoring technique (purpose), aim and how data was collected is outlined for Deans Head and Shag Rock Reserve.

Several monitoring techniques have been implemented on Deans Head for ground movement, ground water, rainfall (weather), seismic and laser scan monitoring in Shag Rock Reserve. Addressing key site constraints and site features was important when selecting the most appropriate monitoring technique for Deans Head. These were identified and discussed in risk workshops with the project geotechnical team, survey team, project managers, client and key stakeholders so all hazards were covered and a robust monitoring network established. Some of the main constraints discussed during the Deans Head project included; the type of geohazards (and hazards) on site, mode of failure, likely triggers, access to the site (and reducing people in high risk areas), how often data is required, what cost effective equipment is available and proposed works on site. During the Deans Head project, each monitoring technique was run through a simple what are we trying to carry out (purpose), the aim of the technique and how would this be measured to identify if the main modes of failure and geohazard have been covered. An overview of the purpose, aim and how data was collected for each monitoring technique is outlined in Figure 2.

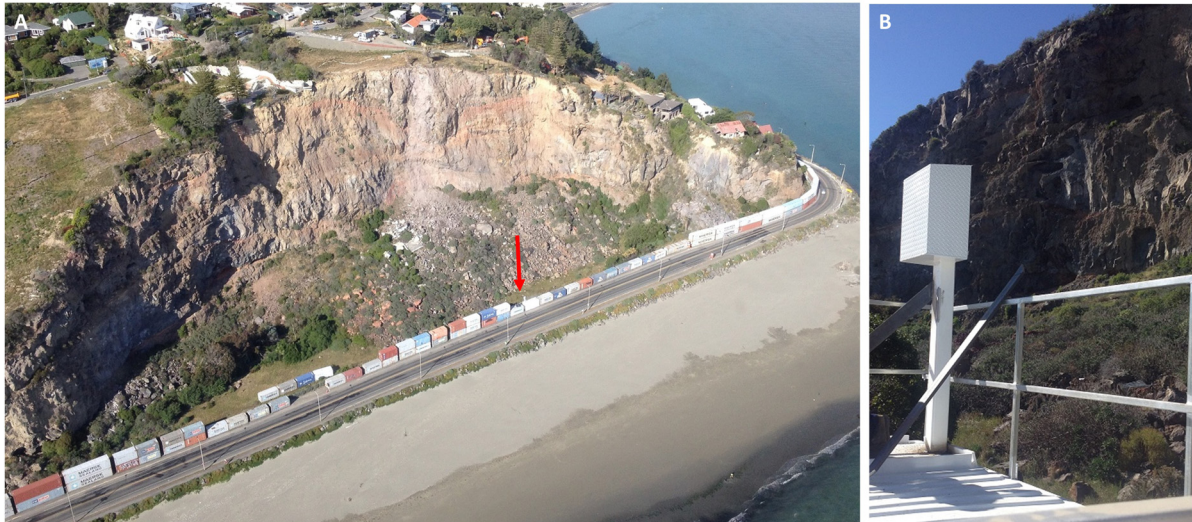
Figure 4. Laser scan monitoring Shag Rock Reserve, Sumner; A, aerial of Shag Rock Reserve cliff face and reserve area, the monitoring container location is shown with the red arrow; B, laser scan unit in monitoring box mounted in the monitoring container (as indicated by red arrow in photograph A).

Cliff face monitoring was undertaken to identify cliff face changes below the site in Shag Rock Reserve. A laser scan MS50 laser scanner was established adjacent to Main Road to remotely measure cliff face changes using a mesh comparison model full time. Similar to the set up of the ground movement monitoring system as outlined in Section 2.1 above, several issues arose prior to equipment establishment, including limited suitable locations for equipment set up, security of equipment, powering the equipment, how will data be received and stabilising equipment (a low movement tolerance).

With Main Road and the Shag Rock beach area below, suitable site locations were limited. Equipment was housed in a purpose built container along Main Road and in alignment with other temporary containers protecting the road against potential rockfall. Equipment was secured on a thick steel pole that was welded to the top of a container. The internal area of the container was reinforced below the steel pole to reduce warping of the container and equipment movement. One of the control prisms on reserve Spit (from the ground movement monitoring) were referenced as a control prism and an additional prism was mounted in Shag Rock Reserve. The laser scanner was linked to solar power and battery units to power equipment continuously. Data was relayed to the project office via the same radio communication system used for ground movement monitoring. Photographs of the laser scan monitoring set up and aerial of the Shag Rock Reserve cliff face area are shown in Figure 4 (overleaf).
