# EXCAVATION, STRUCTURAL STABILISATION AND GROUNDWATER MANAGEMENT BY JET GROUTING ON SYDNEY HARBOUR FORESHORE

David A Chadwick<sup>1</sup> and Derek L Avalle<sup>2</sup>  
<sup>1</sup>Southern Region Manager, <sup>2</sup>Senior Engineer  
Keller Ground Engineering Pty Ltd, Sydney, Australia

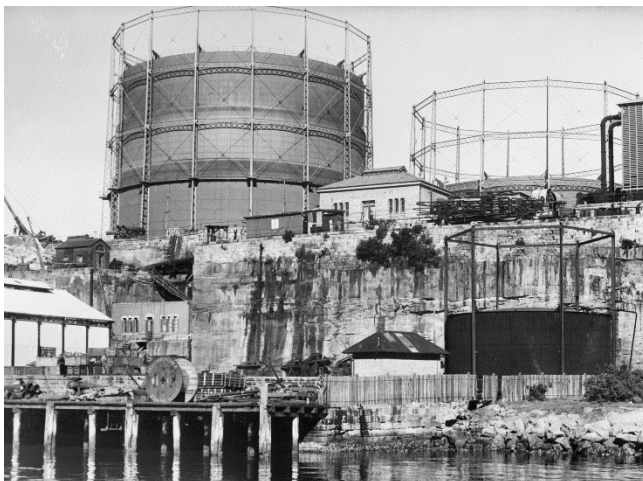
Figure 1: The northern part of the site in the early-1900s. (HMAS Platypus 2012)

Hawkesbury Sandstone cliffs form the western side of the site (as can be seen in Figure 1). The fairly flat concreted area from the foot of the cliff to the seawall comprises mainly fill (see Figure 3). The fill deepens progressively towards the seawall, to a maximum depth of about 7m. A thin and variable layer of marine mud occurs between the base of the fill and the sandstone bedrock. Contamination extended through the fill and into the muds.

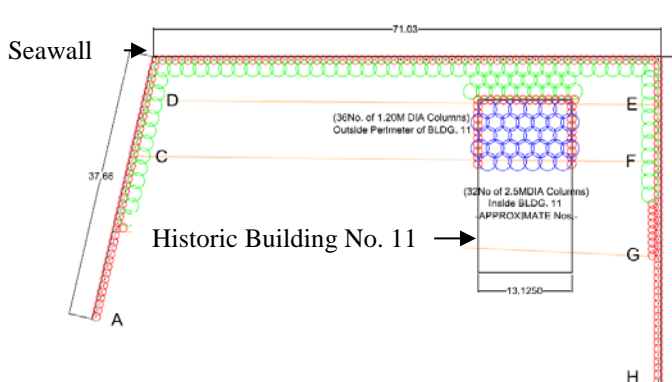
Figure 4: Plan showing Jet Grout column locations.

- The first row of columns behind the seawall and the columns underpinning the exterior of Building No. 11 were 1.2m diameter, spaced at 0.9m centres.
- A second row of columns 2.2m diameter at 1.8m centres was installed behind the first row in the sections of deepest seawall, adjacent to Building No. 10 and in the area between Building No. 11 and the seawall.

- Columns 2.5m diameter were utilised within Building No. 11 for insitu stabilisation, as the floor in this area was to be retained (see Figure 4).
- Jet-Grout columns were installed using a “Double” jet grouting system (see Figures 7 and 8), utilising either a standard jet grouting rig, or a rig suited to restricted access and/or limited headroom conditions (see Figures 12, 13 and 15).

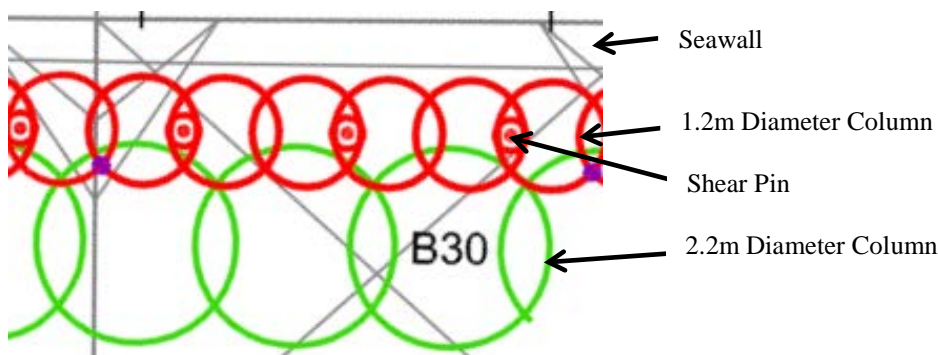
Figure 6: Detail arrangement of Jet Grout columns and shear pins.

The following description and figures highlight the main features of the solution adopted by KGE, in accordance with the Client’s specification, and are illustrated in Figures 4 to 6 (Keller Ground Engineering 2012):

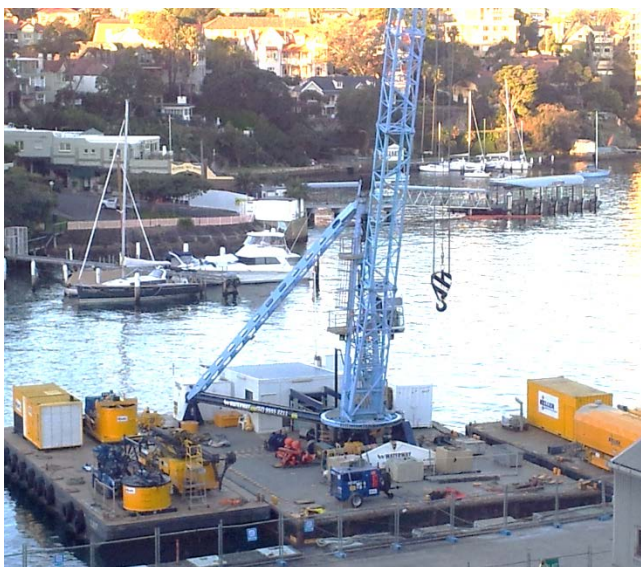
Figure 9: Most KGE plant and equipment was transported to/from site by barge and craned onto/off the wharf.

Due to residential street access constraints, the very limited space on the site for truck entry and turning, road load restrictions, and limitations on delivery times, most of the plant, equipment and materials were delivered to site by barge, with the Jet Grouting batching area established on the wharf (see Figures 9 to 11).

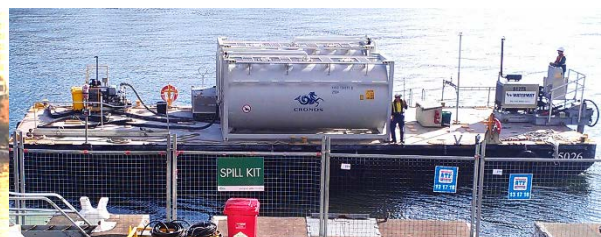
Figure 10: Cement supplies arrived daily by barge.

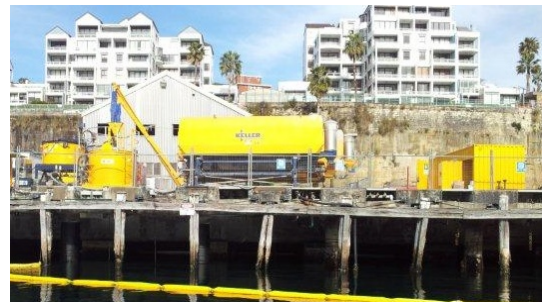
Figure 11: Jet Grouting support plant on the wharf.

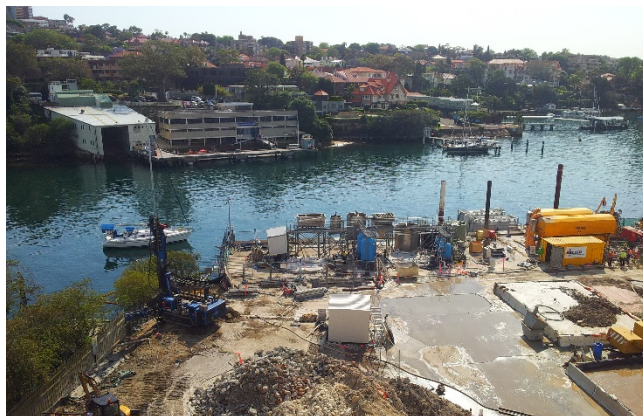
Figure 12: Jet Grouting on the seawall after initial trials.

The trials and early works in the northern section of the site commenced prior to erection of the OCE. Figures 12 and 13 illustrate the works at this stage of the project. Works in the southern section of the site were conducted in restricted access conditions either within existing buildings or in small isolated work areas. The spoil generated by the jet grouting process was pumped to above ground storage lagoons, located in the northern part of the site, where it was allowed to set over a period of 1-2 days before being stockpiled for disposal off site.

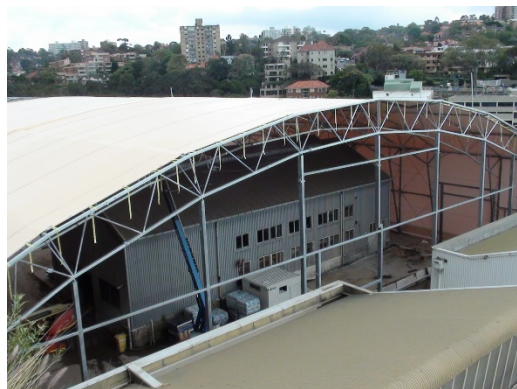
Figure 14: The OCE under construction (over the top of Building No. 11).

Once the dome had been erected and remedial works commenced, the environmental and occupational health aspects dictated stringent precautions for operating personnel. Figures 14 and 15 give an idea of the working conditions during this phase of the project.

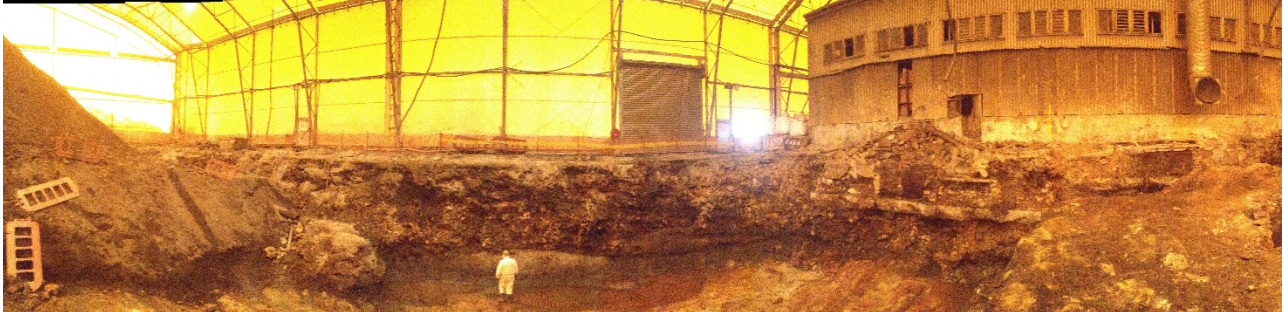
Figure 17: Panorama during excavation – centre facing the rear of the seawall (approx. 7m excavation depth and up to 6m below sea level), to the right is the underpinned Building No. 11.

The excavation works to remove and treat the contaminated fill were carried out sequentially across the site. Observations of the jet grout wall and base of the excavation were made during this process in regard to water ingress – seepages were not measurable and appeared to come mainly from the land side. The works were carried out in what were essentially dry conditions (see Figure 17).

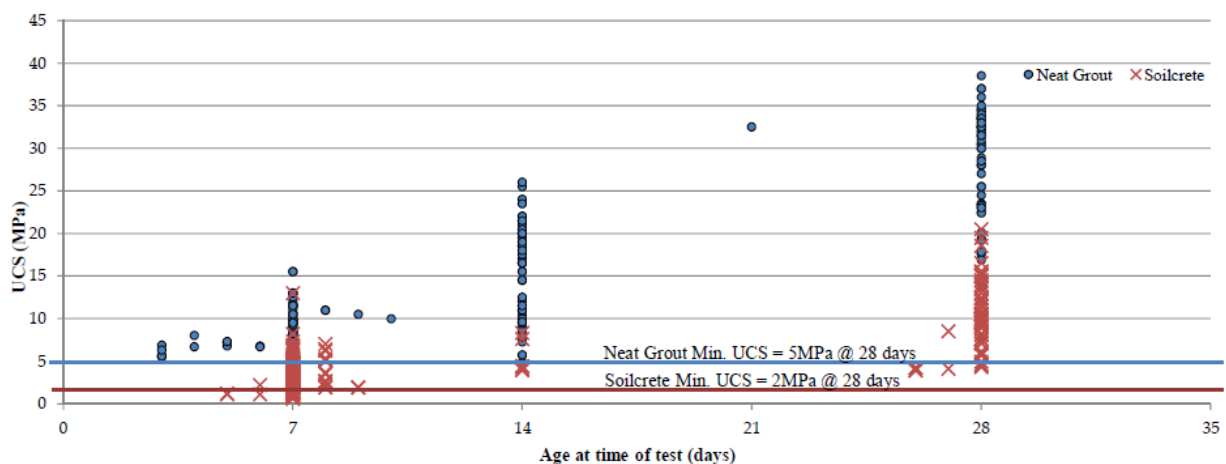
Figure 18: Soilcrete and neat grout Unconfined Compressive Strength test results.

Unconfined Compressive Strength (UCS) testing was conducted throughout the project on representative samples of jet grout slurry returns (Soilcrete); grout from the jet grout batch plant (neat grout); shear pin installation grout (homing grout) and the grout used for rock grouting. The information relating to Soilcrete, neat grout and homing grout is summarised in Table 1 and demonstrates compliance with both the project specification and the KGE design requirements. Figure 18 shows the increase in UCS over time for the Soilcrete and neat grout samples.
