# CONTAMINANT FLOW IN GROUNDWATER IN HAWKESBURY SANDSTONE – EXPERIENCE FROM MAJOR BASEMENT EXCAVATIONS

**Malcolm Dale**

## ABSTRACT

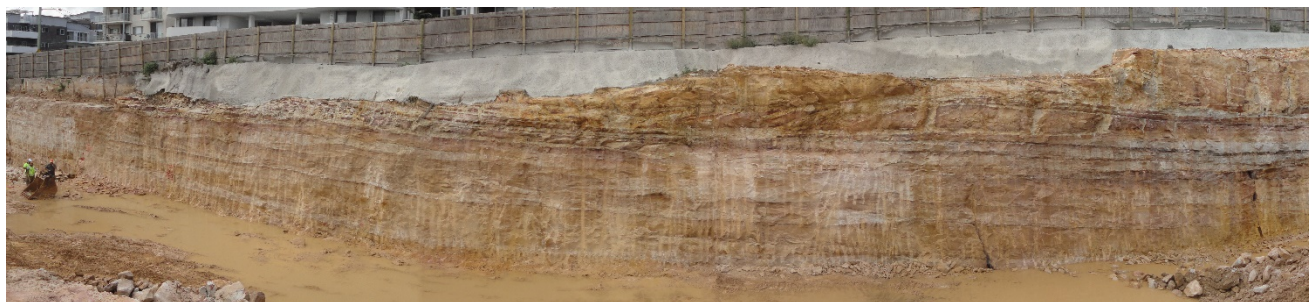
Figure 1 Various sedimentary facies exposed over nearly 100 m at Mortlake, NSW.

There is considerable lateral and vertical variation of facies within the Hawkesbury Sandstone making it difficult to correlate the three facies over long distances but they can usually be correlated in most basement excavations (See Figure 1).

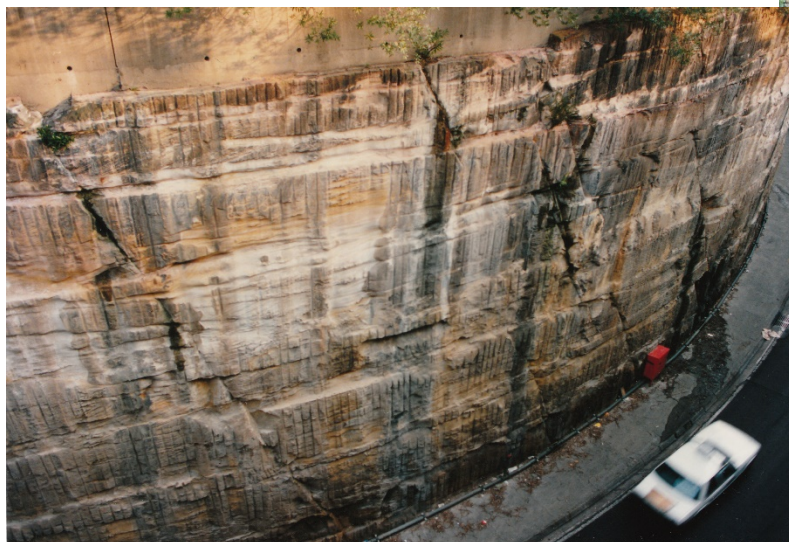
Figure 2: Sub-vertical continuous and discontinuous joints within the Hawkesbury Sandstone in the Fort Street cut near the Harbour Bridge.

Two dominant joint directions have been identified, oriented at 005 — 035 degrees (true) and 090 — 125 degrees. The latter coincides with the dominant igneous dyke directions (Herbert, 1980 & Dale et al, 1997). In addition to the dominant direction, joint swarms are noted in the NNE – SSW direction by many commentators and documented in Och et al 2012. Joint swarms have been observed by the author at approximately 300 m spacing in the inner city similar to those identified in Figure 2. The joints in the swarms tend to be relatively continuous across the sedimentary facies but may also be offset with both types visible in Figure 2.

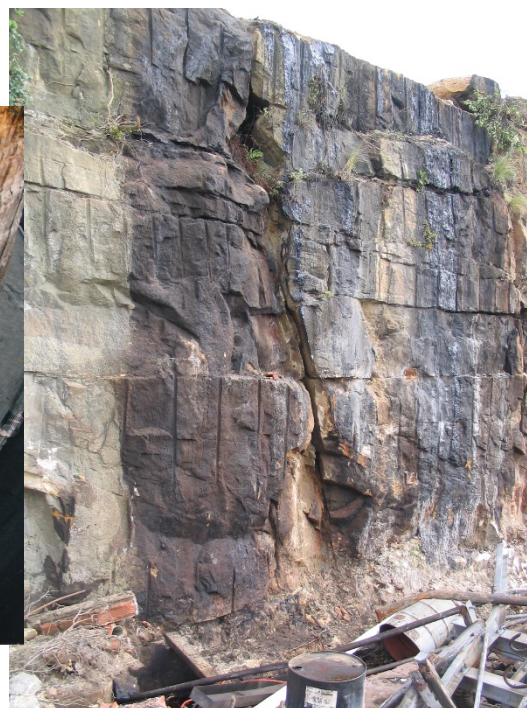
Figure 3: Sub-vertical joint and primary migration pathway Ballast Point, Birchgrove, NSW.

Elsewhere, joints often terminate on a bedding plane visible in Figures 3, 4 and 8.

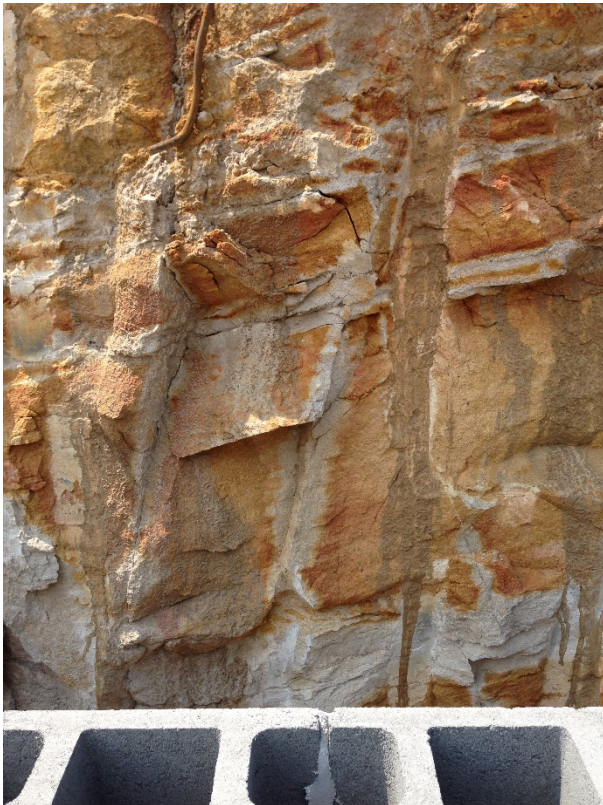
Figure 5: Weathering along cross bedding planes, and subvertical joints at Meadowbank

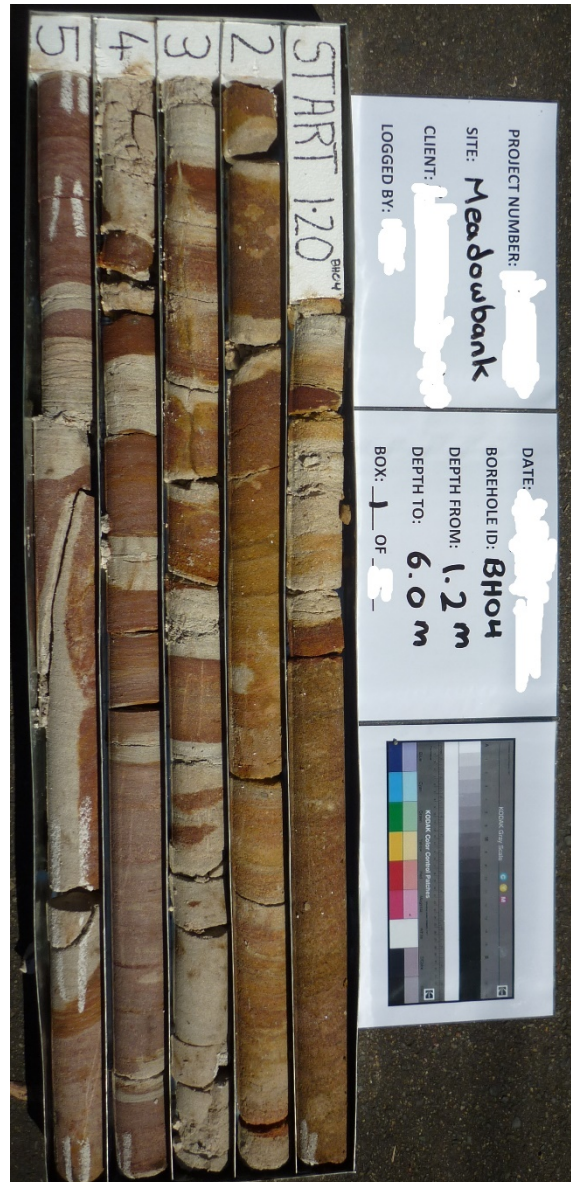
Figure 6: Borehole close to excavation in Figure 8 showing weathering in NMLC core

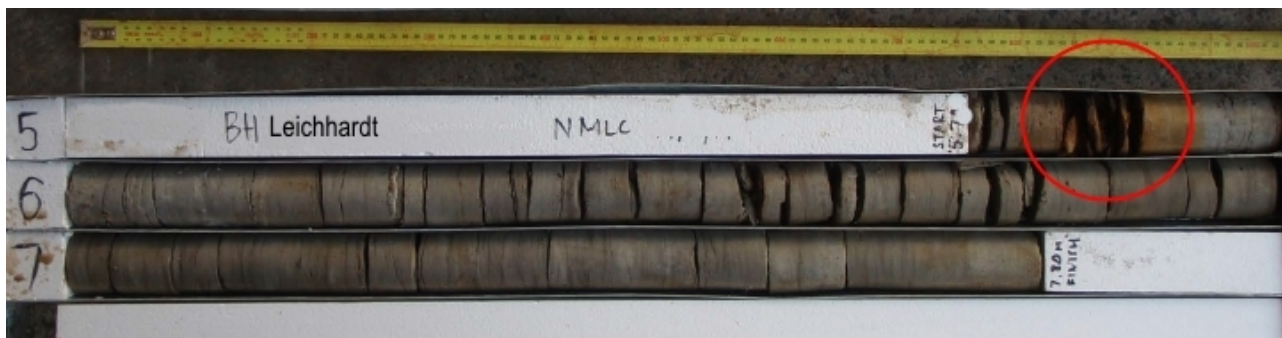
Figure 7 Migration pathway for chlorinated solvents along major bedding plane, Leichhardt

At most sites, the groundwater is present in the surficial fill and residual soil layers and in the underlying sandstone bedrock fractures. The amount of water will be dependent on the general surface water recharge and prevailing weather conditions of the local area. Sites near the top of a ridge crest area, may have limited catchment areas which is often restricted by paved surfaces, building footprints and the various street/stormwater drainage systems. The infiltration will migrate across the bedrock surface and into any weathered bedrock or bedrock joints and bedding planes. Vertical migration is controlled by the vertical or sub-vertical joint sets (and any faults or dykes) and the rock matrix permeability and the horizontal migration is controlled by the bedding planes and any structural unloading cracks. Migration pathways are often seen on selected bedding plane fractures and are visible in many of the core photographs provided in the various geotechnical and environmental reports (see Figure 7).

Fracture/bedding patterns can be identified and developed into a conceptual site model (CSM) from regional data (as indicated above); but, details regarding specific fracture/joint orientation, bedding plane locations, depths, and interconnections (continuous or discontinuous) on a local site scale is much more uncertain without detailed investigation. Water transmitting characteristics of individual fractures are related to aperture size, openness, and interconnections with other fractures or bedding planes. Fractures in the Hawkesbury Sandstone within the top 20 m, generally tend to be more open and transmissive than those in fresher sandstone at depth (Tammetta & Hewitt, 2005). For example, a permeability of 2 m/d was measured near the bedding plane in Figure 7 at 5.7 m below the surface.

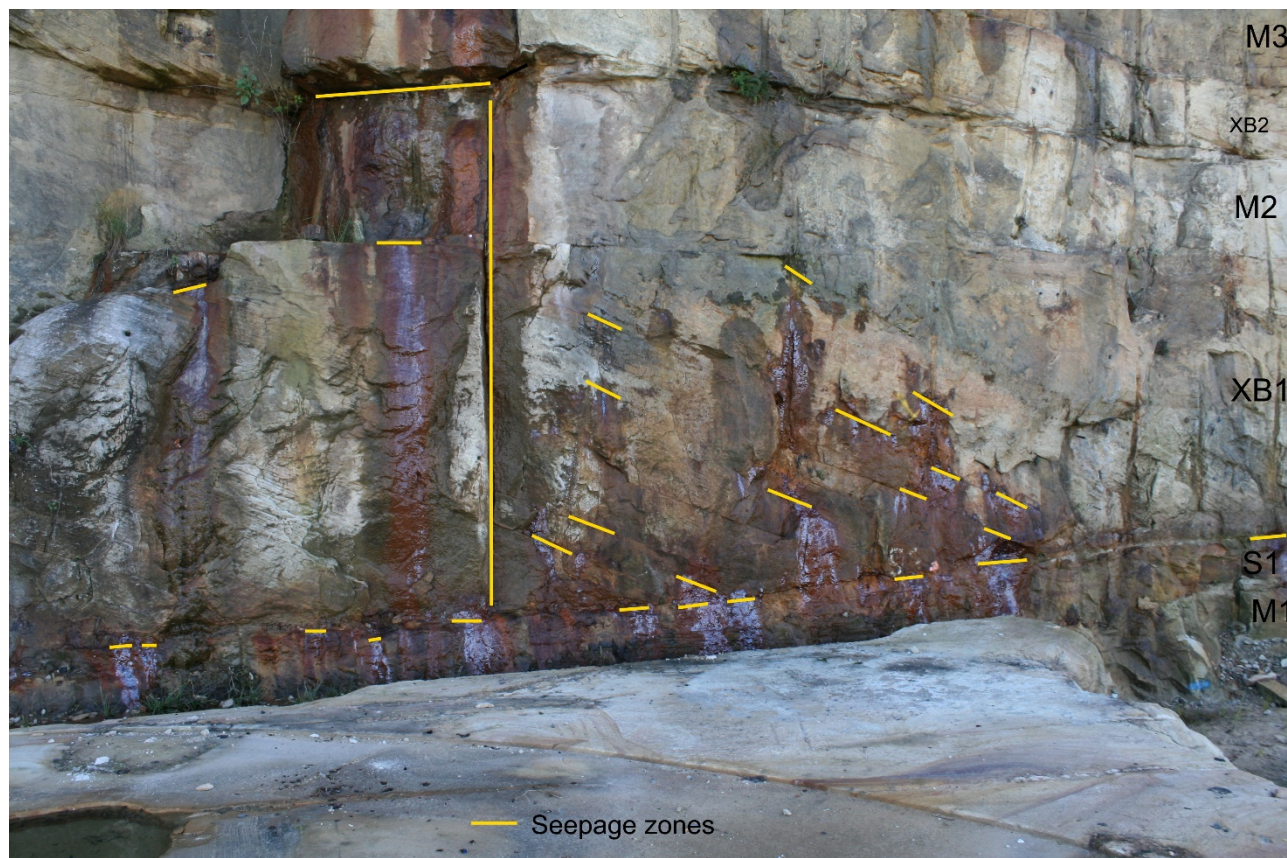
Figure 8 Hydrocarbon impacted seepage visible on bedding planes at Ballast Point, Birchgrove. Several zones of groundwater were encountered in the Hawkesbury Sandstone at Mortlake (Figures 1, 4 & 9). The perched zone identified localised seepage water present at the fill / sandstone interface, and was influenced by fresh surface infiltration. The upper groundwater zone was present within a water bearing zone highly weathered, iron stained sandstone present beneath the site (depicted in Figure 4), at an approximate depth of 6 – 8m below the surface. Below this cross bedded and laminated (with siltstone) sandstone, massive fresher sandstone was encountered which was saturated (the lower groundwater zone) and continually seeped into the excavation. The base of upper groundwater zone overlying the fresher massive rock an erosional surface characterised by a siltstone breccia.

The impact of open discontinuous fractures can be seen in the Hawkesbury Sandstone at Ballast Point (Figure 8) which was a former oil and grease terminal and now developed into a harbour side park. Residual hydrocarbon contamination which is present in the open joints and the rock matrix is seeping out of the sandstone on the planar and cross bedded bedding planes (above layer S1). The contamination is degrading within the fractures and rock mass resulting in the development of a low oxygen environment causing the iron to convert to the ferrous state ( $Fe^{2+}$ ). On exposure to air the iron converts to ferric iron ( $Fe^{3+}$ ), often with a bacterial slime as depicted in Figure 8. The joint terminates on the S1 layer with seepage and build-up of saturated rock on the planar surface. The resultant saturation has also allowed seepage from the cross bedding planes sloping downwards from the main joint. On some days the hydrocarbon odour is still present but was previously assessed as very low risk to human health and the environment.
